Severity: LOW | Risk Score: 14.0/100

| Field | Value |
|---|---|
| Zone ID | live_1279be6a_2 |

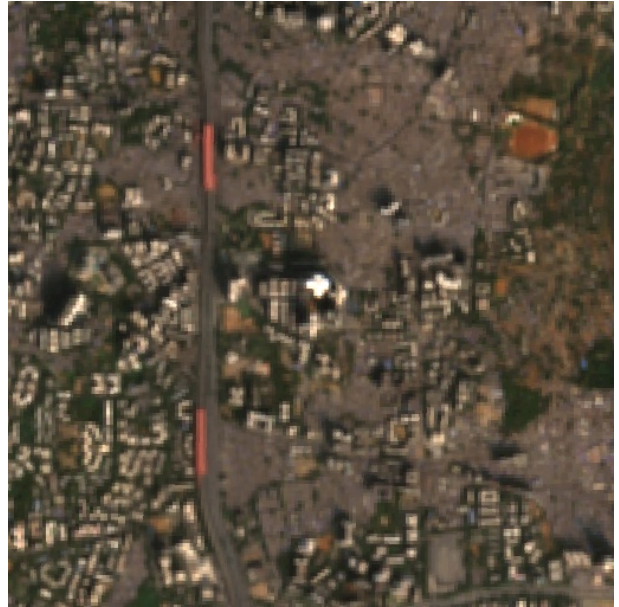
2025 - After Construction

This zone received a LOW score of 14.0/100 because the detected construction covers 1100 sq metres - a small satellite-detected built-up change.

Land Classification Note: The land classification for this zone could not be verified against available zoning data. The flag is based solely on the magnitude of satellite-detected construction change. Ground verification is required to determine the applicable land use rules.

The images below show the flagged location in 2024 (before) and 2025 (after). Visible change in land cover - new grey/brown built-up area replacing green or open land - confirms the satellite detection.
