# AutoSentinel

## Premium Unauthorized Construction Detection Report

Generated: 03 August 2026, 22:14 IST | Analysis period: 2019–2026

Area analysed: Mapped construction alert

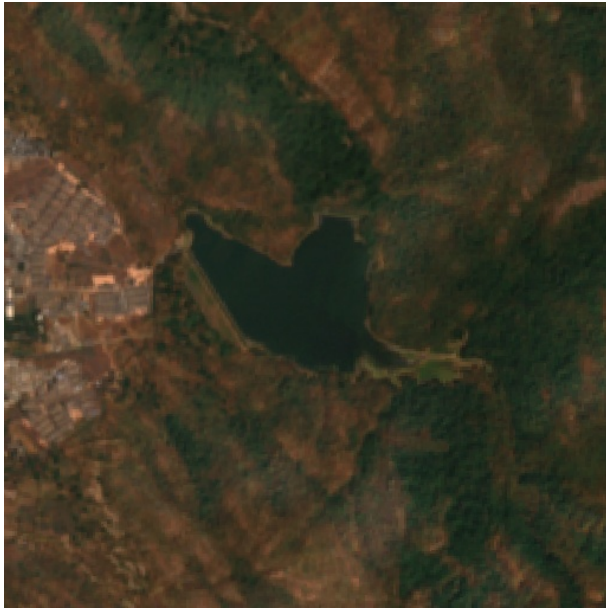
2019 - Before Construction

The images below show the flagged location in 2019 (before) and 2026 (after). Visible change in land cover - new grey/brown built-up area replacing green or open land - confirms the satellite detection.

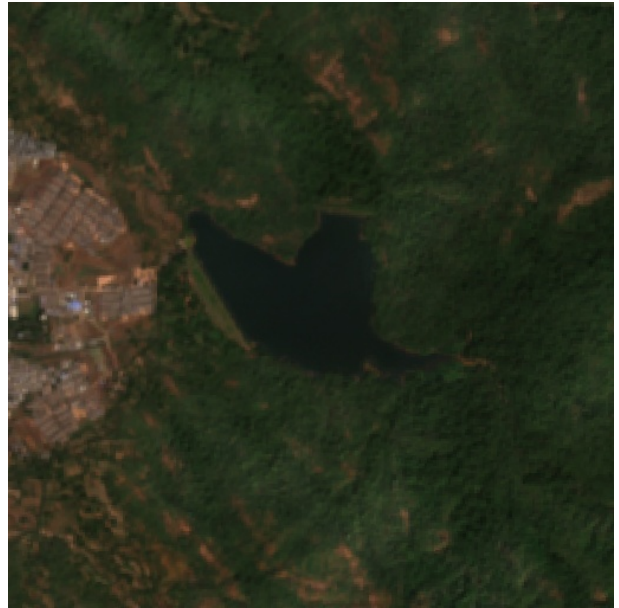
2026 - After Construction

This zone received a CRITICAL score of 99.0/100 because the detected construction covers 19.6 hectares - exceeding the 5-hectare threshold that indicates large-scale unauthorized development. Structures of this size cannot be accidental extensions and should be reviewed against local approvals.

Land Classification Note: The construction location falls within an area classified as protected forest or woodland in the available reference overlays. Construction on forest land without Forest Department clearance may be prohibited under the Forest Conservation Act, 1980.
