# AutoSentinel

## Premium Unauthorized Construction Detection Report

Area analysed: Mapped construction alert

Severity: CRITICAL | Risk Score: 90.2/100

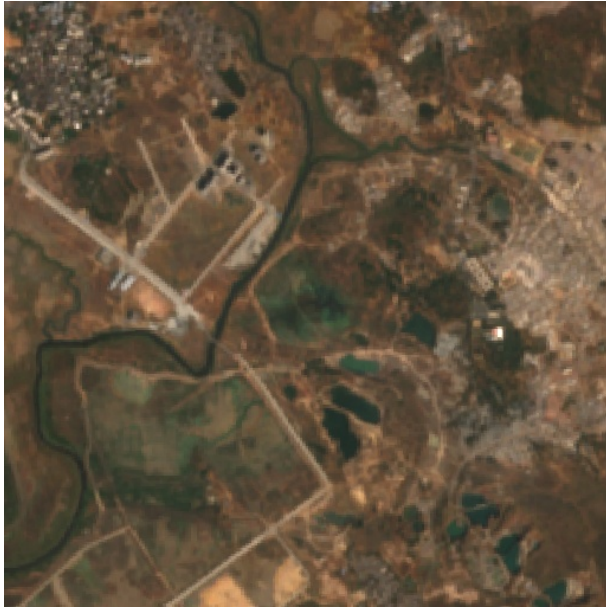
2019 - Before Construction

The images below show the flagged location in 2019 (before) and 2026 (after). Visible change in land cover - new grey/brown built-up area replacing green or open land - confirms the satellite detection.

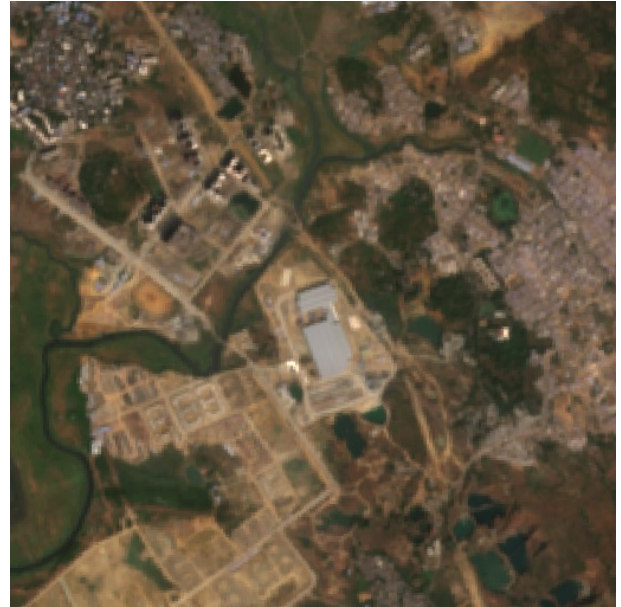
2026 - After Construction

This zone received a CRITICAL score of 90.2/100 because the detected construction covers 5.2 hectares - exceeding the 5-hectare threshold that indicates large-scale unauthorized development. Structures of this size cannot be accidental extensions and should be reviewed against local approvals.

Land Classification Note: The construction location falls within an area classified as protected forest or woodland in the available reference overlays. Construction on forest land without Forest Department clearance may be prohibited under the Forest Conservation Act, 1980.
