# AutoSentinel

## Unauthorized Construction Detection Report

Generated: 02 August 2026, 14:49 IST | Analysis period: 2019–2026  
Area analysed: Custom scanned area (19.4237, 72.7740) to (19.4293, 72.7817)

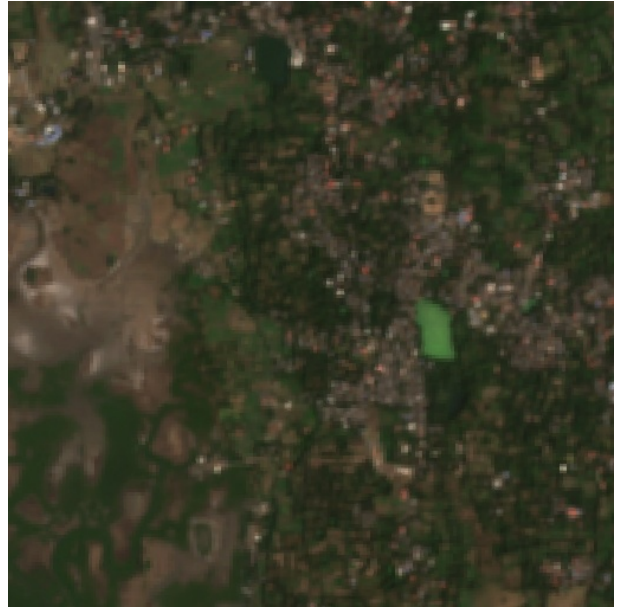
2026 - After Construction

This zone received a LOW score of 10.7/100 because the detected construction covers 600 sq metres - a small satellite-detected built-up change.

The images below show the flagged location in 2019 (before) and 2026 (after). Visible change in land cover - new grey/brown built-up area replacing green or open land - confirms the satellite detection.

Land Classification Note: The detected change requires a land-use and permit review against available zoning data. Ground inspection is required to determine the applicable land use rules.
