# AutoSentinel

## Unauthorized Construction Detection Report

Generated: 25 July 2026, 22:40 IST | Analysis period: January 2025–January 2026

Area analysed: Mapped construction alert

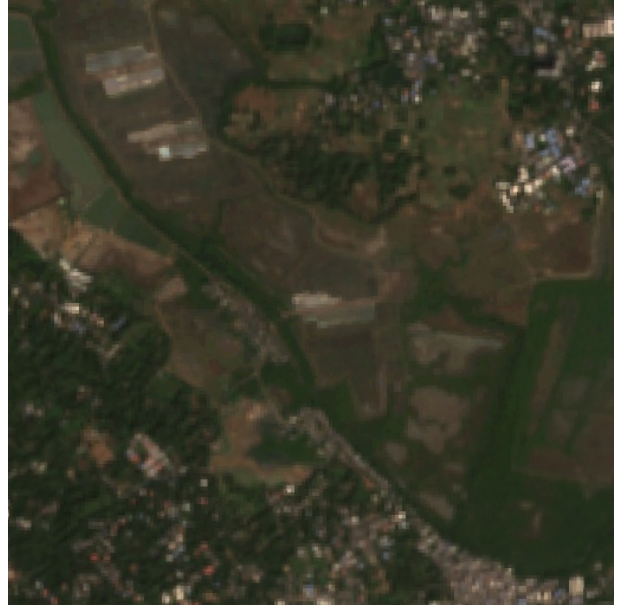
This zone received a MEDIUM score of 41.0/100 because the detected construction covers 0.22 hectares - between 0.2 and 1 hectare. This is a moderate satellite-detected change requiring human verification.

Land Classification Note: The land classification for this zone could not be verified against available zoning data. The flag is based solely on the magnitude of satellite-detected construction change. Ground verification is required to determine the applicable land use rules.

January 2026 - After Construction
