Severity: LOW | Risk Score: 10.0/100

| Field | Value |
|---|---|
| Zone ID | live_35cccf72_0 |
| Violation Type | UNVERIFIED ZONE |

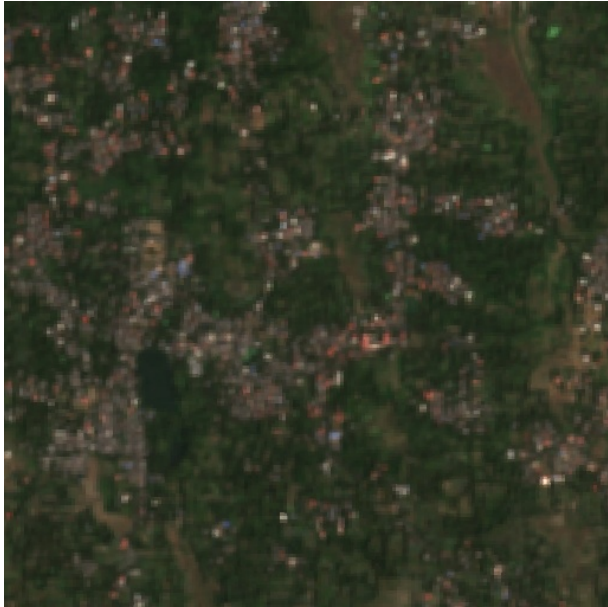
2024 - Before Construction

The images below show the flagged location in 2024 (before) and 2025 (after). Visible change in land cover - new grey/brown built-up area replacing green or open land - confirms the satellite detection.

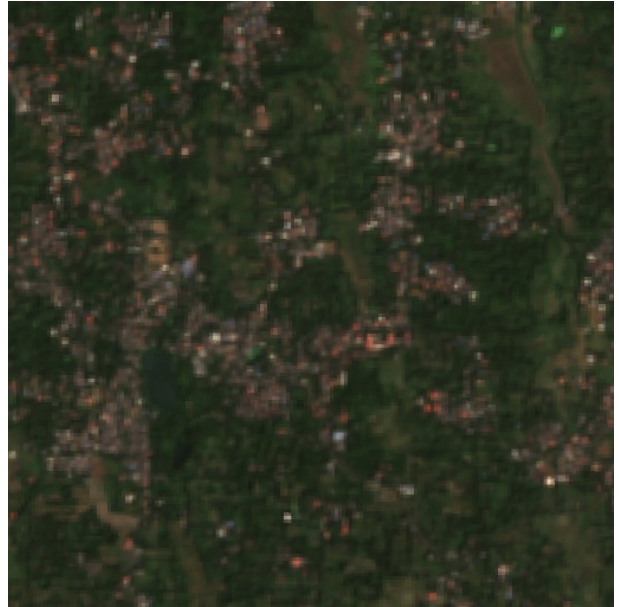
2025 - After Construction

This zone received a LOW score of 10.0/100 because the detected construction covers 500 sq metres - a small satellite-detected built-up change.

Land Classification Note: The land classification for this zone could not be verified against available zoning data. The flag is based solely on the magnitude of satellite-detected construction change. Ground verification is required to determine the applicable land use rules.
