# AutoSentinel

## Unauthorized Construction Detection Report

Generated: 03 August 2026, 21:49 IST | Analysis period: 2019–2026  
Area analysed: Custom scanned area (19.2250, 72.8452) to (19.2503, 72.8659)

Severity: MEDIUM | Risk Score: 59.0/100

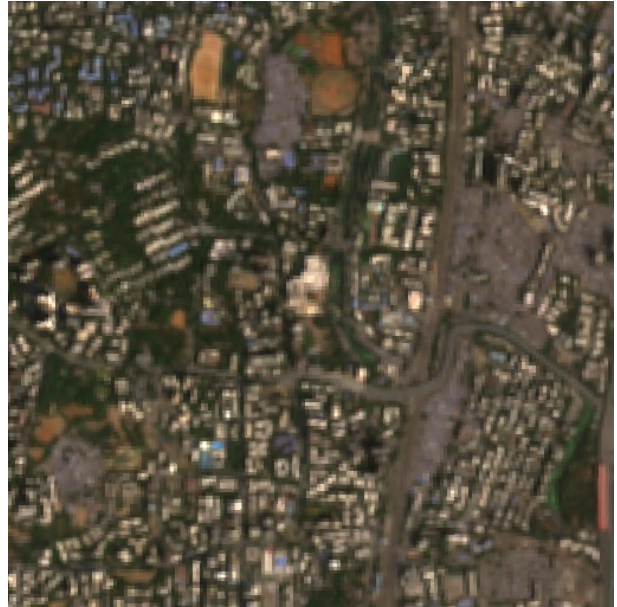
2026 - After Construction

The zone was checked against the available ISRO Bhuvan-compatible land-use layer. Dominant classification: **Protected ridge buffer**; polygon overlap: **74.4%**; confidence: **Low**. Source: No land-use polygon intersected.

This zone received a MEDIUM score of 59.0/100 because the detected construction covers 0.58 hectares - between 0.2 and 1 hectare. This is a moderate satellite-detected change requiring human verification.

The images below show the flagged location in 2019 (before) and 2026 (after). Visible change in land cover - new grey/brown built-up area replacing green or open land - confirms the satellite detection.

Land Classification Note: The detected change requires a land-use and permit review against available zoning data. Ground inspection is required to determine the applicable land use rules.
