■ Severity: MEDIUM | Risk Score: 41.5/100

Zone Details

| Field | Value |
|---|---|
| Zone ID | 729 |

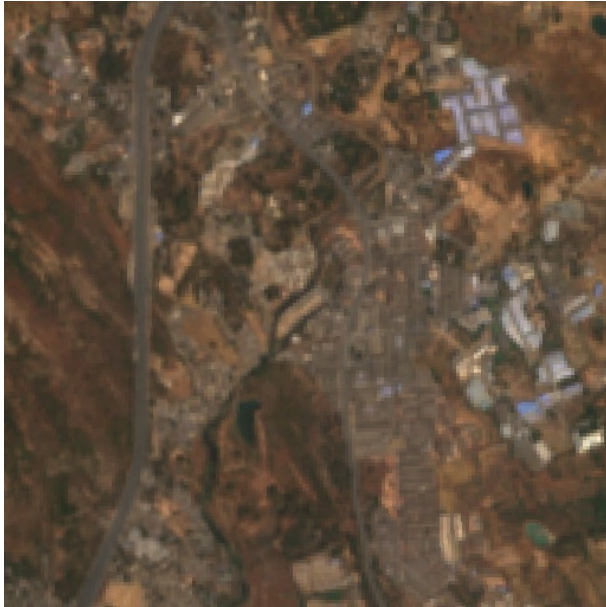
2019 — Before Construction

The images below show the flagged location in 2019 (before) and 2023 (after). Visible change in land cover — new grey/brown built-up area replacing green or open land — confirms the satellite detection.

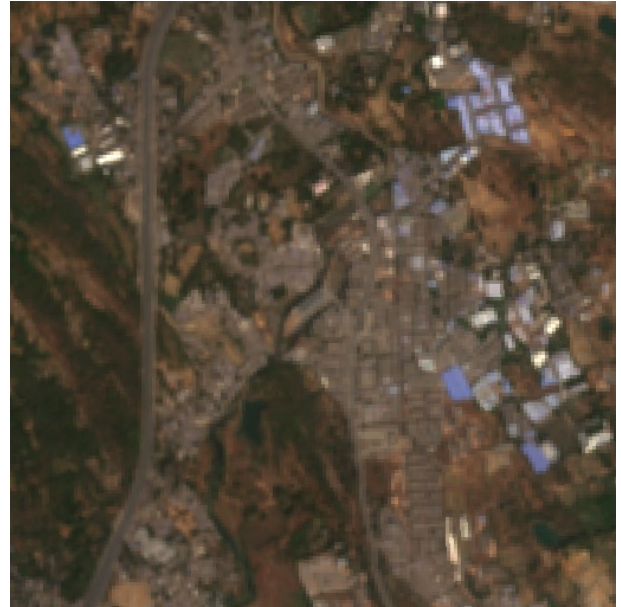
2023 — After Construction

This zone received a MEDIUM score of 41.5/100 because the detected construction covers 0.23 hectares — between 0.2 and 1 hectare. This is a moderate unauthorized structure that warrants scheduled inspection.

1. Add to inspection queue for next available field officer visit.
2. Check online permit records before physical inspection.
3. Issue advisory notice if minor violations found.
