Severity: MEDIUM | Risk Score: 63.0/100

| Field | Value |
|---|---|
| Violation Type | RIVER BUFFER VIOLATION |

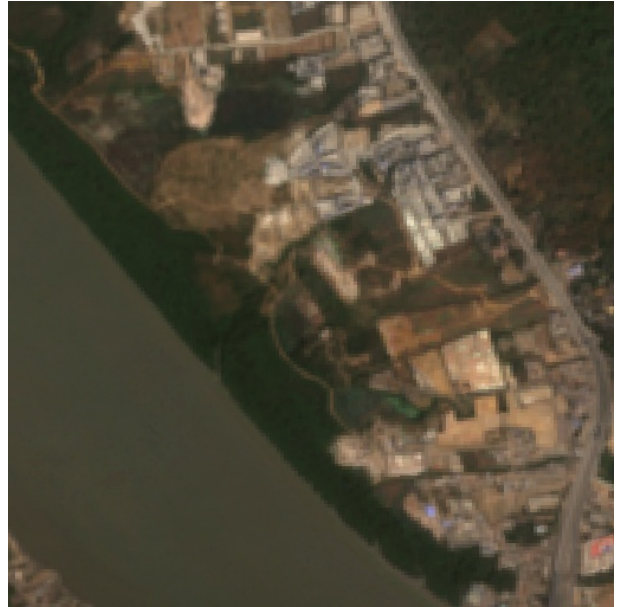
2023 - After Construction

This zone received a MEDIUM score of 63.0/100 because the detected construction covers 0.26 hectares - between 0.2 and 1 hectare. This is a moderate satellite-detected change requiring human verification.

The images below show the flagged location in 2019 (before) and 2023 (after). Visible change in land cover - new grey/brown built-up area replacing green or open land - confirms the satellite detection.
