■ Severity: LOW | Risk Score: 40.7/100

| Field | Value |
|---|---|
| Zone ID | live_569bf945_4 |

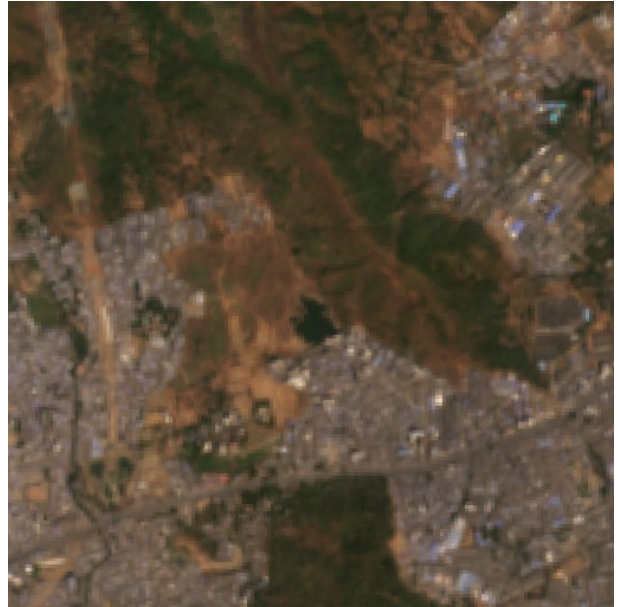
2023 - After Construction

This zone received a LOW score of 40.7/100 because the detected construction covers 600 sq metres - a small structure that should be logged for routine inspection.

Legal Analysis: OSM infrastructure overlays detected: RAILWAY BUFFER VIOLATION, RIVER BUFFER VIOLATION. This construction appears to violate: RAILWAY BUFFER VIOLATION, RIVER BUFFER VIOLATION. Risk reason: Railway boost +15; River boost +15. Final risk: 40.7/100.

The images below show the flagged location in 2019 (before) and 2023 (after). Visible change in land cover - new grey/brown built-up area replacing green or open land - confirms the satellite detection.

1. Log in municipal records for routine inspection cycle.
2. No immediate action required unless escalated by complaint.
