# AutoSentinel

## Unauthorized Construction Detection Report

Generated: 15 July 2026, 20:01 IST | Area: Custom scanned area (19.2260, 72.8317) to (19.3019, 72.9114) | Analysis Period: 2024-2025

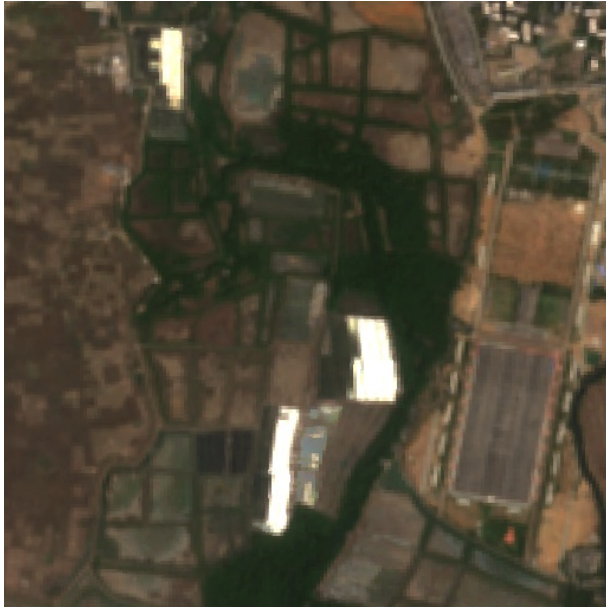
2024 - Before Construction

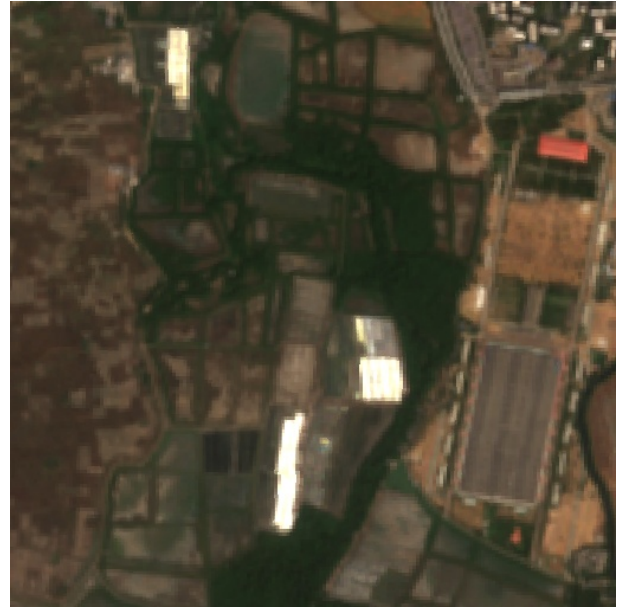
| Field | Value |
|---|---|
| Violation Type | WETLAND ENCROACHMENT |

This zone received a HIGH score of 90.3/100 because the detected construction covers 1.1 hectares - between 1 and 5 hectares. This scale of development on unverified land indicates significant unauthorized construction activity.

The images below show the flagged location in 2024 (before) and 2025 (after). Visible change in land cover - new grey/brown built-up area replacing green or open land - confirms the satellite detection.

2025 - After Construction
