Severity: MEDIUM | Risk Score: 42.5/100

| Field | Value |
|---|---|
| Zone ID | live_6bb03b35_360 |

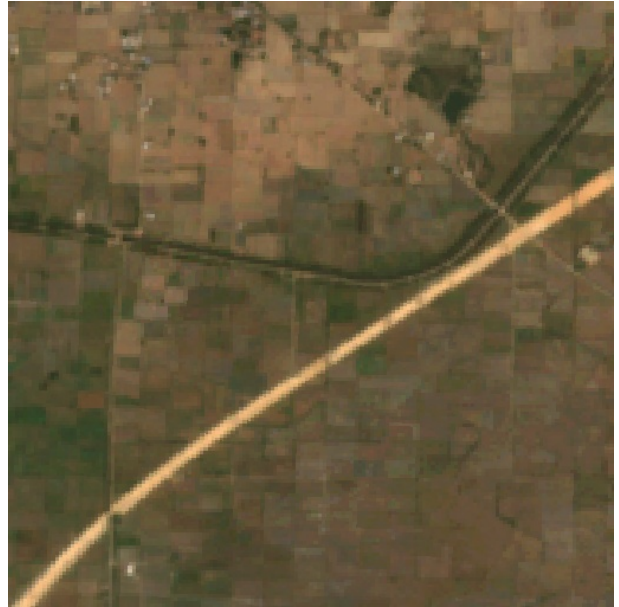
2025 - After Construction

This zone received a MEDIUM score of 42.5/100 because the detected construction covers 0.25 hectares - between 0.2 and 1 hectare. This is a moderate satellite-detected change requiring human verification.

The images below show the flagged location in 2024 (before) and 2025 (after). Visible change in land cover - new grey/brown built-up area replacing green or open land - confirms the satellite detection.

Land Classification Note: The land classification for this zone could not be verified against available zoning data. The flag is based solely on the magnitude of satellite-detected construction change. Ground verification is required to determine the applicable land use rules.
