■ Severity: HIGH | Risk Score: 100.0/100

| Field | Value |
|---|---|
| Zone ID | live_b8d0965d_90 |
| Violation Type | RAILWAY BUFFER VIOLATION |

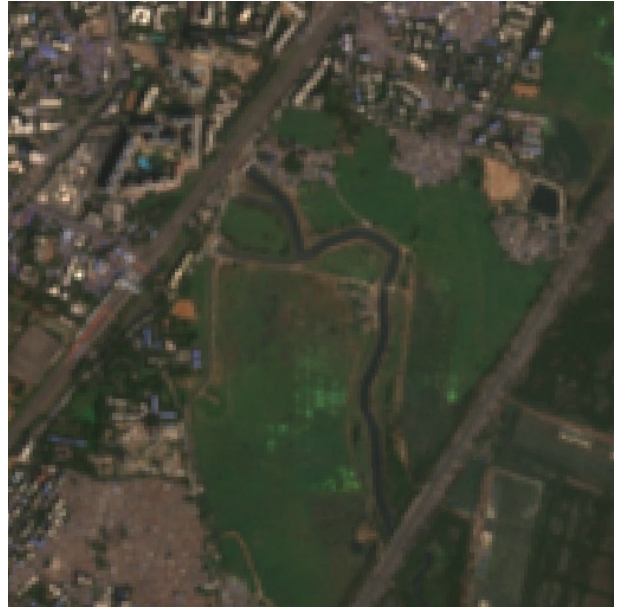
2023 - After Construction

This zone received a HIGH score of 100.0/100 because the detected construction covers 2.9 hectares - between 1 and 5 hectares. This scale of development on unverified land indicates significant unauthorized construction activity.

Legal Analysis: OSM infrastructure overlays detected: RAILWAY BUFFER VIOLATION, RIVER BUFFER VIOLATION, INDUSTRIAL ZONE ACTIVITY. This construction appears to violate: RAILWAY BUFFER VIOLATION, RIVER BUFFER VIOLATION, INDUSTRIAL ZONE ACTIVITY. Risk reason: Railway boost +15; River boost +15; Industrial boost +5. Final risk: 100.0/100.

1. Schedule ground inspection within 48 hours.
2. Verify building permit status with local municipal authority.
3. Issue notice to owner if construction is found to be unauthorized.
4. Escalate to CRITICAL if structure is found on protected land.
