■ Severity: CRITICAL | Risk Score: 90.2/100

## Zone Details

| Field | Value |
|---|---|
| Zone ID | 655 |

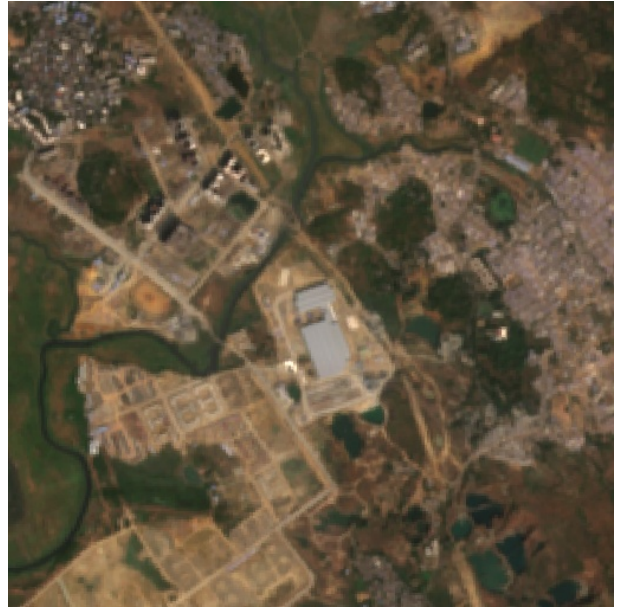
2023 - After Construction

This zone received a CRITICAL score of 90.2/100 because the detected construction covers 5.2 hectares - exceeding the 5-hectare threshold that indicates large-scale unauthorized development. Structures of this size cannot be accidental extensions and require immediate enforcement action.

Land Classification Note: The land classification for this zone could not be verified against available zoning data. The flag is based solely on the magnitude of satellite-detected construction change. Ground verification is required to determine the applicable land use rules.

1. Dispatch ground inspection team immediately to verify satellite findings.
2. Cross-check location against RERA permit database for registered projects.
3. If no valid permit found, issue Stop Work Notice under MRTP Act Section 52.
4. Initiate demolition proceedings if construction exceeds permissible limits.
5. File case with District Collector if land falls under Forest/Government category.
