■ Severity: LOW | Risk Score: 14.7/100

Zone Details

| Field | Value |
|---|---|
| Zone ID | live_27a826b5_5 |

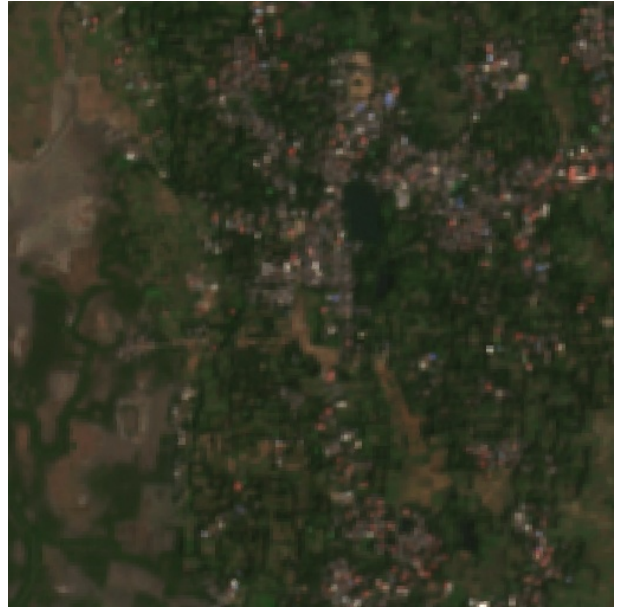
2023 - After Construction

This zone received a LOW score of 14.7/100 because the detected construction covers 1200 sq metres - a small structure that should be logged for routine inspection.

Land Classification Note: The land classification for this zone could not be verified against available zoning data. The flag is based solely on the magnitude of satellite-detected construction change. Ground verification is required to determine the applicable land use rules.

1. Log in municipal records for routine inspection cycle.
2. No immediate action required unless escalated by complaint.
