### ■ Severity: MEDIUM | Risk Score: 76.5/100

| Field | Value |
|---|---|
| Zone ID | live_3e6d34d7_0 |
| Violation Type | UNVERIFIED ZONE |

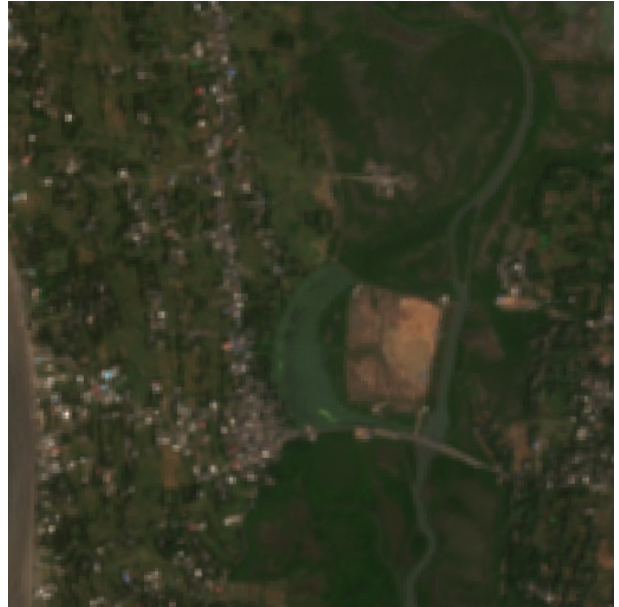
2023 - After Construction

This zone received a MEDIUM score of 76.5/100 because the detected construction covers 0.93 hectares - between 0.2 and 1 hectare. This is a moderate unauthorized structure that warrants scheduled inspection.

Land Classification Note: The land classification for this zone could not be verified against available zoning data. The flag is based solely on the magnitude of satellite-detected construction change. Ground verification is required to determine the applicable land use rules.

1. Add to inspection queue for next available field officer visit.
2. Check online permit records before physical inspection.
3. Issue advisory notice if minor violations found.
