■ Severity: MEDIUM | Risk Score: 42.5/100

Zone Details

| Field | Value |
|---|---|
| Zone ID | live_9aaa6ee0_3 |

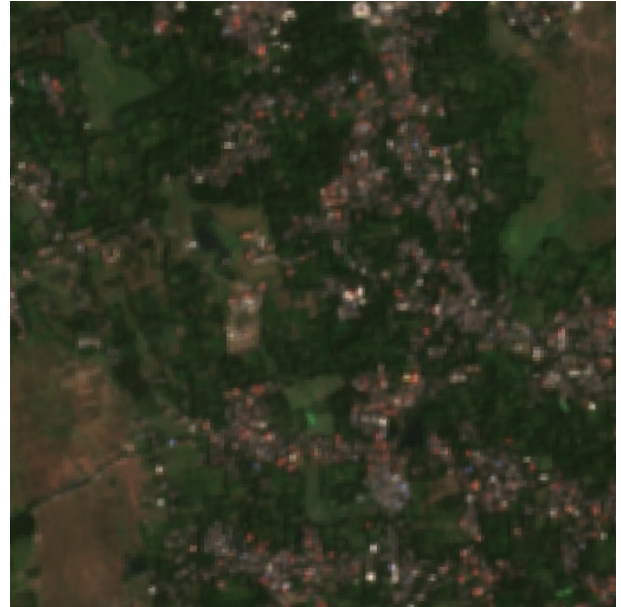
2023 - After Construction

This zone received a MEDIUM score of 42.5/100 because the detected construction covers 0.25 hectares - between 0.2 and 1 hectare. This is a moderate unauthorized structure that warrants scheduled inspection.

Land Classification Note: The land classification for this zone could not be verified against available zoning data. The flag is based solely on the magnitude of satellite-detected construction change. Ground verification is required to determine the applicable land use rules.

1. Add to inspection queue for next available field officer visit.
2. Check online permit records before physical inspection.
3. Issue advisory notice if minor violations found.
