■ Severity: LOW | Risk Score: 29.7/100

| Field | Value |
|---|---|
| Zone ID | live_d286688c_5 |
| Violation Type | RIVER BUFFER VIOLATION |

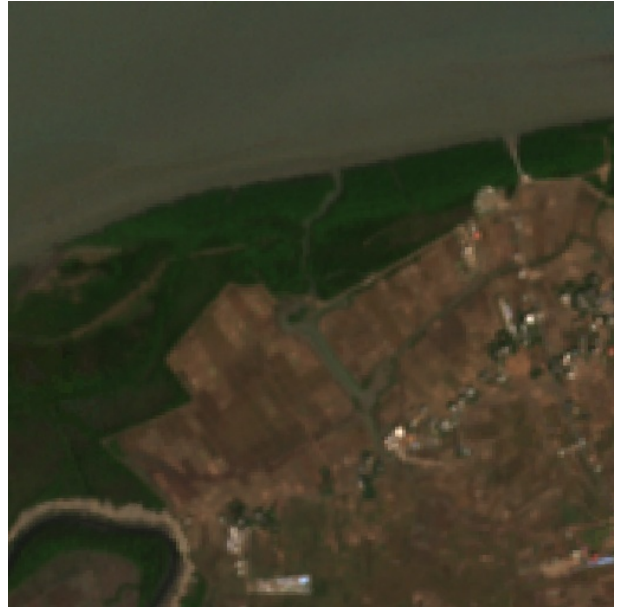
2023 - After Construction

This zone received a LOW score of 29.7/100 because the detected construction covers 1200 sq metres - a small structure that should be logged for routine inspection.

Legal Analysis: OSM infrastructure overlays detected: RIVER BUFFER VIOLATION. This construction appears to violate: RIVER BUFFER VIOLATION. Risk reason: River boost +15. Final risk: 29.7/100.

The images below show the flagged location in 2019 (before) and 2023 (after). Visible change in land cover - new grey/brown built-up area replacing green or open land - confirms the satellite detection.

1. Log in municipal records for routine inspection cycle.
2. No immediate action required unless escalated by complaint.
