## Severity: MEDIUM | Risk Score: 76.5/100

| Field | Value |
|---|---|
| Violation Type | FOREST ENCROACHMENT |

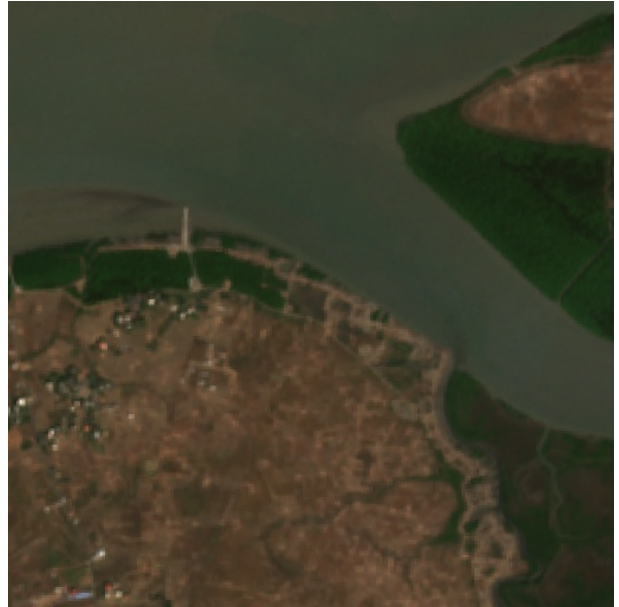
2023 - After Construction

This zone received a MEDIUM score of 76.5/100 because the detected construction covers 0.93 hectares - between 0.2 and 1 hectare. This is a moderate satellite-detected change requiring human verification.

Land Classification Note: The construction location falls within an area classified as protected forest or woodland in the available reference overlays. Construction on forest land without Forest Department clearance may be prohibited under the Forest Conservation Act, 1980.

The images below show the flagged location in 2019 (before) and 2023 (after). Visible change in land cover - new grey/brown built-up area replacing green or open land - confirms the satellite detection.
