Severity: CRITICAL | Risk Score: 99.0/100

## Zone Details

| Field | Value |
|---|---|
| Zone ID | 930 |

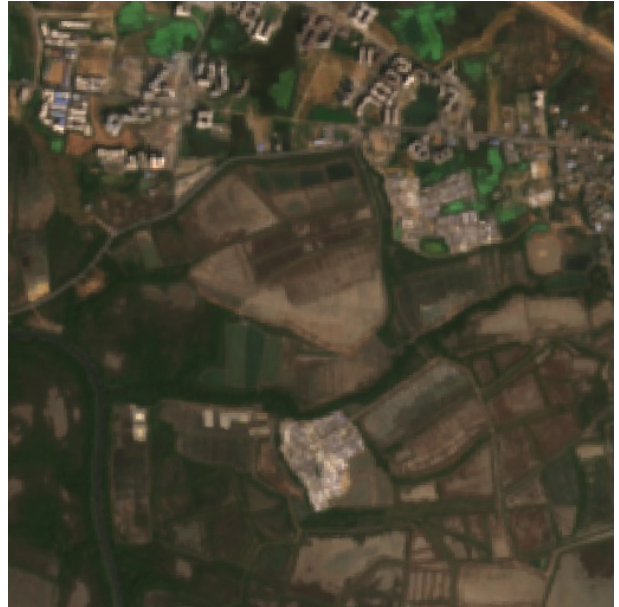
2023 - After Construction

This zone received a CRITICAL score of 99.0/100 because the detected construction covers 19.0 hectares - exceeding the 5-hectare threshold that indicates large-scale unauthorized development. Structures of this size cannot be accidental extensions and should be reviewed against local approvals.

Land Classification Note: The construction location falls on land classified as agricultural. Converting agricultural land to non-agricultural use without Maharashtra government permission violates the Maharashtra Land Revenue Code.

The images below show the flagged location in 2019 (before) and 2023 (after). Visible change in land cover - new grey/brown built-up area replacing green or open land - confirms the satellite detection.
