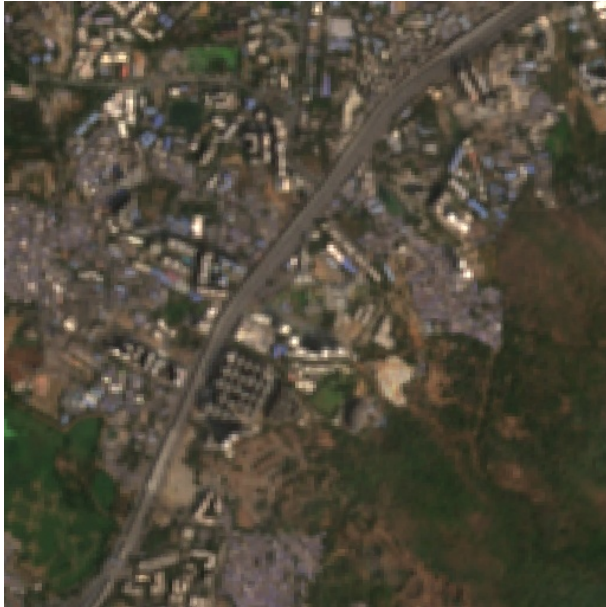
2024 - Before Construction

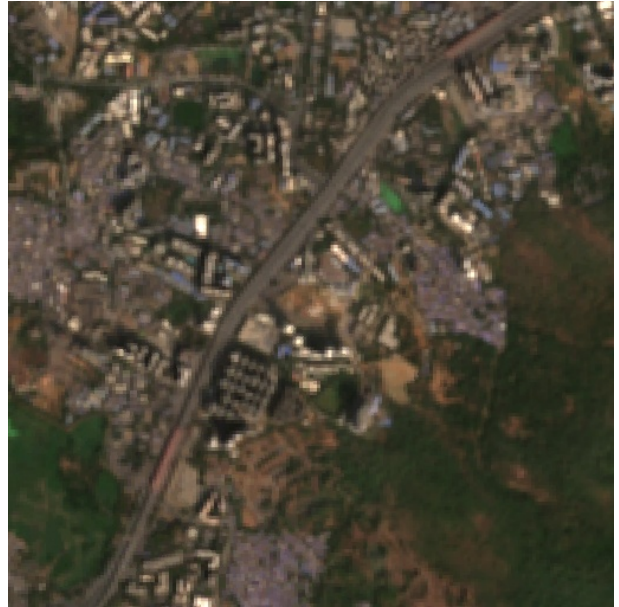
This zone received a MEDIUM score of 71.0/100 because the detected construction covers 0.82 hectares - between 0.2 and 1 hectare. This is a moderate satellite-detected change requiring human verification.

Land Classification Note: The land classification for this zone could not be verified against available zoning data. The flag is based solely on the magnitude of satellite-detected construction change. Ground verification is required to determine the applicable land use rules.

2025 - After Construction
