■ Severity: CRITICAL | Risk Score: 99.0/100

| Field | Value |
|---|---|
| Zone ID | 376 |
| Primary Violation | UNVERIFIED ZONE |

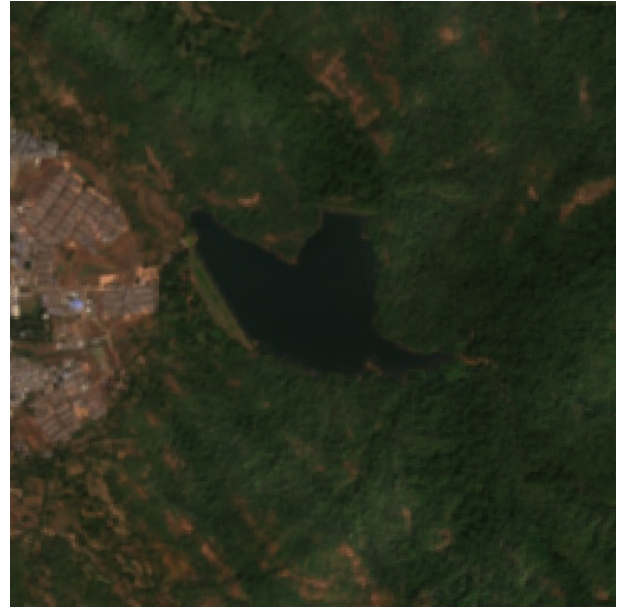
2023 — After Construction

This zone received a CRITICAL score of 99.0/100 because the detected construction covers 19.6 hectares — exceeding the 5-hectare threshold that indicates large-scale unauthorized development. Structures of this size cannot be accidental extensions and require immediate enforcement action.

Land Classification Note: The land classification for this zone could not be verified against available legal layers. No forest, water, agricultural, or railway-buffer data intersected this location at the time of the check. The flag is based solely on the magnitude of satellite-detected construction change, and ground verification is required to determine applicable land-use rules.

### Immediate ground inspection required — large unauthorized structure detected

1. Dispatch ground inspection team immediately to verify satellite findings.
2. Cross-check location against RERA permit database for registered projects.
3. If no valid permit found, issue Stop Work Notice under MRTP Act Section 52.
4. Initiate demolition proceedings if construction exceeds permissible limits.
5. File case with District Collector if land falls under Forest/Government category.
