■ Severity: MEDIUM | Risk Score: 50.0/100

| Field | Value |
|---|---|
| Zone ID | live_52cc7ecf_3 |
| Primary Violation | LIVE SCAN RESULT |

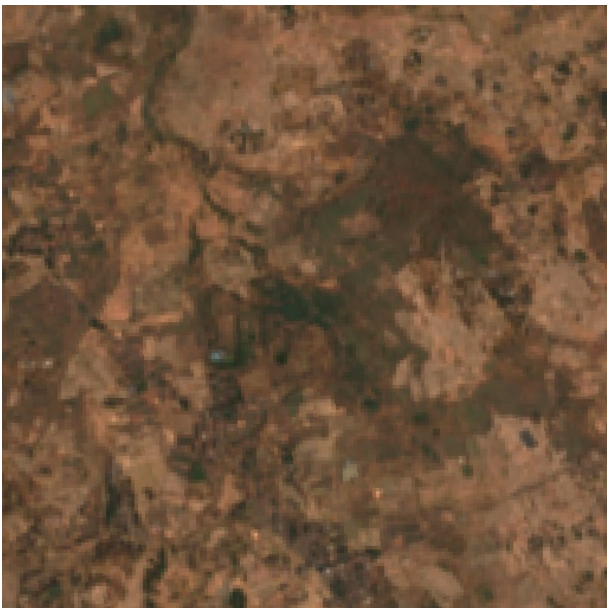
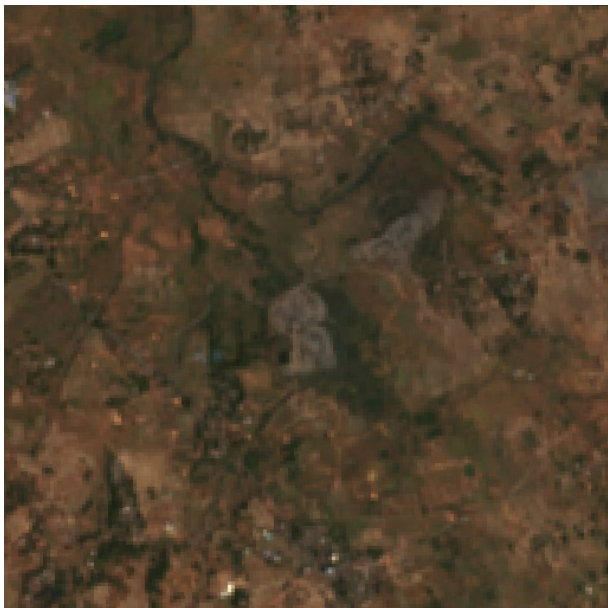
This zone received a MEDIUM score of 50.0/100 because the detected construction covers 0.40 hectares — between 0.2 and 1 hectare. This is a moderate unauthorized structure that warrants scheduled inspection.

The images below show the flagged location in 2019 (before) and 2023 (after). Visible change in land cover — new grey/brown built-up area replacing green or open land — confirms the satellite detection.

1. Add to inspection queue for next available field officer visit.
2. Check online permit records before physical inspection.
3. Issue advisory notice if minor violations found.
