■ Severity: LOW | Risk Score: 13.3/100

| Field | Value |
|---|---|
| Zone ID | live_5fe86f78_21 |
| Primary Violation | LIVE SCAN RESULT |

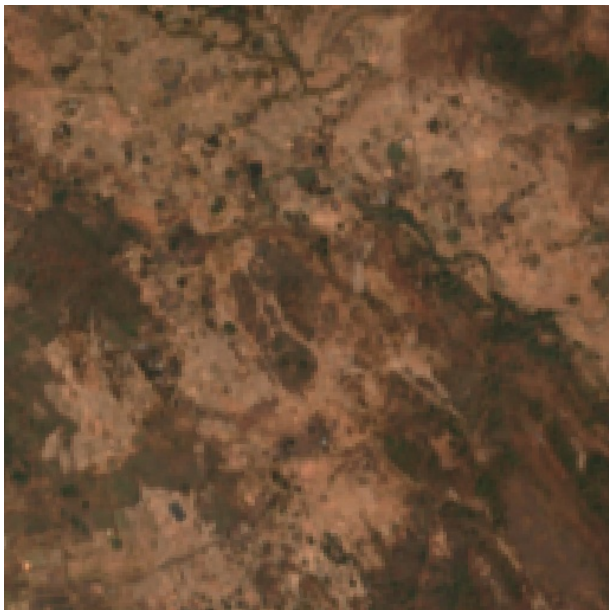
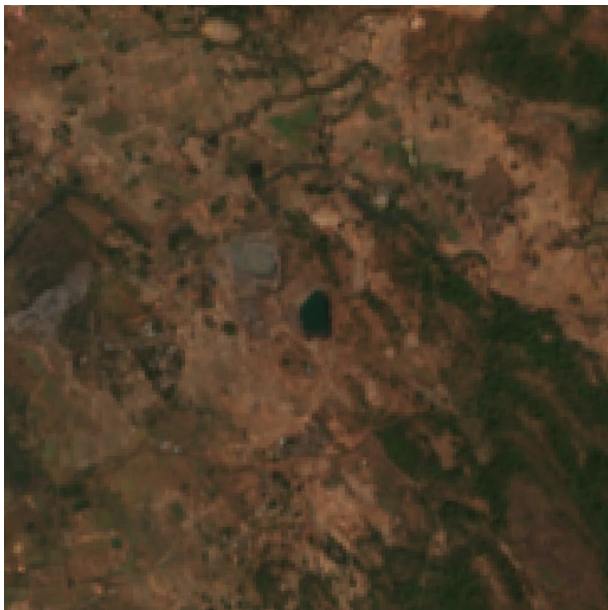
This zone received a LOW score of 13.3/100 because the detected construction covers 1000 sq metres — a small structure that should be logged for routine inspection.

The images below show the flagged location in 2019 (before) and 2023 (after). Visible change in land cover — new grey/brown built-up area replacing green or open land — confirms the satellite detection.

1. Log in municipal records for routine inspection cycle.
2. No immediate action required unless escalated by complaint.
