■ Severity: CRITICAL | Risk Score: 99.0/100

| Field | Value |
|---|---|
| Violation Type | FOREST ENCROACHMENT |

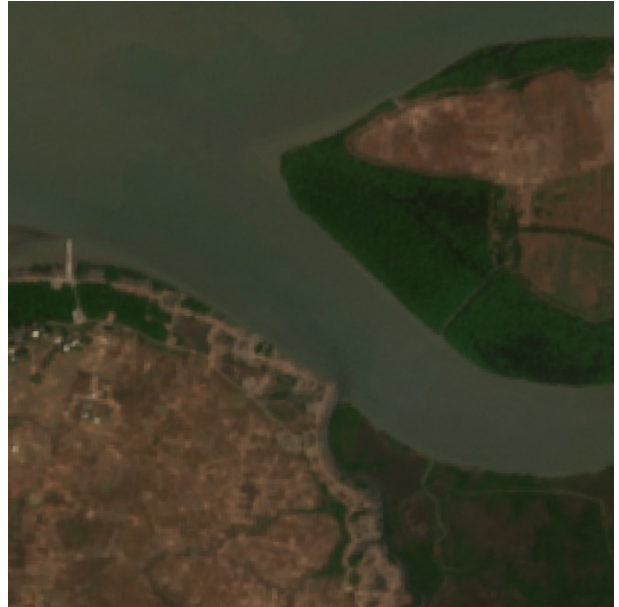
2023 - After Construction

This zone received a CRITICAL score of 99.0/100 because the detected construction covers 51.7 hectares - exceeding the 5-hectare threshold that indicates large-scale unauthorized development. Structures of this size cannot be accidental extensions and require immediate enforcement action.

Land Classification Note: The construction location falls within an area classified as protected forest or woodland by ISRO Bhuvan land use data. Construction on forest land without Forest Department clearance is prohibited under the Forest Conservation Act, 1980.

The images below show the flagged location in 2019 (before) and 2023 (after). Visible change in land cover - new grey/brown built-up area replacing green or open land - confirms the satellite detection.
