Severity: MEDIUM | Risk Score: 86.0/100

## Zone Details

| Field | Value |
|---|---|
| Zone ID | live_802ac3b2_56 |
| Violation Type | RAILWAY BUFFER VIOLATION |

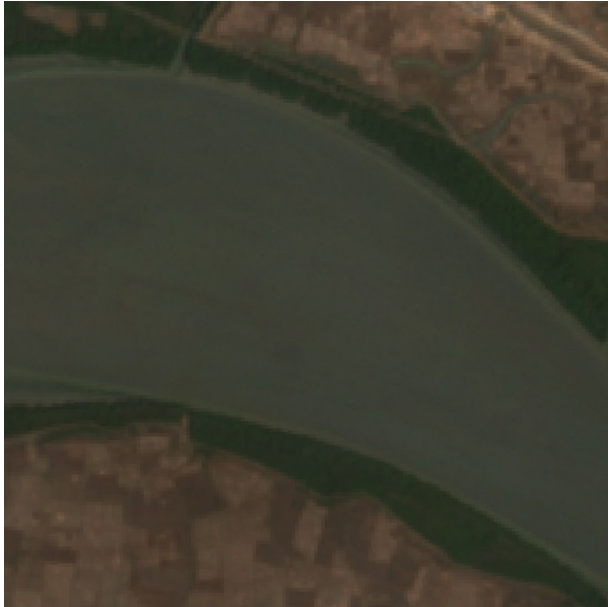
2019 - Before Construction

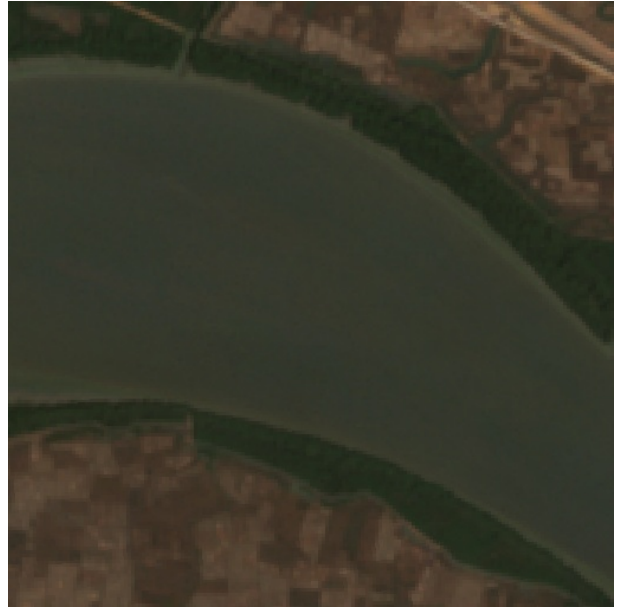
This zone received a MEDIUM score of 86.0/100 because the detected construction covers 0.42 hectares - between 0.2 and 1 hectare. This is a moderate satellite-detected change requiring human verification.

The images below show the flagged location in 2019 (before) and 2023 (after). Visible change in land cover - new grey/brown built-up area replacing green or open land - confirms the satellite detection.

2023 - After Construction
