Severity: LOW | Risk Score: 10.0/100

| Field | Value |
|---|---|
| Zone ID | 200 |
| Violation Type | FOREST ENCROACHMENT |

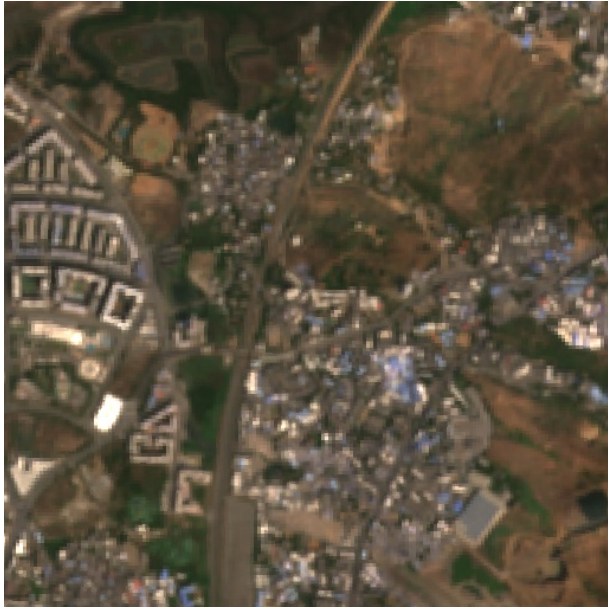
2019 - Before Construction

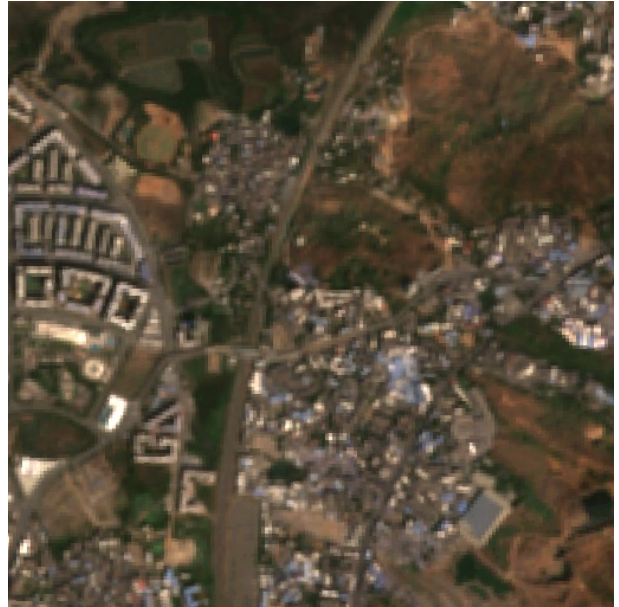
This zone received a LOW score of 10.0/100 because the detected construction covers 500 sq metres - a small satellite-detected built-up change.

Land Classification Note: The construction location falls within an area classified as protected forest or woodland in the available reference overlays. Construction on forest land without Forest Department clearance may be prohibited under the Forest Conservation Act, 1980.

2023 - After Construction
