***Landslide Field Survey (NH 6 & NH 206, Meghalaya) following Extreme Rainfall Events on 30-31 May 2025***

**Report on**  
**Landslide Field Survey (NH 6 & NH 206, Meghalaya) following Extreme Rainfall Events on**  
**30–31 May 2025**

**Submitted To**  
**State Disaster Management Authority, Meghalaya**

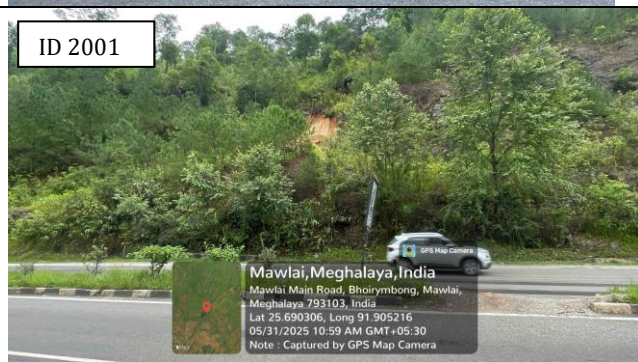
ID 2001

| ID | SLIDE_ID | YEAR | MONTH | STATE | DISTRICT | LS_NAME | NH_SH_AFFECTED | LAT | LOX | DATE_OF_EVENT | STATUS | REMARKS |
|---|---|---|---|---|---|---|---|---|---|---|---|---|
| 2001 | Field Survey/2025/Meghalaya/34 | 2025 | May | Meghalaya | Ri Bhoi | Sumer Landslide 1 | NH 6 | 25.69024 | 91.90534 | 30-05-2025 | Verified | Road Affected |

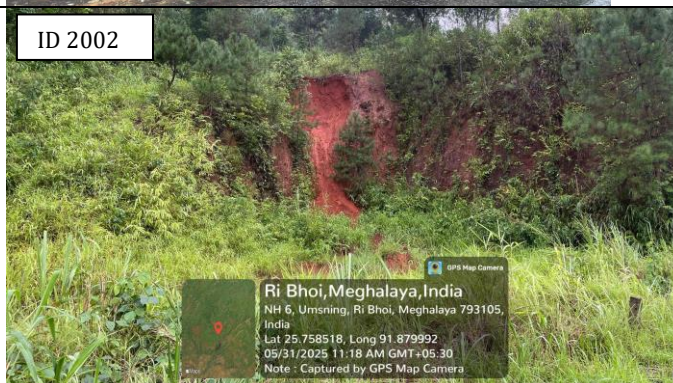
ID 2002

| ID | SLIDE_ID | YEAR | MONTH | STATE | DISTRICT | LS_NAME | NH_SH_AFFECTED | LAT | LOX | DATE_OF_EVENT | STATUS | REMARKS |
|---|---|---|---|---|---|---|---|---|---|---|---|---|
| 2002 | Field Survey/2025/Meghalaya/35 | 2025 | May | Meghalaya | Ri Bhoi | Umsamlem Landslide | NH 6 | 25.75852 | 91.87999 | 30-05-2025 | Verified | Road Affected |

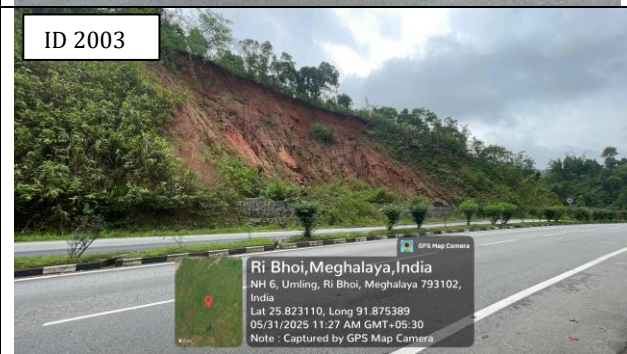
ID 2003

| ID | SLIDE_ID | YEAR | MONTH | STATE | DISTRICT | LS_NAME | NH_SH_AFFECTED | LAT | LOX | DATE_OF_EVENT | STATUS | REMARKS |
|---|---|---|---|---|---|---|---|---|---|---|---|---|
| 2003 | Field Survey/2025/Meghalaya/36 | 2025 | May | Meghalaya | Ri Bhoi | Kwinain Landslide | NH 6 | 25.82308 | 91.87242 | 30-05-2025 | Verified | Road Affected |

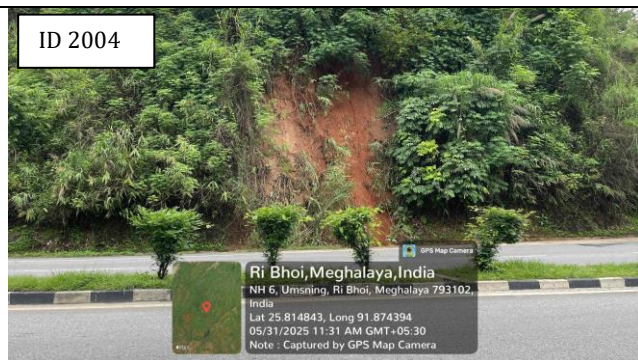
ID 2004

| ID | SLIDE_ID | YEAR | MONTH | STATE | DISTRICT | LS_NAME | NH_SH_AFFECTED | LAT | LOX | DATE_OF_EVENT | STATUS | REMARKS |
|---|---|---|---|---|---|---|---|---|---|---|---|---|
| 2004 | Field Survey/2025/Meghalaya/37 | 2025 | May | Meghalaya | Ri Bhoi | Umnget Landslide | NH 6 | 25.81488 | 91.87571 | 30-05-2025 | Verified | Road Affected |

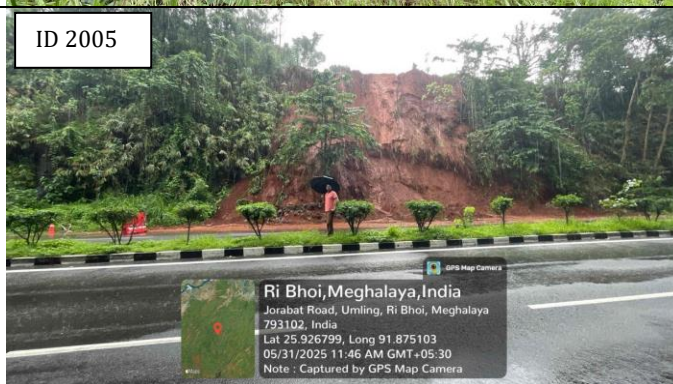
ID 2005

| ID | SLIDE_ID | YEAR | MONTH | STATE | DISTRICT | LS_NAME | NH_SH_AFFECTED | LAT | LOX | DATE_OF_EVENT | STATUS | REMARKS |
|---|---|---|---|---|---|---|---|---|---|---|---|---|
| 2005 | Field Survey/2025/Meghalaya/38 | 2025 | May | Meghalaya | Ri Bhoi | Umling Landslide | NH 6 | 25.92683 | 91.87521 | 30-05-2025 | Verified | Road Affected |

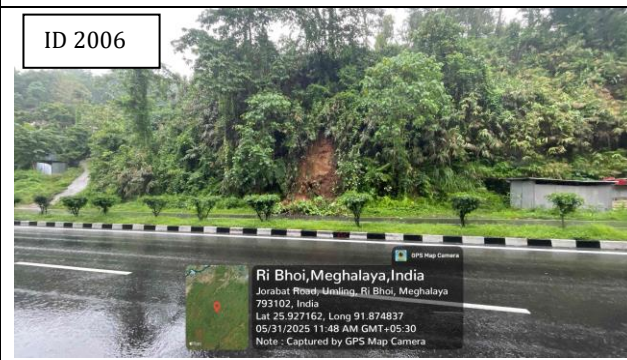
ID 2006

| ID | SLIDE_ID | YEAR | MONTH | STATE | DISTRICT | LS_NAME | NH_SH_AFFECTED | LAT | LOX | DATE_OF_EVENT | STATUS | REMARKS |
|---|---|---|---|---|---|---|---|---|---|---|---|---|
| 2006 | Field Survey/2025/Meghalaya/39 | 2025 | May | Meghalaya | Ri Bhoi | Umling Landslide 2 | NH 6 | 25.92723 | 91.87506 | 30-05-2025 | Verified | Road Affected |

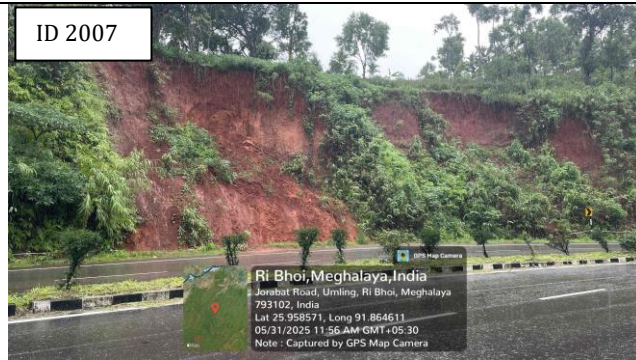
ID 2007

| ID | SLIDE_ID | YEAR | MONTH | STATE | DISTRICT | LS_NAME | NH_SH_AFFECTED | LAT | LOX | DATE_OF_EVENT | STATUS | REMARKS |
|---|---|---|---|---|---|---|---|---|---|---|---|---|
| 2007 | Field Survey/2025/Meghalaya/40 | 2025 | May | Meghalaya | Ri Bhoi | Umling Landslide 3 | NH 6 | 25.95857 | 91.86467 | 30-05-2025 | Verified | Road Affected |

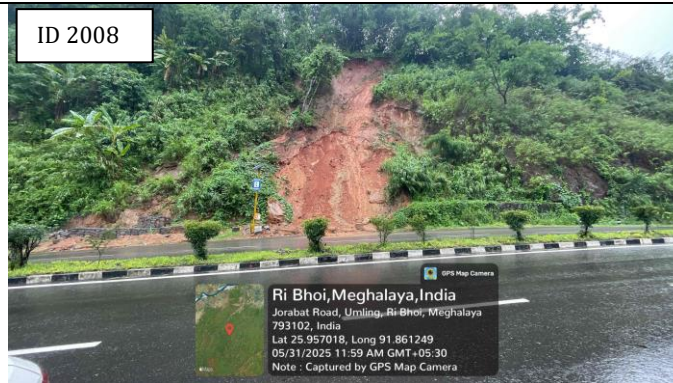
ID 2008

| ID | SLIDE_ID | YEAR | MONTH | STATE | DISTRICT | LS_NAME | NH_SH_AFFECTED | LAT | LOX | DATE_OF_EVENT | STATUS | REMARKS |
|---|---|---|---|---|---|---|---|---|---|---|---|---|
| 2008 | Field Survey/2025/Meghalaya/41 | 2025 | May | Meghalaya | Ri Bhoi | Umling Landslide 4 | NH 6 | 25.9571 | 91.86125 | 30-05-2025 | Verified | Road Affected |

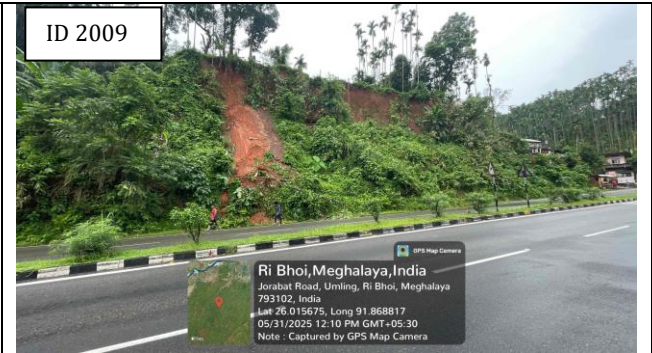
ID 2009

| ID | SLIDE_ID | YEAR | MONTH | STATE | DISTRICT | LS_NAME | NH_SH_AFFECTED | LAT | LOX | DATE_OF_EVENT | STATUS | REMARKS |
|---|---|---|---|---|---|---|---|---|---|---|---|---|
| 2009 | Field Survey/2025/Meghalaya/42 | 2025 | May | Meghalaya | Ri Bhoi | Byrnihat Landslide | NH 6 | 26.01556 | 91.86894 | 30-05-2025 | Verified | Road Affected |

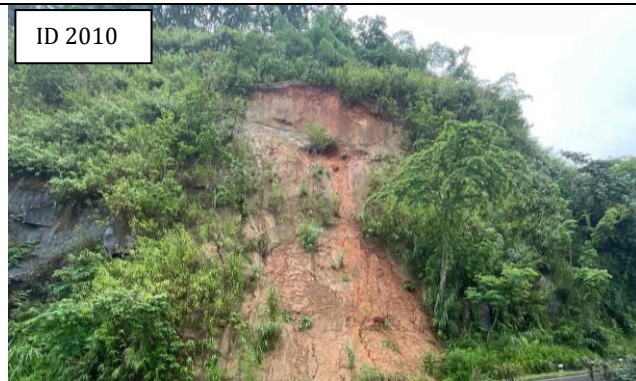
ID 2010

| ID | SLIDE_ID | YEAR | MONTH | STATE | DISTRICT | LS_NAME | NH_SH_AFFECTED | LAT | LOX | DATE_OF_EVENT | STATUS | REMARKS |
|---|---|---|---|---|---|---|---|---|---|---|---|---|
| 2010 | Field Survey/2025/Meghalaya/43 | 2025 | May | Meghalaya | Ri Bhoi | Byrnihat Landslide 2 | NH 6 | 26.0169 | 91.86662 | 30-05-2025 | Verified | Road Affected |

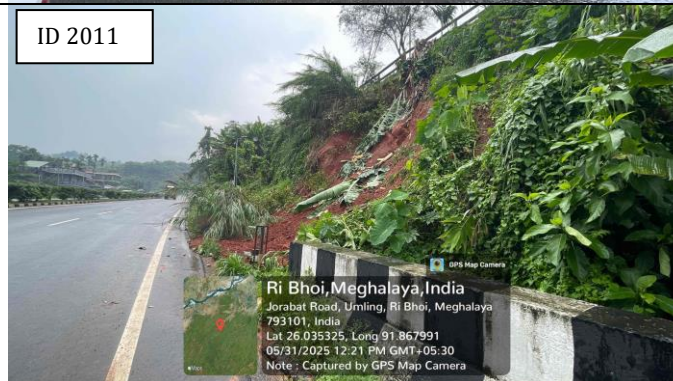
ID 2011

| ID | SLIDE_ID | YEAR | MONTH | STATE | DISTRICT | LS_NAME | NH_SH_AFFECTED | LAT | LOX | DATE_OF_EVENT | STATUS | REMARKS |
|---|---|---|---|---|---|---|---|---|---|---|---|---|
| 2011 | Field Survey/2025/Meghalaya/44 | 2025 | May | Meghalaya | Ri Bhoi | 17 Mile Landslide | NH 6 | 26.02992 | 91.86895 | 30-05-2025 | Verified | Road Affected |

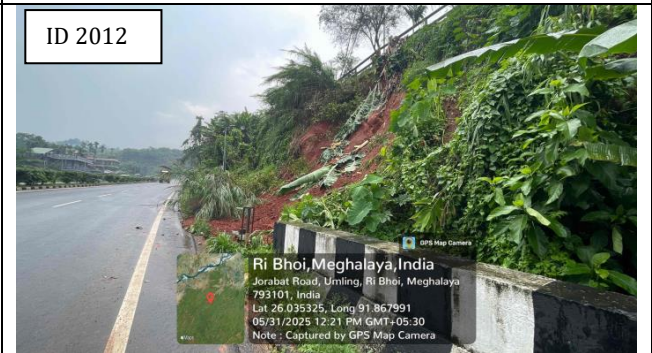
ID 2012

| ID | SLIDE_ID | YEAR | MONTH | STATE | DISTRICT | LS_NAME | NH_SH_AFFECTED | LAT | LOX | DATE_OF_EVENT | STATUS | REMARKS |
|---|---|---|---|---|---|---|---|---|---|---|---|---|
| 2012 | Field Survey/2025/Meghalaya/45 | 2025 | May | Meghalaya | Ri Bhoi | Byrnihat Landslide 3 | NH 6 | 26.03532 | 91.86799 | 30-05-2025 | Verified | Road Affected |

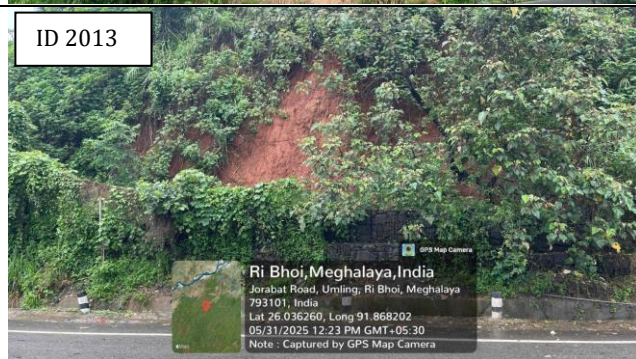
ID 2013

| ID | SLIDE_ID | YEAR | MONTH | STATE | DISTRICT | LS_NAME | NH_SH_AFFECTED | LAT | LOX | DATE_OF_EVENT | STATUS | REMARKS |
|---|---|---|---|---|---|---|---|---|---|---|---|---|
| 2013 | Field Survey/2025/Meghalaya/46 | 2025 | May | Meghalaya | Ri Bhoi | Byrnihat Landslide 4 | NH 6 | 26.03628 | 91.86832 | 30-05-2025 | Verified | Road Affected |

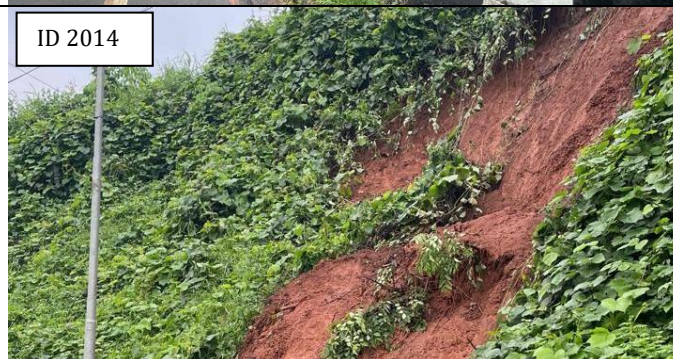
ID 2014

| ID | SLIDE_ID | YEAR | MONTH | STATE | DISTRICT | LS_NAME | NH_SH_AFFECTED | LAT | LOX | DATE_OF_EVENT | STATUS | REMARKS |
|---|---|---|---|---|---|---|---|---|---|---|---|---|
| 2014 | Field Survey/2025/Meghalaya/47 | 2025 | May | Meghalaya | Ri Bhoi | Ampher Landslide | NH 6 | 26.08904 | 91.87737 | 30-05-2025 | Verified | Road Affected |

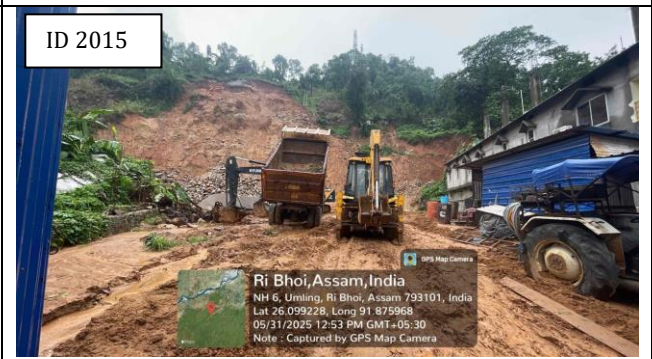
ID 2015

| ID | SLIDE_ID | YEAR | MONTH | STATE | DISTRICT | LS_NAME | NH_SH_AFFECTED | LAT | LOX | DATE_OF_EVENT | STATUS | REMARKS |
|---|---|---|---|---|---|---|---|---|---|---|---|---|
| 2015 | Field Survey/2025/Meghalaya/48 | 2025 | May | Meghalaya | Ri Bhoi | Jorabat Landslide | NH 6 | 26.09923 | 91.87597 | 30-05-2025 | Verified | Road Affected |

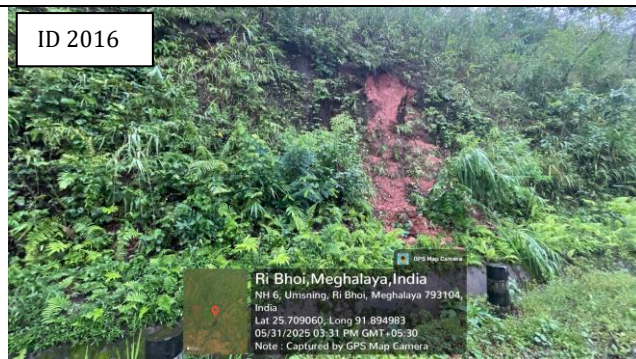
ID 2016

| ID | SLIDE_ID | YEAR | MONTH | STATE | DISTRICT | LS_NAME | NH_SH_AFFECTED | LAT | LOX | DATE_OF_EVENT | STATUS | REMARKS |
|---|---|---|---|---|---|---|---|---|---|---|---|---|
| 2016 | Field Survey/2025/Meghalaya/49 | 2025 | May | Meghalaya | Ri Bhoi | Umsning Landslide | NH 6 | 25.70906 | 91.89498 | 30-05-2025 | Verified | Road Affected |

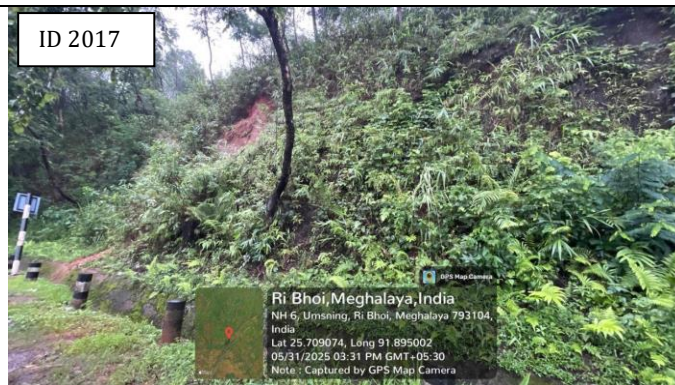
ID 2017

| ID | SLIDE_ID | YEAR | MONTH | STATE | DISTRICT | LS_NAME | NH_SH_AFFECTED | LAT | LOX | DATE_OF_EVENT | STATUS | REMARKS |
|---|---|---|---|---|---|---|---|---|---|---|---|---|
| 2017 | Field Survey/2025/Meghalaya/50 | 2025 | May | Meghalaya | Ri Bhoi | Umsning Landslide 2 | NH 6 | 25.70907 | 91.895 | 30-05-2025 | Verified | Road Affected |

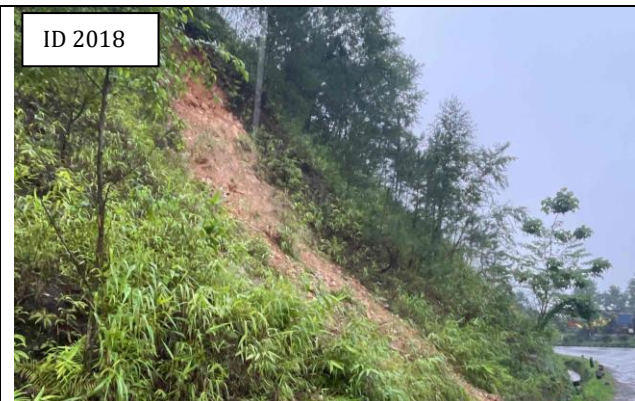
ID 2018

| ID | SLIDE_ID | YEAR | MONTH | STATE | DISTRICT | LS_NAME | NH_SH_AFFECTED | LAT | LOX | DATE_OF_EVENT | STATUS | REMARKS |
|---|---|---|---|---|---|---|---|---|---|---|---|---|
| 2018 | Field Survey/2025/Meghalaya/51 | 2025 | May | Meghalaya | Ri Bhoi | Umiam Landslide 8 | NH 6 | 25.6792 | 91.89967 | 30-05-2025 | Verified | Road Affected |

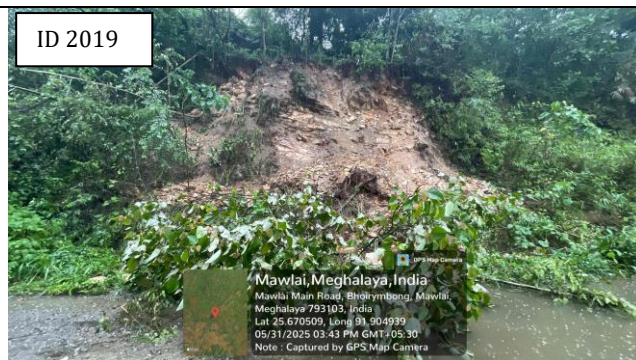
ID 2019

| ID | SLIDE_ID | YEAR | MONTH | STATE | DISTRICT | LS_NAME | NH_SH_AFFECTED | LAT | LOX | DATE_OF_EVENT | STATUS | REMARKS |
|---|---|---|---|---|---|---|---|---|---|---|---|---|
| 2019 | Field Survey/2025/Meghalaya/52 | 2025 | May | Meghalaya | Ri Bhoi | Umiam Landslide 9 | NH 6 | 25.67051 | 91.90494 | 30-05-2025 | Verified | Road Affected |

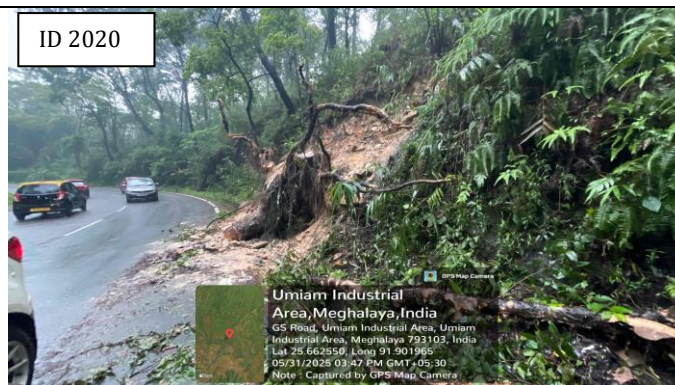
ID 2020

| ID | SLIDE_ID | YEAR | MONTH | STATE | DISTRICT | LS_NAME | NH_SH_AFFECTED | LAT | LOX | DATE_OF_EVENT | STATUS | REMARKS |
|---|---|---|---|---|---|---|---|---|---|---|---|---|
| 2020 | Field Survey/2025/Meghalaya/53 | 2025 | May | Meghalaya | Ri Bhoi | Umiam Landslide 10 | NH 6 | 25.66272 | 91.90127 | 30-05-2025 | Verified | Road Affected |

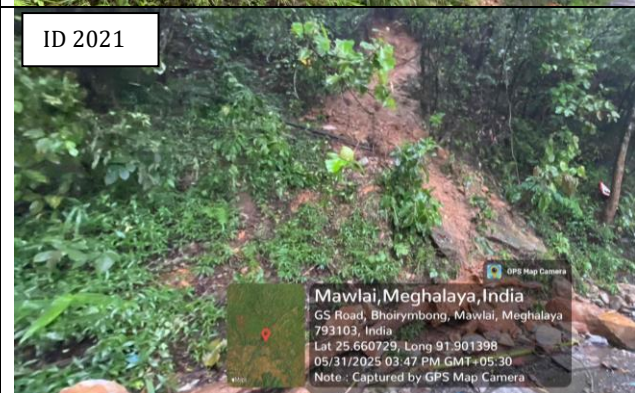
ID 2021

| ID | SLIDE_ID | YEAR | MONTH | STATE | DISTRICT | LS_NAME | NH_SH_AFFECTED | LAT | LOX | DATE_OF_EVENT | STATUS | REMARKS |
|---|---|---|---|---|---|---|---|---|---|---|---|---|
| 2021 | Field Survey/2025/Meghalaya/54 | 2025 | May | Meghalaya | Ri Bhoi | Umiam Landslide 11 | NH 6 | 25.66073 | 91.9014 | 30-05-2025 | Verified | Road Affected |

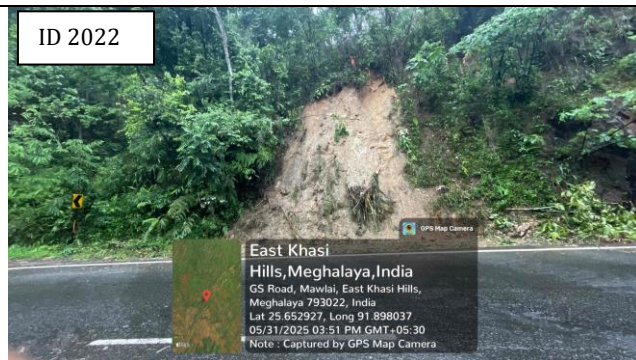
ID 2022

| ID | SLIDE_ID | YEAR | MONTH | STATE | DISTRICT | LS_NAME | NH_SH_AFFECTED | LAT | LOX | DATE_OF_EVENT | STATUS | REMARKS |
|---|---|---|---|---|---|---|---|---|---|---|---|---|
| 2022 | Field Survey/2025/Meghalaya/55 | 2025 | May | Meghalaya | East Khasi Hills | Umiam Landslide 12 | NH 6 | 25.65293 | 91.89804 | 30-05-2025 | Verified | Road Affected |

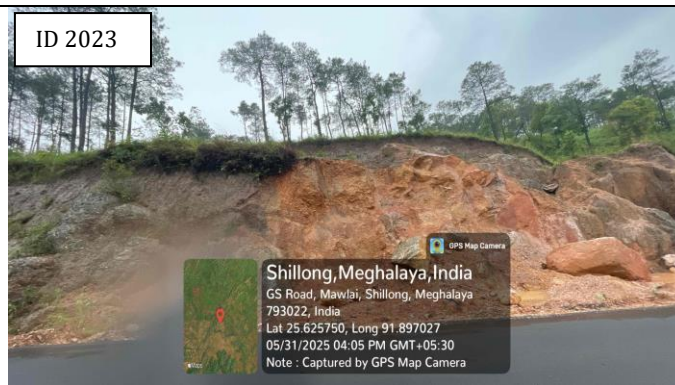
ID 2023

| ID | SLIDE_ID | YEAR | MONTH | STATE | DISTRICT | LS_NAME | NH_SH_AFFECTED | LAT | LOX | DATE_OF_EVENT | STATUS | REMARKS |
|---|---|---|---|---|---|---|---|---|---|---|---|---|
| 2023 | Field Survey/2025/Meghalaya/56 | 2025 | May | Meghalaya | East Khasi Hills | ISBT Bypass Landslide 1 | NH 6 | 25.62575 | 91.89703 | 30-05-2025 | Verified | Road Affected |

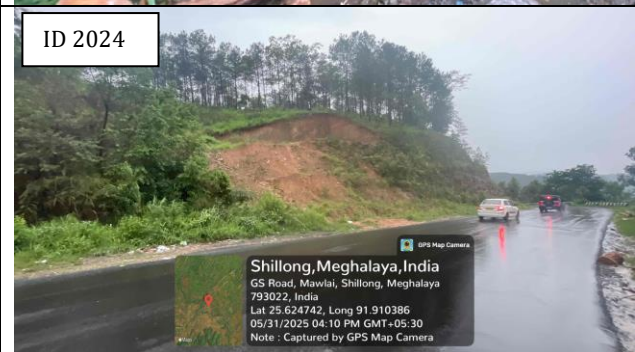
ID 2024

| ID | SLIDE_ID | YEAR | MONTH | STATE | DISTRICT | LS_NAME | NH_SH_AFFECTED | LAT | LOX | DATE_OF_EVENT | STATUS | REMARKS |
|---|---|---|---|---|---|---|---|---|---|---|---|---|
| 2024 | Field Survey/2025/Meghalaya/57 | 2025 | May | Meghalaya | East Khasi Hills | ISBT Bypass Landslide 2 | NH 6 | 25.6248 | 91.91046 | 30-05-2025 | Verified | Road Affected |

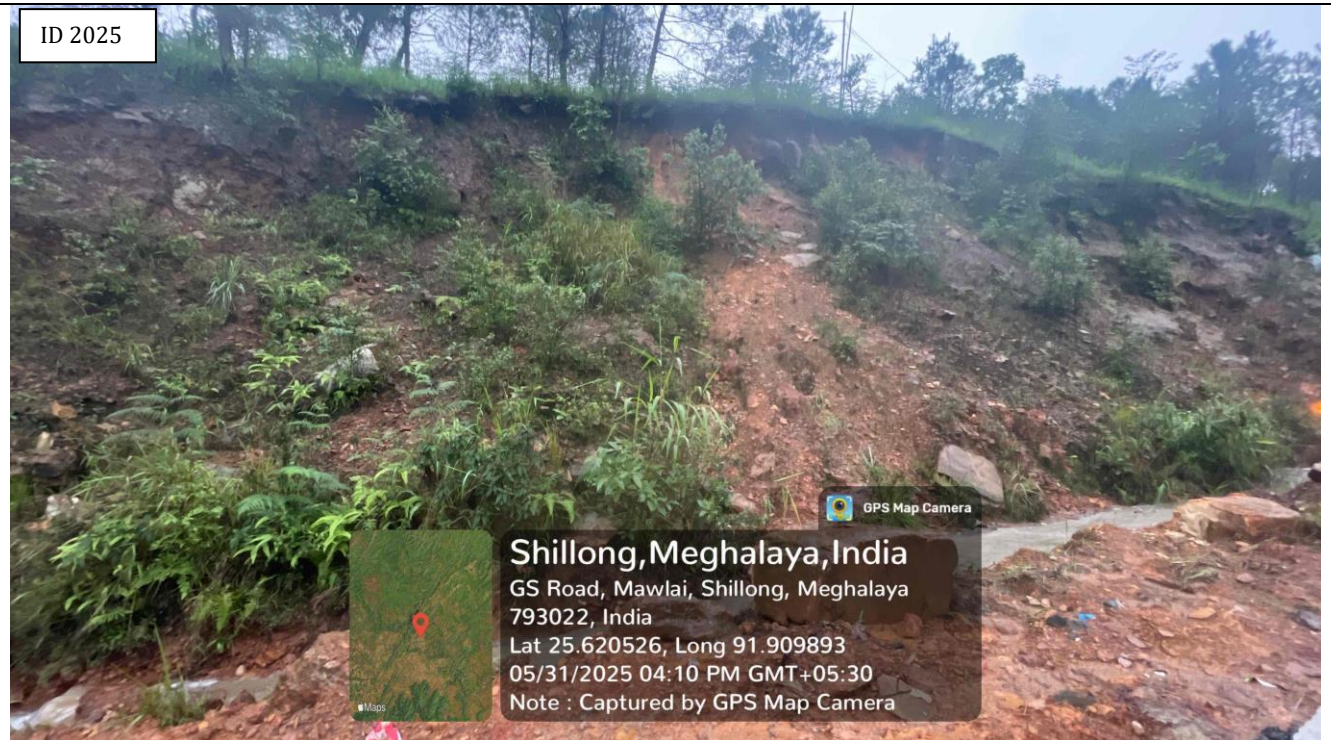
ID 2025

| ID | SLIDE_ID | YEAR | MONTH | STATE | DISTRICT | LS_NAME | NH_SH_AFFECTED | LAT | LOX | DATE_OF_EVENT | STATUS | REMARKS |
|---|---|---|---|---|---|---|---|---|---|---|---|---|
| 2025 | Field Survey/2025/Meghalaya/58 | 2025 | May | Meghalaya | East Khasi Hills | ISBT Bypass Landslide 3 | NH 6 | 25.62053 | 91.90989 | 30-05-2025 | Verified | Road Affected |

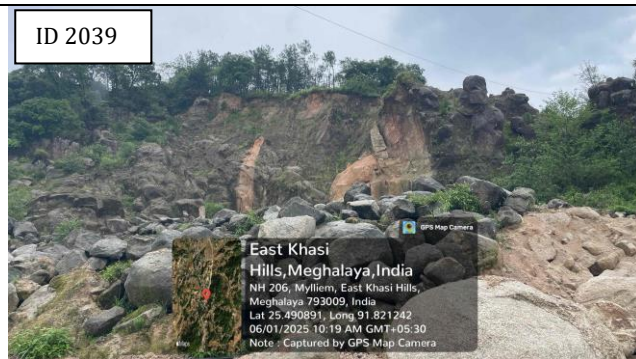
ID 2039

| ID | SLIDE_ID | YEAR | MONTH | STATE | DISTRICT | LS_NAME | NH_SH_AFFECTED | LAT | LON | DATE_OF_EVENT | STATUS | REMARKS |
|---|---|---|---|---|---|---|---|---|---|---|---|---|
| 2039 | Field Survey/2025/Meghalaya/72 | 2025 | May | Meghalaya | East Khasi Hills | Mylliem Landslide 2 | NH 206 | 25.49086 | 91.82135 | 30-05-2025 | Verified | Road Affected |

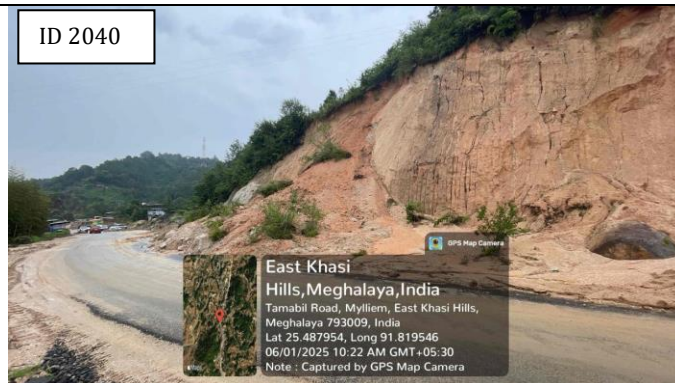
ID 2040

| ID | SLIDE_ID | YEAR | MONTH | STATE | DISTRICT | LS_NAME | NH_SH_AFFECTED | LAT | LON | DATE_OF_EVENT | STATUS | REMARKS |
|---|---|---|---|---|---|---|---|---|---|---|---|---|
| 2040 | Field Survey/2025/Meghalaya/73 | 2025 | May | Meghalaya | East Khasi Hills | Mylliem Landslide 3 | NH 206 | 25.48787 | 91.81959 | 30-05-2025 | Verified | Road Affected |

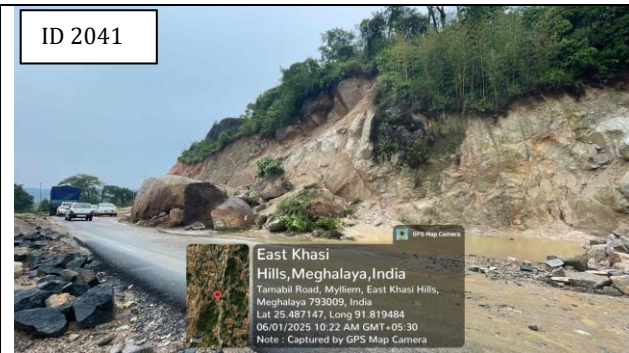
ID 2041

| ID | SLIDE_ID | YEAR | MONTH | STATE | DISTRICT | LS_NAME | NH_SH_AFFECTED | LAT | LON | DATE_OF_EVENT | STATUS | REMARKS |
|---|---|---|---|---|---|---|---|---|---|---|---|---|
| 2041 | Field Survey/2025/Meghalaya/74 | 2025 | May | Meghalaya | East Khasi Hills | Mylliem Landslide 4 | NH 206 | 25.48715 | 91.81948 | 30-05-2025 | Verified | Road Affected |

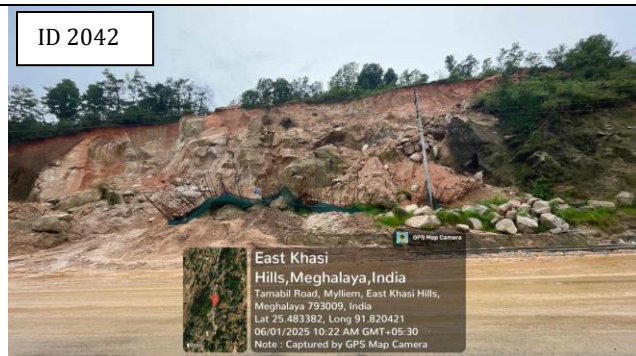
ID 2042

| ID | SLIDE_ID | YEAR | MONTH | STATE | DISTRICT | LS_NAME | NH_SH_AFFECTED | LAT | LON | DATE_OF_EVENT | STATUS | REMARKS |
|---|---|---|---|---|---|---|---|---|---|---|---|---|
| 2042 | Field Survey/2025/Meghalaya/75 | 2025 | May | Meghalaya | East Khasi Hills | Mylliem Landslide 5 | NH 206 | 25.4868 | 91.81987 | 30-05-2025 | Verified | Road Affected |

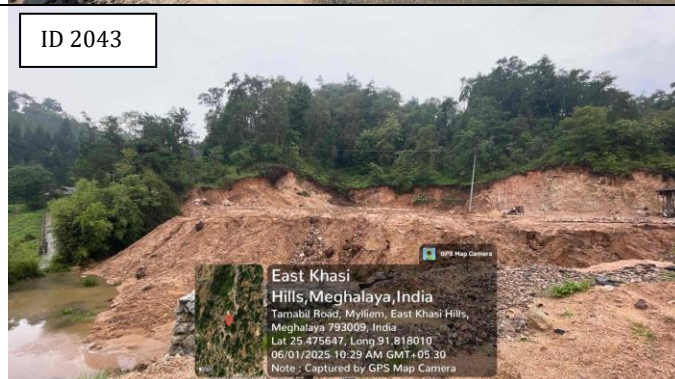
ID 2043

| ID | SLIDE_ID | YEAR | MONTH | STATE | DISTRICT | LS_NAME | NH_SH_AFFECTED | LAT | LON | DATE_OF_EVENT | STATUS | REMARKS |
|---|---|---|---|---|---|---|---|---|---|---|---|---|
| 2043 | Field Survey/2025/Meghalaya/76 | 2025 | May | Meghalaya | East Khasi Hills | Mylliem Landslide 6 | NH 206 | 25.47565 | 91.81801 | 30-05-2025 | Verified | Road Affected |

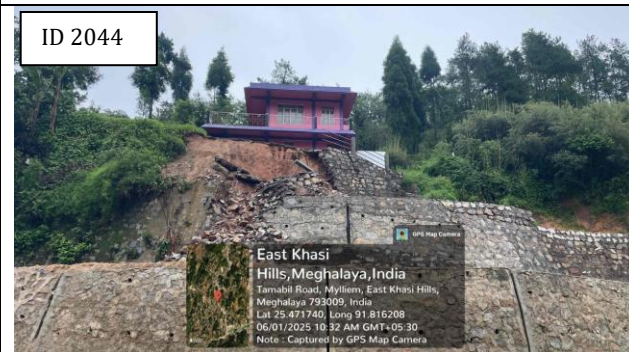
ID 2044

| ID | SLIDE_ID | YEAR | MONTH | STATE | DISTRICT | LS_NAME | NH_SH_AFFECTED | LAT | LON | DATE_OF_EVENT | STATUS | REMARKS |
|---|---|---|---|---|---|---|---|---|---|---|---|---|
| 2044 | Field Survey/2025/Meghalaya/77 | 2025 | May | Meghalaya | East Khasi Hills | Mylliem Landslide 7 | NH 206 | 25.47174 | 91.81621 | 31-05-2025 | Verified | Road Affected |

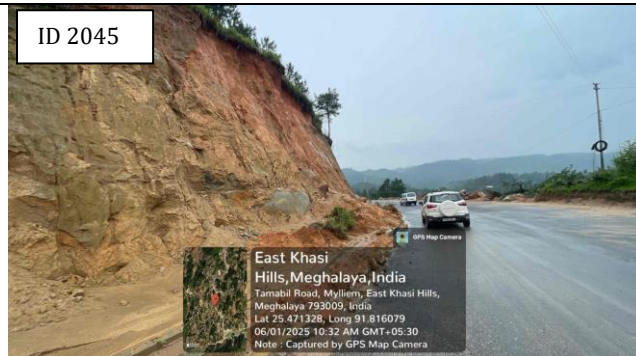
ID 2045

| ID | SLIDE_ID | YEAR | MONTH | STATE | DISTRICT | LS_NAME | NH_SH_AFFECTED | LAT | LON | DATE_OF_EVENT | STATUS | REMARKS |
|---|---|---|---|---|---|---|---|---|---|---|---|---|
| 2045 | Field Survey/2025/Meghalaya/78 | 2025 | May | Meghalaya | East Khasi Hills | Mylliem Landslide 8 | NH 206 | 25.47133 | 91.81608 | 30-05-2025 | Verified | Road Affected |

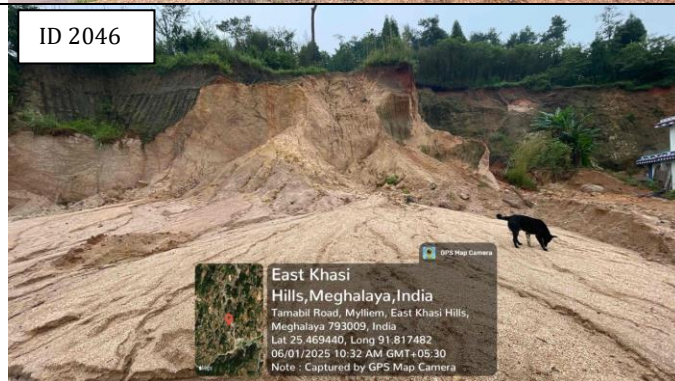
ID 2046

| ID | SLIDE_ID | YEAR | MONTH | STATE | DISTRICT | LS_NAME | NH_SH_AFFECTED | LAT | LON | DATE_OF_EVENT | STATUS | REMARKS |
|---|---|---|---|---|---|---|---|---|---|---|---|---|
| 2046 | Field Survey/2025/Meghalaya/79 | 2025 | May | Meghalaya | East Khasi Hills | Mylliem Landslide 9 | NH 206 | 25.46944 | 91.81748 | 30-05-2025 | Verified | Road Affected |

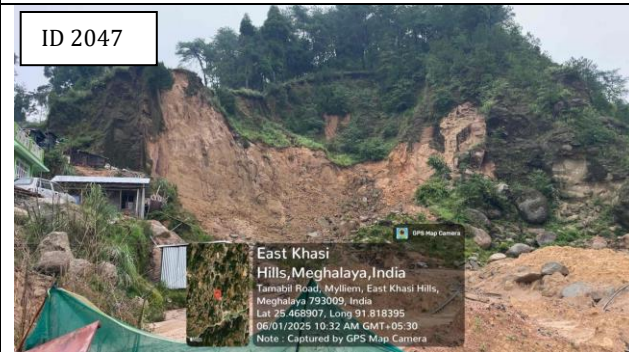
ID 2047

| ID | SLIDE_ID | YEAR | MONTH | STATE | DISTRICT | LS_NAME | NH_SH_AFFECTED | LAT | LON | DATE_OF_EVENT | STATUS | REMARKS |
|---|---|---|---|---|---|---|---|---|---|---|---|---|
| 2047 | Field Survey/2025/Meghalaya/80 | 2025 | May | Meghalaya | East Khasi Hills | Mylliem Landslide 10 | NH 206 | 25.46891 | 91.8184 | 30-05-2025 | Verified | Road Affected |

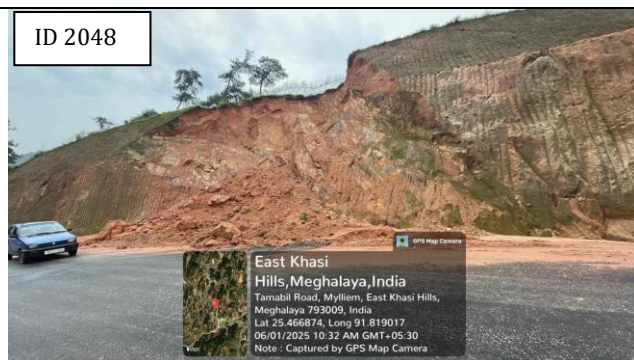
ID 2048

| ID | SLIDE_ID | YEAR | MONTH | STATE | DISTRICT | LS_NAME | NH_SH_AFFECTED | LAT | LON | DATE_OF_EVENT | STATUS | REMARKS |
|---|---|---|---|---|---|---|---|---|---|---|---|---|
| 2048 | Field Survey/2025/Meghalaya/81 | 2025 | May | Meghalaya | East Khasi Hills | Mylliem Landslide 11 | NH 206 | 25.46687 | 91.81902 | 31-05-2025 | Verified | Road Affected |

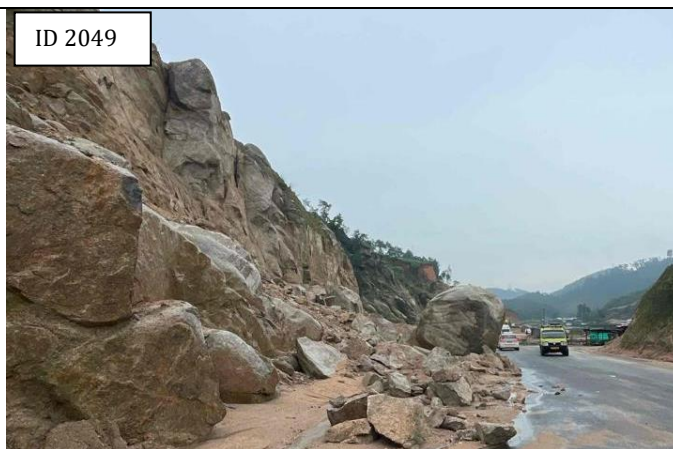
ID 2049

| ID | SLIDE_ID | YEAR | MONTH | STATE | DISTRICT | LS_NAME | NH_SH_AFFECTED | LAT | LON | DATE_OF_EVENT | STATUS | REMARKS |
|---|---|---|---|---|---|---|---|---|---|---|---|---|
| 2049 | Field Survey/2025/Meghalaya/82 | 2025 | May | Meghalaya | East Khasi Hills | Mylliem Landslide 12 | NH 206 | 25.46591 | 91.82085 | 31-05-2025 | Verified | Road Affected |

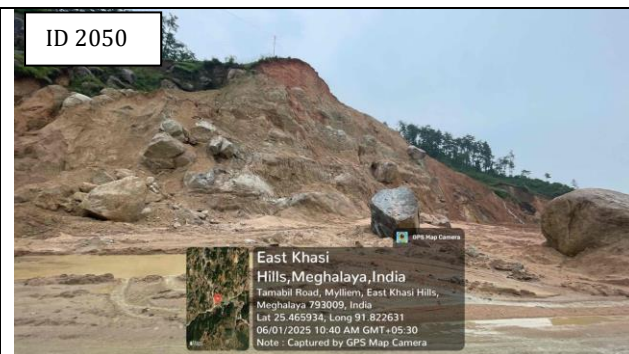
ID 2050

| ID | SLIDE_ID | YEAR | MONTH | STATE | DISTRICT | LS_NAME | NH_SH_AFFECTED | LAT | LON | DATE_OF_EVENT | STATUS | REMARKS |
|---|---|---|---|---|---|---|---|---|---|---|---|---|
| 2050 | Field Survey/2025/Meghalaya/83 | 2025 | May | Meghalaya | East Khasi Hills | Mylliem Landslide 13 | NH 206 | 25.46593 | 91.82263 | 30-05-2025 | Verified | Road Affected |

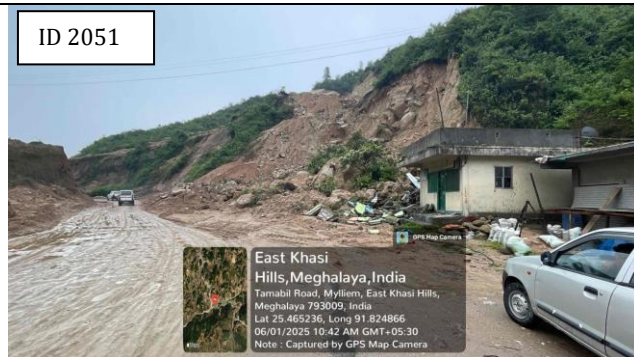
ID 2051

| ID | SLIDE_ID | YEAR | MONTH | STATE | DISTRICT | LS_NAME | NH_SH_AFFECTED | LAT | LON | DATE_OF_EVENT | STATUS | REMARKS |
|---|---|---|---|---|---|---|---|---|---|---|---|---|
| 2051 | Field Survey/2025/Meghalaya/84 | 2025 | May | Meghalaya | East Khasi Hills | Umtyngar Landslide | NH 206 | 25.46529 | 91.82496 | 31-05-2025 | Verified | Road Affected |

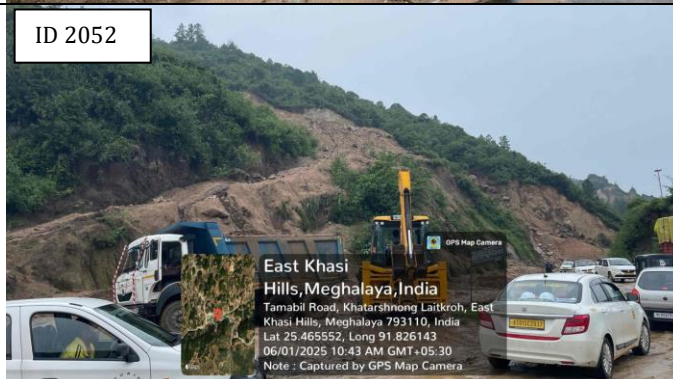
ID 2052

| ID | SLIDE_ID | YEAR | MONTH | STATE | DISTRICT | LS_NAME | NH_SH_AFFECTED | LAT | LON | DATE_OF_EVENT | STATUS | REMARKS |
|---|---|---|---|---|---|---|---|---|---|---|---|---|
| 2052 | Field Survey/2025/Meghalaya/85 | 2025 | May | Meghalaya | East Khasi Hills | Umtyngar Landslide 2 | NH 206 | 25.46555 | 91.82614 | 30-05-2025 | Verified | Road Affected |

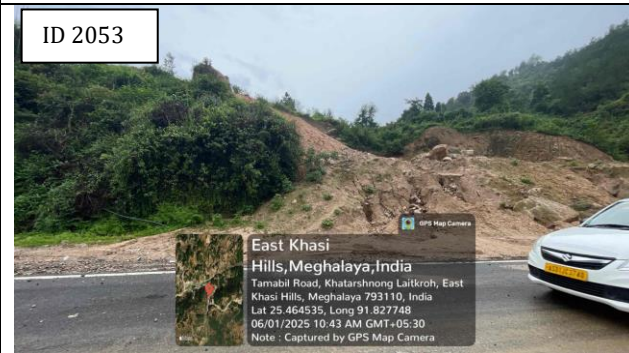
ID 2053

| ID | SLIDE_ID | YEAR | MONTH | STATE | DISTRICT | LS_NAME | NH_SH_AFFECTED | LAT | LON | DATE_OF_EVENT | STATUS | REMARKS |
|---|---|---|---|---|---|---|---|---|---|---|---|---|
| 2053 | Field Survey/2025/Meghalaya/86 | 2025 | May | Meghalaya | East Khasi Hills | Umtyngar Landslide 3 | NH 206 | 25.46443 | 91.82775 | 31-05-2025 | Verified | Road Affected |

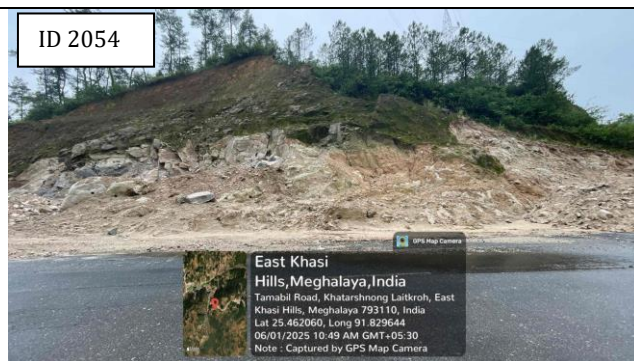
ID 2054

| ID | SLIDE_ID | YEAR | MONTH | STATE | DISTRICT | LS_NAME | NH_SH_AFFECTED | LAT | LON | DATE_OF_EVENT | STATUS | REMARKS |
|---|---|---|---|---|---|---|---|---|---|---|---|---|
| 2054 | Field Survey/2025/Meghalaya/87 | 2025 | May | Meghalaya | East Khasi Hills | Laitkroh Landslide | NH 206 | 25.46194 | 91.82976 | 31-05-2025 | Verified | Road Affected |

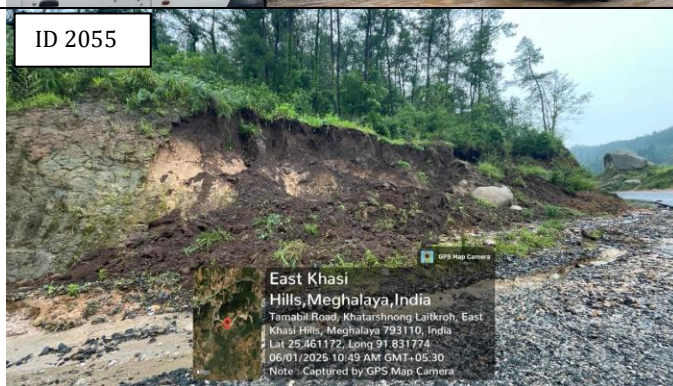
ID 2055

| ID | SLIDE_ID | YEAR | MONTH | STATE | DISTRICT | LS_NAME | NH_SH_AFFECTED | LAT | LON | DATE_OF_EVENT | STATUS | REMARKS |
|---|---|---|---|---|---|---|---|---|---|---|---|---|
| 2055 | Field Survey/2025/Meghalaya/88 | 2025 | May | Meghalaya | East Khasi Hills | Laitkroh Landslide 2 | NH 206 | 25.46117 | 91.83177 | 31-05-2025 | Verified | Road Affected |

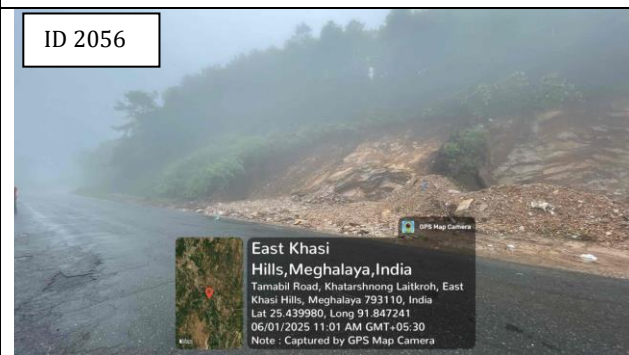
ID 2056

| ID | SLIDE_ID | YEAR | MONTH | STATE | DISTRICT | LS_NAME | NH_SH_AFFECTED | LAT | LON | DATE_OF_EVENT | STATUS | REMARKS |
|---|---|---|---|---|---|---|---|---|---|---|---|---|
| 2056 | Field Survey/2025/Meghalaya/89 | 2025 | May | Meghalaya | East Khasi Hills | Laitkroh Landslide 3 | NH 206 | 25.44031 | 91.84712 | 30-05-2025 | Verified | Road Affected |

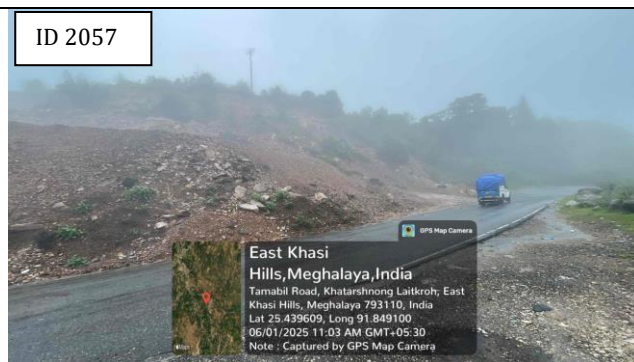
ID 2057

| ID | SLIDE_ID | YEAR | MONTH | STATE | DISTRICT | LS_NAME | NH_SH_AFFECTED | LAT | LON | DATE_OF_EVENT | STATUS | REMARKS |
|---|---|---|---|---|---|---|---|---|---|---|---|---|
| 2057 | Field Survey/2025/Meghalaya/90 | 2025 | May | Meghalaya | East Khasi Hills | Laitkroh Landslide 4 | NH 206 | 25.43961 | 91.8491 | 30-05-2025 | Verified | Road Affected |

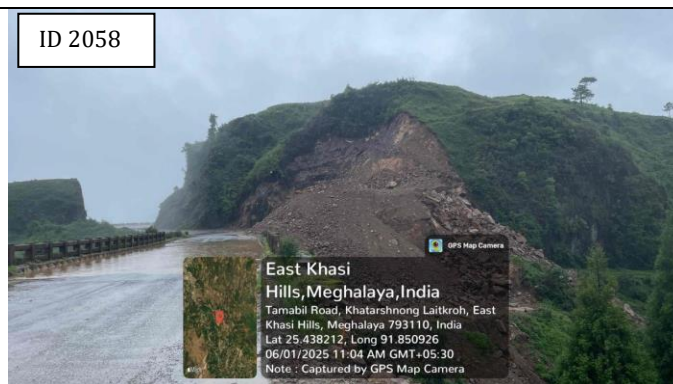
ID 2058

| ID | SLIDE_ID | YEAR | MONTH | STATE | DISTRICT | LS_NAME | NH_SH_AFFECTED | LAT | LON | DATE_OF_EVENT | STATUS | REMARKS |
|---|---|---|---|---|---|---|---|---|---|---|---|---|
| 2058 | Field Survey/2025/Meghalaya/91 | 2025 | May | Meghalaya | East Khasi Hills | Laitkroh Landslide 5 | NH 206 | 25.43813 | 91.85107 | 30-05-2025 | Verified | Road Affected |

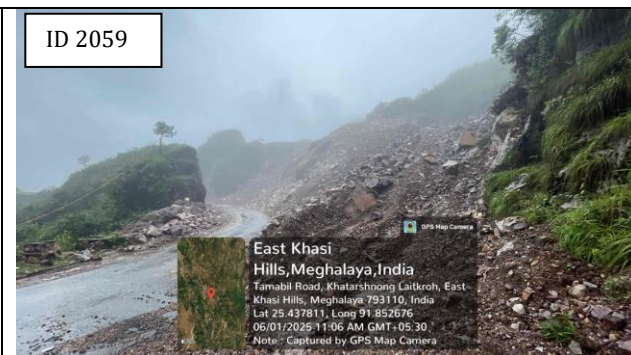
ID 2059

| ID | SLIDE_ID | YEAR | MONTH | STATE | DISTRICT | LS_NAME | NH_SH_AFFECTED | LAT | LON | DATE_OF_EVENT | STATUS | REMARKS |
|---|---|---|---|---|---|---|---|---|---|---|---|---|
| 2059 | Field Survey/2025/Meghalaya/92 | 2025 | May | Meghalaya | East Khasi Hills | Lum Thnagding Landslide | NH 206 | 25.43763 | 91.85282 | 31-05-2025 | Verified | Road Affected |

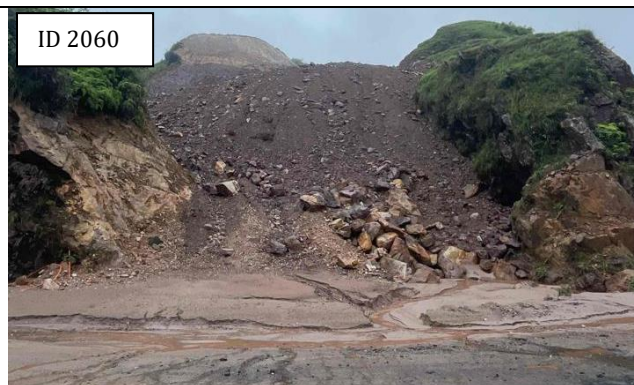
ID 2060

| ID | SLIDE_ID | YEAR | MONTH | STATE | DISTRICT | LS_NAME | NH_SH_AFFECTED | LAT | LON | DATE_OF_EVENT | STATUS | REMARKS |
|---|---|---|---|---|---|---|---|---|---|---|---|---|
| 2060 | Field Survey/2025/Meghalaya/93 | 2025 | May | Meghalaya | East Khasi Hills | Lum Thnagding Landslide 2 | NH 206 | 25.43763 | 91.85432 | 30-05-2025 | Verified | Road Affected |

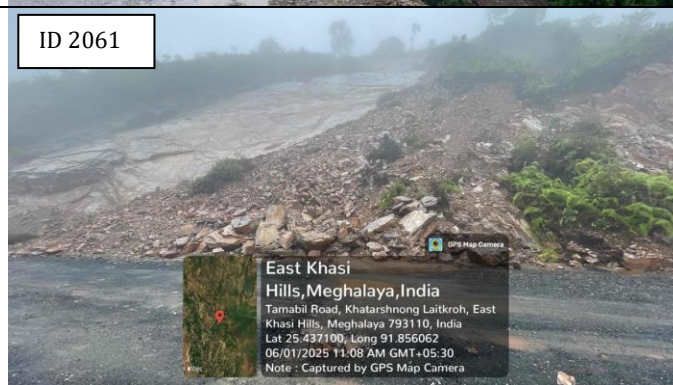
ID 2061

| ID | SLIDE_ID | YEAR | MONTH | STATE | DISTRICT | LS_NAME | NH_SH_AFFECTED | LAT | LON | DATE_OF_EVENT | STATUS | REMARKS |
|---|---|---|---|---|---|---|---|---|---|---|---|---|
| 2061 | Field Survey/2025/Meghalaya/94 | 2025 | May | Meghalaya | East Khasi Hills | Lum Thnagding Landslide 3 | NH 206 | 25.43707 | 91.8561 | 30-05-2025 | Verified | Road Affected |

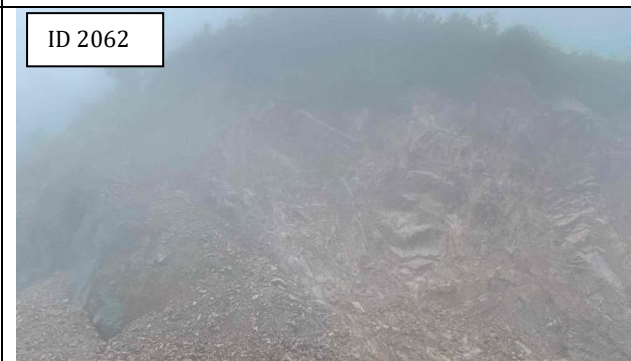
ID 2062

| ID | SLIDE_ID | YEAR | MONTH | STATE | DISTRICT | LS_NAME | NH_SH_AFFECTED | LAT | LON | DATE_OF_EVENT | STATUS | REMARKS |
|---|---|---|---|---|---|---|---|---|---|---|---|---|
| 2062 | Field Survey/2025/Meghalaya/95 | 2025 | May | Meghalaya | East Khasi Hills | Lum Thnagding Landslide 4 | NH 206 | 25.437 | 91.85824 | 30-05-2025 | Verified | Road Affected |

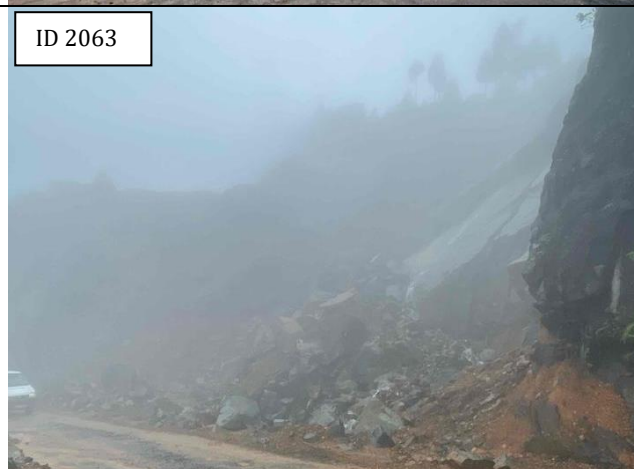
ID 2063

| ID | SLIDE_ID | YEAR | MONTH | STATE | DISTRICT | LS_NAME | NH_SH_AFFECTED | LAT | LON | DATE_OF_EVENT | STATUS | REMARKS |
|---|---|---|---|---|---|---|---|---|---|---|---|---|
| 2063 | Field Survey/2025/Meghalaya/96 | 2025 | May | Meghalaya | East Khasi Hills | Wah Bnoh Landslide | NH 206 | 25.43398 | 91.86066 | 31-05-2025 | Verified | Road Affected |

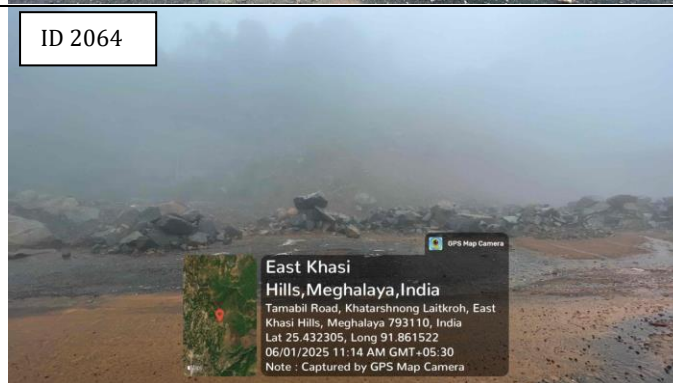
ID 2064

| ID | SLIDE_ID | YEAR | MONTH | STATE | DISTRICT | LS_NAME | NH_SH_AFFECTED | LAT | LON | DATE_OF_EVENT | STATUS | REMARKS |
|---|---|---|---|---|---|---|---|---|---|---|---|---|
| 2064 | Field Survey/2025/Meghalaya/97 | 2025 | May | Meghalaya | East Khasi Hills | Wah Bnoh Landslide 2 | NH 206 | 25.43231 | 91.86152 | 31-05-2025 | Verified | Road Affected |

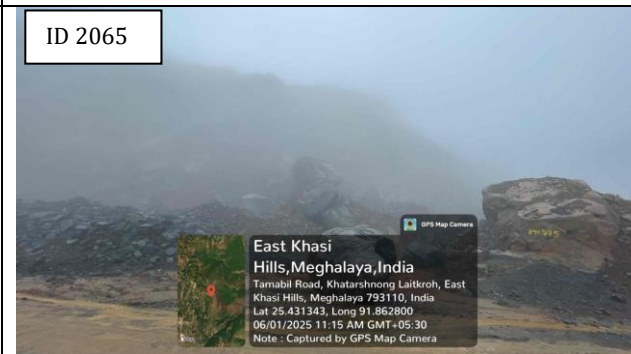
ID 2065

| ID | SLIDE_ID | YEAR | MONTH | STATE | DISTRICT | LS_NAME | NH_SH_AFFECTED | LAT | LON | DATE_OF_EVENT | STATUS | REMARKS |
|---|---|---|---|---|---|---|---|---|---|---|---|---|
| 2065 | Field Survey/2025/Meghalaya/98 | 2025 | May | Meghalaya | East Khasi Hills | Wah Bnoh Landslide 3 | NH 206 | 25.43141 | 91.86274 | 31-05-2025 | Verified | Road Affected |

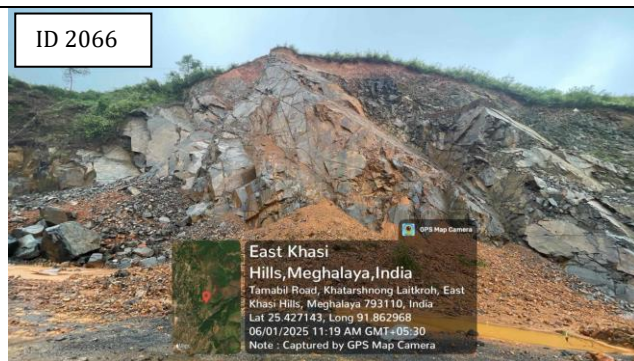
ID 2066

| ID | SLIDE_ID | YEAR | MONTH | STATE | DISTRICT | LS_NAME | NH_SH_AFFECTED | LAT | LON | DATE_OF_EVENT | STATUS | REMARKS |
|---|---|---|---|---|---|---|---|---|---|---|---|---|
| 2066 | Field Survey/2025/Meghalaya/99 | 2025 | May | Meghalaya | East Khasi Hills | Wah Bnoh Landslide 4 | NH 206 | 25.42705 | 91.86312 | 30-05-2025 | Verified | Road Affected |

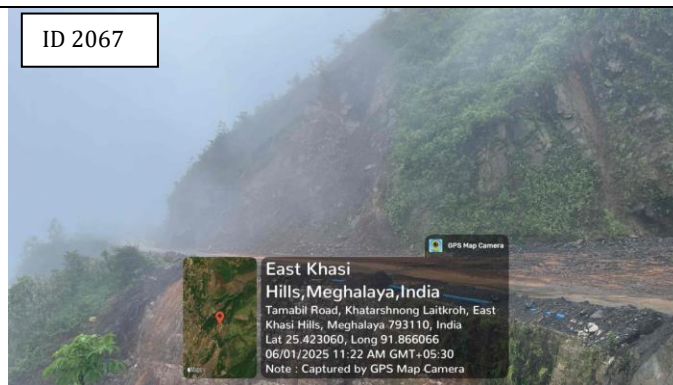
ID 2067

| ID | SLIDE_ID | YEAR | MONTH | STATE | DISTRICT | LS_NAME | NH_SH_AFFECTED | LAT | LON | DATE_OF_EVENT | STATUS | REMARKS |
|---|---|---|---|---|---|---|---|---|---|---|---|---|
| 2067 | Field Survey/2025/Meghalaya/100 | 2025 | May | Meghalaya | East Khasi Hills | Wah Bnoh Landslide 5 | NH 206 | 25.4229 | 91.86607 | 31-05-2025 | Verified | Road Affected |

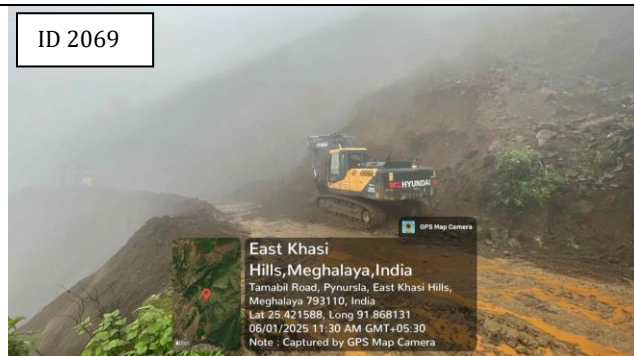
ID 2069

| ID | SLIDE_ID | YEAR | MONTH | STATE | DISTRICT | LS_NAME | NH_SH_AFFECTED | LAT | LON | DATE_OF_EVENT | STATUS | REMARKS |
|---|---|---|---|---|---|---|---|---|---|---|---|---|
| 2069 | Field Survey/2025/Meghalaya/102 | 2025 | May | Meghalaya | East Khasi Hills | Pomlum Landslide | NH 206 | 25.42162 | 91.86807 | 31-05-2025 | Verified | Road Affected |

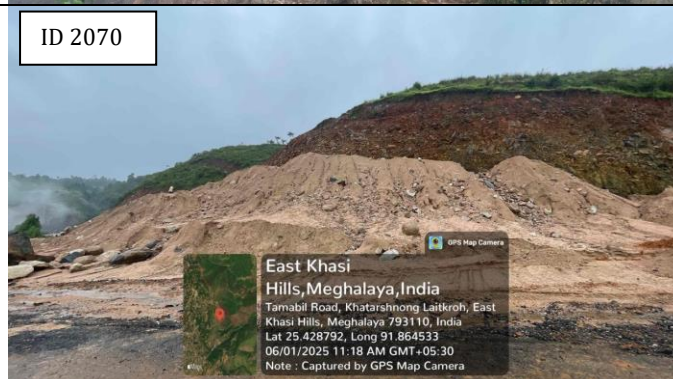
ID 2070

| ID | SLIDE_ID | YEAR | MONTH | STATE | DISTRICT | LS_NAME | NH_SH_AFFECTED | LAT | LON | DATE_OF_EVENT | STATUS | REMARKS |
|---|---|---|---|---|---|---|---|---|---|---|---|---|
| 2070 | Field Survey/2025/Meghalaya/103 | 2025 | May | Meghalaya | East Khasi Hills | Pomlum Landslide 2 | NH 206 | 25.42881 | 91.86459 | 30-05-2025 | Verified | Road Affected |

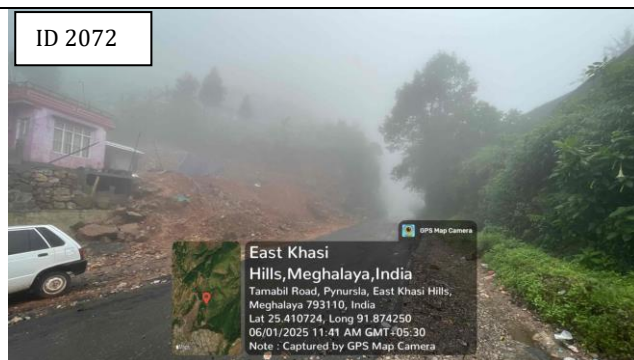
ID 2072

| ID | SLIDE_ID | YEAR | MONTH | STATE | DISTRICT | LS_NAME | NH_SH_AFFECTED | LAT | LON | DATE_OF_EVENT | STATUS | REMARKS |
|---|---|---|---|---|---|---|---|---|---|---|---|---|
| 2072 | Field Survey/2025/Meghalaya/105 | 2025 | May | Meghalaya | East Khasi Hills | Pomlum Landslide 4 | NH 206 | 25.41072 | 91.87425 | 30-05-2025 | Verified | Road Affected |

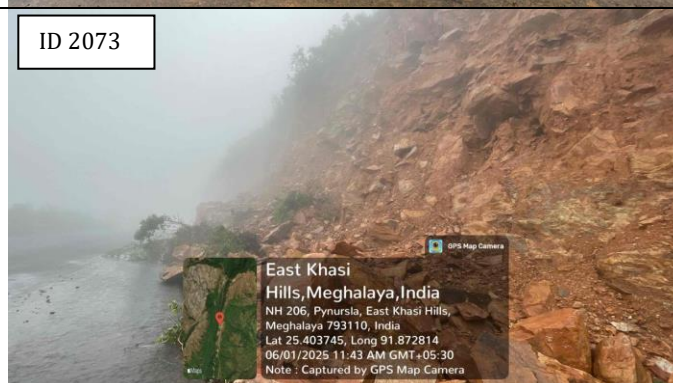
ID 2073

| ID | SLIDE_ID | YEAR | MONTH | STATE | DISTRICT | LS_NAME | NH_SH_AFFECTED | LAT | LON | DATE_OF_EVENT | STATUS | REMARKS |
|---|---|---|---|---|---|---|---|---|---|---|---|---|
| 2073 | Field Survey/2025/Meghalaya/106 | 2025 | May | Meghalaya | East Khasi Hills | Mawkejam Landslide | NH 206 | 25.40375 | 91.87281 | 31-05-2025 | Verified | Road Affected |

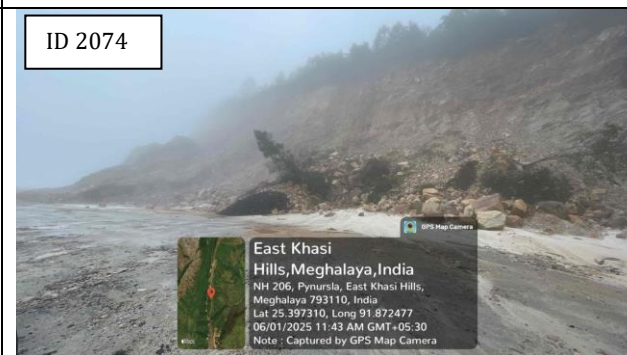
ID 2074

| ID | SLIDE_ID | YEAR | MONTH | STATE | DISTRICT | LS_NAME | NH_SH_AFFECTED | LAT | LON | DATE_OF_EVENT | STATUS | REMARKS |
|---|---|---|---|---|---|---|---|---|---|---|---|---|
| 2074 | Field Survey/2025/Meghalaya/107 | 2025 | May | Meghalaya | East Khasi Hills | Mawkejam Landslide 2 | NH 206 | 25.39732 | 91.87258 | 31-05-2025 | Verified | Road Affected |

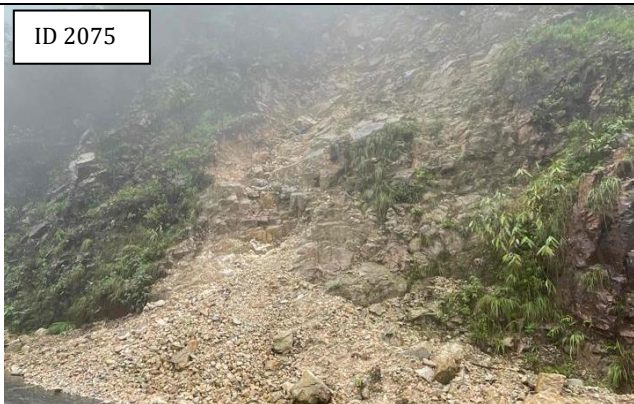
ID 2075

| ID | SLIDE_ID | YEAR | MONTH | STATE | DISTRICT | LS_NAME | NH_SH_AFFECTED | LAT | LON | DATE_OF_EVENT | STATUS | REMARKS |
|---|---|---|---|---|---|---|---|---|---|---|---|---|
| 2075 | Field Survey/2025/Meghalaya/108 | 2025 | May | Meghalaya | East Khasi Hills | Mawkejam Landslide 3 | NH 206 | 25.39072 | 91.87185 | 31-05-2025 | Verified | Road Affected |

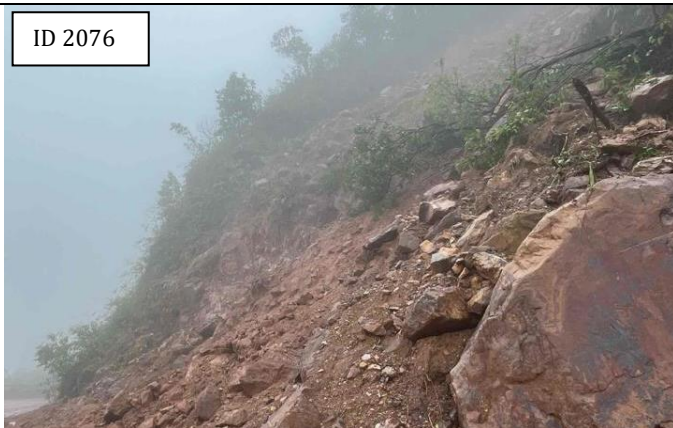
ID 2076

| ID | SLIDE_ID | YEAR | MONTH | STATE | DISTRICT | LS_NAME | NH_SH_AFFECTED | LAT | LON | DATE_OF_EVENT | STATUS | REMARKS |
|---|---|---|---|---|---|---|---|---|---|---|---|---|
| 2076 | Field Survey/2025/Meghalaya/109 | 2025 | May | Meghalaya | East Khasi Hills | Mawkejam Landslide 4 | NH 206 | 25.3852 | 91.87428 | 31-05-2025 | Verified | Road Affected |

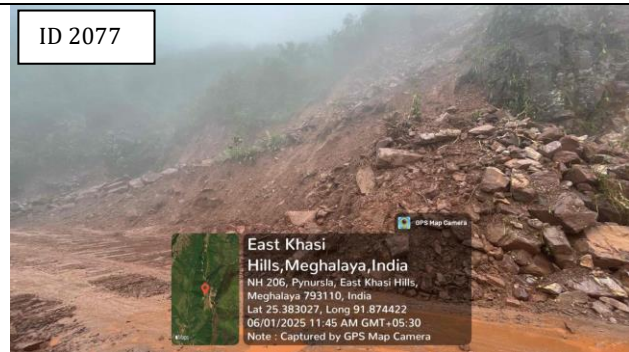
ID 2077

| ID | SLIDE_ID | YEAR | MONTH | STATE | DISTRICT | LS_NAME | NH_SH_AFFECTED | LAT | LON | DATE_OF_EVENT | STATUS | REMARKS |
|---|---|---|---|---|---|---|---|---|---|---|---|---|
| 2077 | Field Survey/2025/Meghalaya/110 | 2025 | May | Meghalaya | East Khasi Hills | Rgnain Landslide | NH 206 | 25.38303 | 91.87442 | 31-05-2025 | Verified | Road Affected |

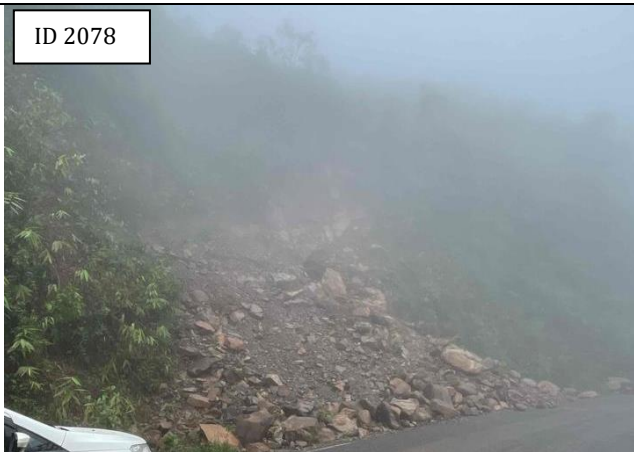
ID 2078

| ID | SLIDE_ID | YEAR | MONTH | STATE | DISTRICT | LS_NAME | NH_SH_AFFECTED | LAT | LON | DATE_OF_EVENT | STATUS | REMARKS |
|---|---|---|---|---|---|---|---|---|---|---|---|---|
| 2078 | Field Survey/2025/Meghalaya/111 | 2025 | May | Meghalaya | East Khasi Hills | Rgnain Landslide 2 | NH 206 | 25.38257 | 91.87439 | 30-05-2025 | Verified | Road Affected |
