***Landslide Field Survey (NH 6 & NH 206, Meghalaya) following Extreme Rainfall Events on 30-31 May 2025***

**Report on**  
**Landslide Field Survey (NH 6 & NH 206, Meghalaya) following Extreme Rainfall Events on**  
**30–31 May 2025**

**Submitted To**  
**State Disaster Management Authority, Meghalaya**

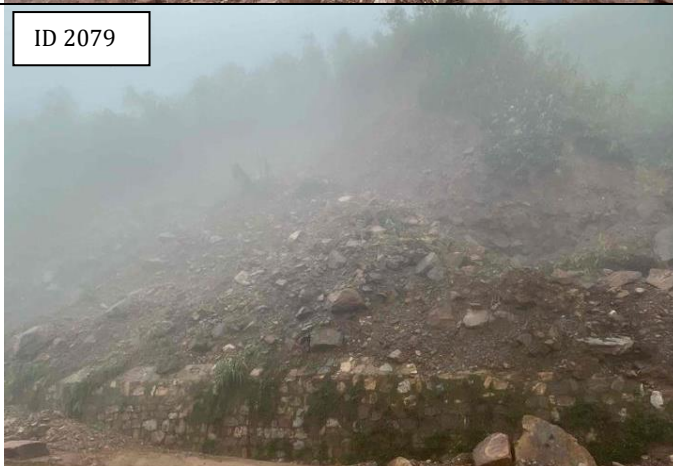
ID 2079

| ID | SLIDE_ID | YEAR | MONTH | STATE | DISTRICT | LS_NAME | NH_SH_AFFECTED | LAT | LON | DATE_OF_EVENT | STATUS | REMARKS |
|---|---|---|---|---|---|---|---|---|---|---|---|---|
| 2079 | Field Survey/2025/Meghalaya/112 | 2025 | May | Meghalaya | East Khasi Hills | Rgnain Landslide 3 | NH 206 | 25.37975 | 91.87347 | 31-05-2025 | Verified | Road Affected |

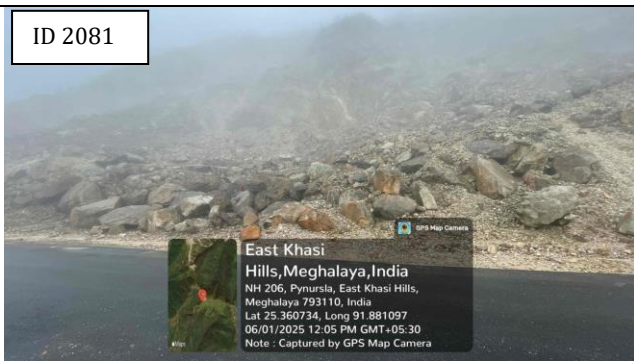
ID 2081

| ID | SLIDE_ID | YEAR | MONTH | STATE | DISTRICT | LS_NAME | NH_SH_AFFECTED | LAT | LON | DATE_OF_EVENT | STATUS | REMARKS |
|---|---|---|---|---|---|---|---|---|---|---|---|---|
| 2081 | Field Survey/2025/Meghalaya/114 | 2025 | May | Meghalaya | East Khasi Hills | Kyntiew Masi Landslide | NH 206 | 25.36093 | 91.88129 | 30-05-2025 | Verified | Road Affected |

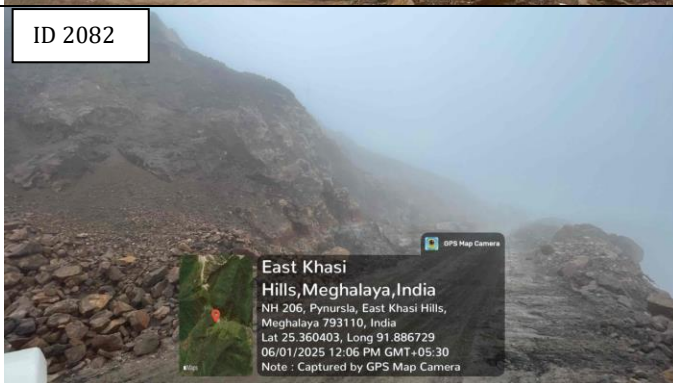
ID 2082

| ID | SLIDE_ID | YEAR | MONTH | STATE | DISTRICT | LS_NAME | NH_SH_AFFECTED | LAT | LON | DATE_OF_EVENT | STATUS | REMARKS |
|---|---|---|---|---|---|---|---|---|---|---|---|---|
| 2082 | Field Survey/2025/Meghalaya/115 | 2025 | May | Meghalaya | East Khasi Hills | Kyntiew Masi Landslide 2 | NH 206 | 25.3604 | 91.88673 | 30-05-2025 | Verified | Road Affected |

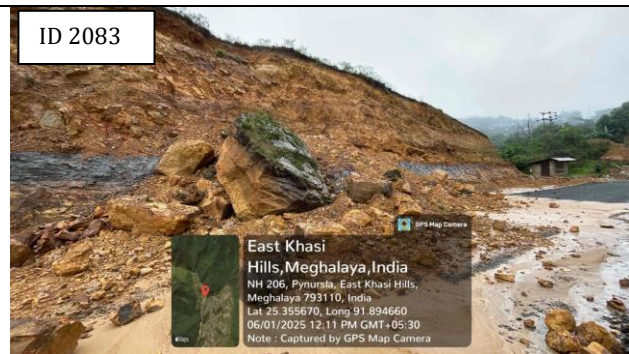
ID 2083

| ID | SLIDE_ID | YEAR | MONTH | STATE | DISTRICT | LS_NAME | NH_SH_AFFECTED | LAT | LON | DATE_OF_EVENT | STATUS | REMARKS |
|---|---|---|---|---|---|---|---|---|---|---|---|---|
| 2083 | Field Survey/2025/Meghalaya/116 | 2025 | May | Meghalaya | East Khasi Hills | Langkyrdem Landslide | NH 206 | 25.35567 | 91.89466 | 31-05-2025 | Verified | Road Affected |

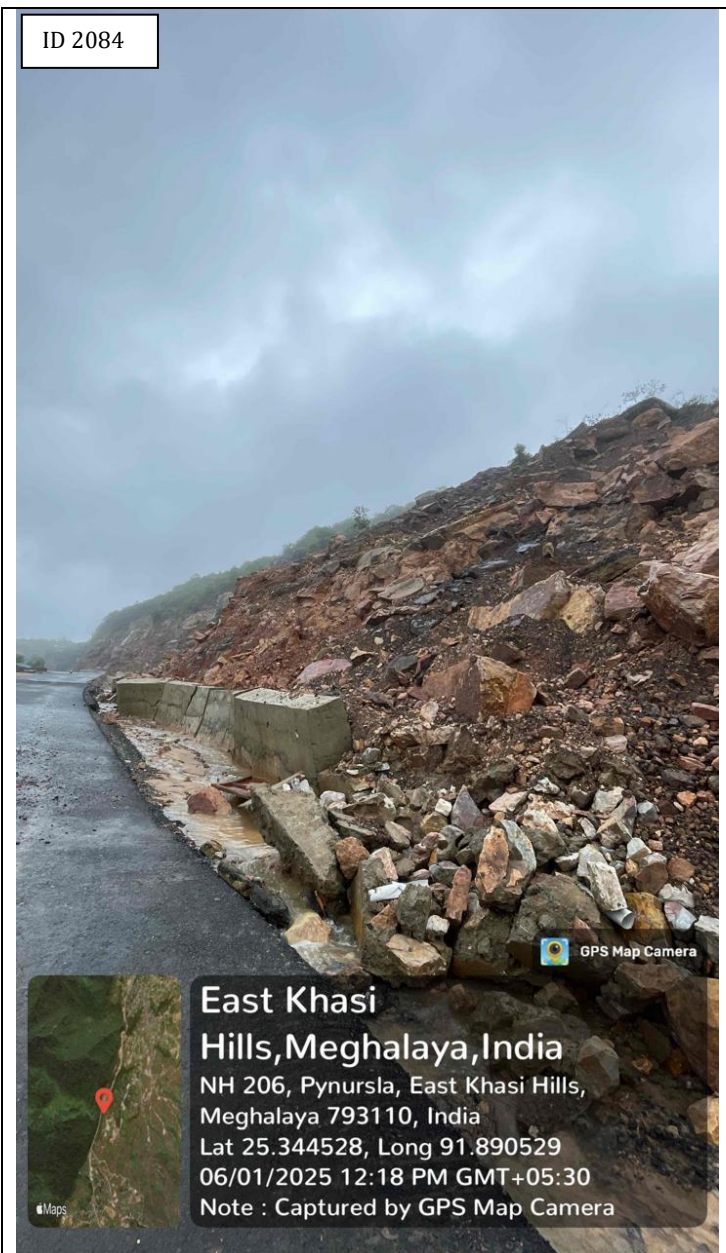
ID 2084

| ID | SLIDE_ID | YEAR | MONTH | STATE | DISTRICT | LS_NAME | NH_SH_AFFECTED | LAT | LON | DATE_OF_EVENT | STATUS | REMARKS |
|---|---|---|---|---|---|---|---|---|---|---|---|---|
| 2084 | Field Survey/2025/Meghalaya/117 | 2025 | May | Meghalaya | East Khasi Hills | Langkyrdem Landslide 2 | NH 206 | 25.34457 | 91.8906 | 30-05-2025 | Verified | Road Affected |
