Solar AI Platform — Project Report (Starter)

Project: Test again (ID: 9)

Address: Testing address

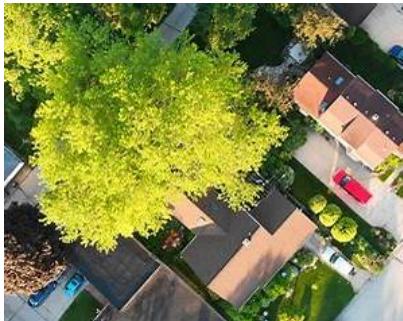
roof_20260101_191031_466567_two image.jpg

Overall Shading Level: **Medium** (Avg 14.6% loss)

Issue: Panels are 0.5m from edge (minimum: 0.9m)

Issue: Edge clearance (0.5m) may not provide adequate fire pathway

Fix: Increase offset_from_edge to 0.9m or greater

Fix: Increase edge offset to 0.9m for fire safety

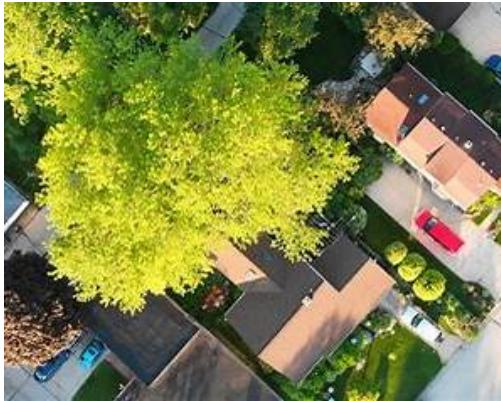
Image 1 — Findings

No visible cracks, rust, corrosion, water damage (staining/darkening), or major structural damage (sagging/holes) are detectable from the provided aerial image.

The primary roof sections of the main L-shaped building appear to be low-slope or flat, consistent with a membrane roof type (e.g., EPDM, TPO, modified bitumen). There may be some small pitched sections with shingles. A very large tree significantly overhangs and casts heavy shade over a substantial portion of the roof, which will negatively impact solar panel efficiency. This tree would likely require significant trimming or removal for optimal solar performance.

The resolution and aerial angle of the image limit the ability to detect subtle roof issues such as minor surface cracks, sealant failures, or granule loss on potential shingle sections.

Roof type identified: Membrane/Flat roof (with possible shingle sections)
Recommendation: A thorough, on-site inspection by a qualified roofing and solar professional is essential to confirm the roof's exact type, structural integrity, identify any hidden or subtle damage, and accurately assess the impact of tree shading before any solar panel installation.

Tree trimming or removal should be considered to maximize solar potential.
