Property Condition Assessment Report

Public Utilities Commission Building

1155 Main Street

NDDS Project No.: 12-0250

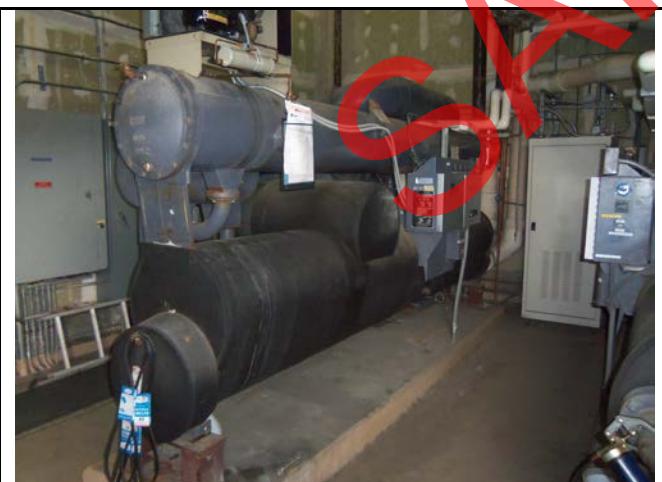
Photo 5. Typical Centrifugal Chiller

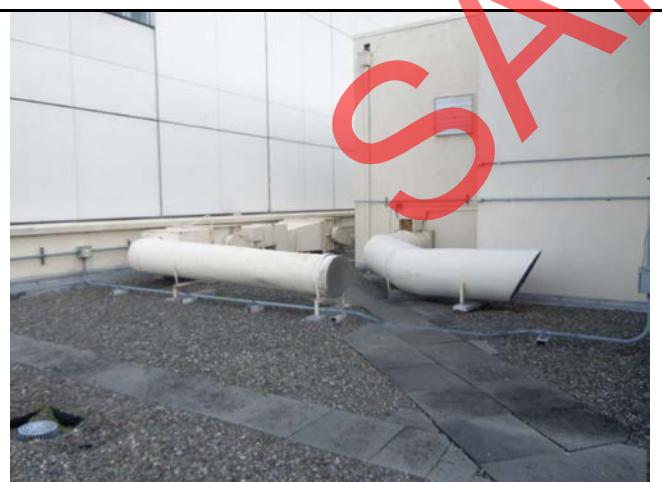
Photo 11. Roof

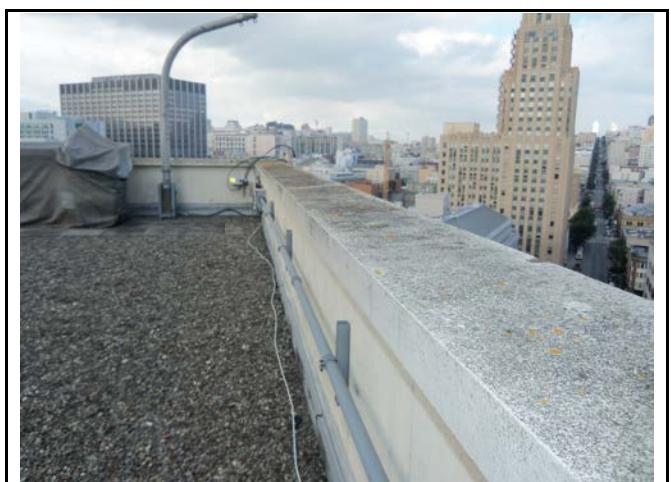
Photo 12. Parapet & wall caps

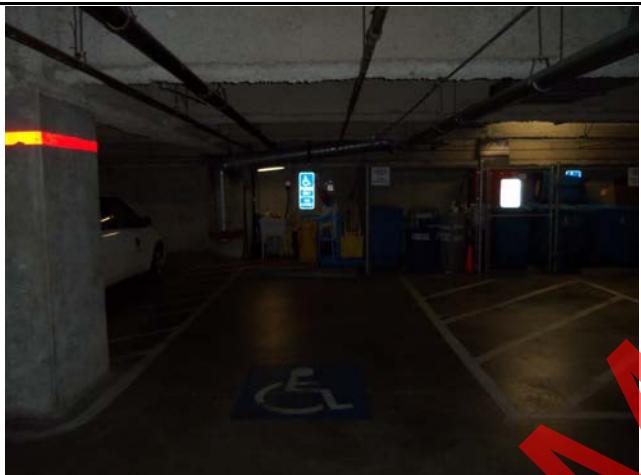
Photo 33. Typical ADA space, basement parking garage

Restriping of the parking spaces is recommended. The cost for this work is minimal; it is considered part of routine maintenance.

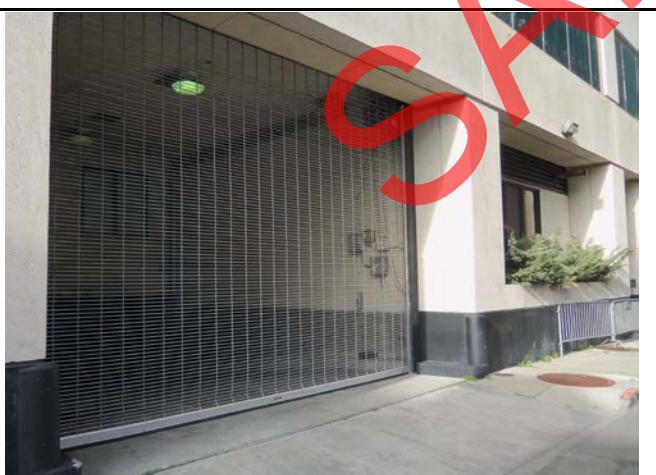
• Poor Access/Egress	No concerns relating to property access or egress were noted by or reported to NDDS's assessor. NDDS did not observe a manual override for operating the overhead garage door in the event of power failure.
• Poor Signage	The signage identifying the property was clearly visible from the road. No concerns regarding the property signage were noted.
• Other	No other concerns relating to access to and egress from the

Photo 35. Entrance to the underground garage

Recommendations: Consideration should be taken concerning correcting/simplifying vehicular overhead door operation and entry/exit from the underground garage in the event of emergency including power failure. The cost for this work is minimal; it is not included in the expenditure tables.
