Beachwalk Owners Association

Level 2 Reserve Study

Report Period - 1/1/2015 to 12/31/2015

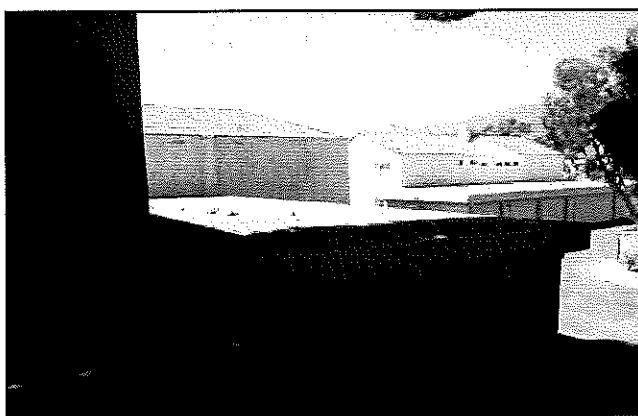
It was reported that these roofs were replaced in 2007. These roofs should generally experience a useful life of approximately 15 to 20 years. Remaining life based on current age.

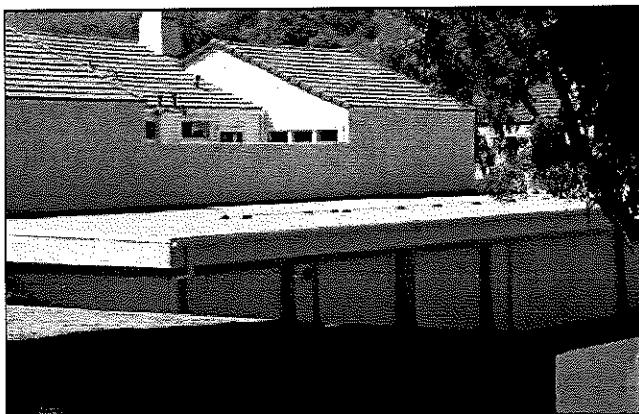
These roofs were replaced in between 2009 and 2010 and are in good condition. No evidence of leaks noted or reported during the site visit. Expect to replace these roofs approximately every 15 to 20 years.

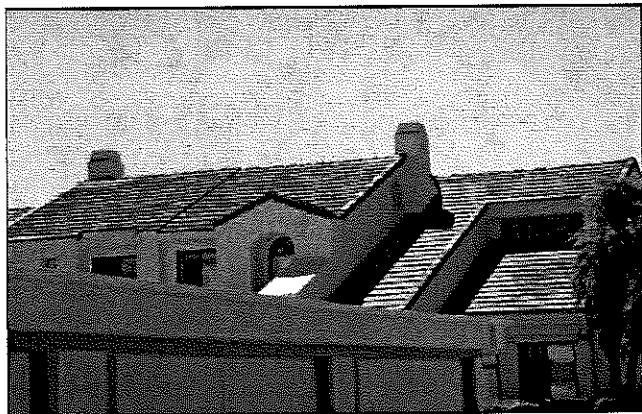
Comp # 106 Pitched Roof - Tile - Replace (2007)

No problems noted or reported with the tiles roofs. Client reported that the tile roofs were replaced in phases. This line item represents the 7 buildings that were replaced in 2007. Remaining life based on current age.

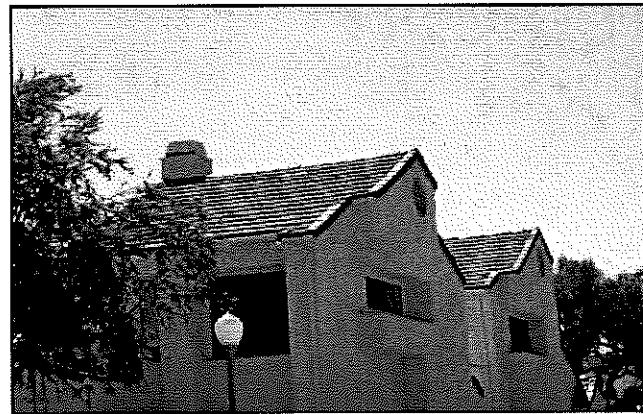
Comp # 106 Pitched Roof - Tile - Replace (2011)

No problems noted or reported with the tiles roofs. Client reported that the tile roofs were replaced in phases. This line item represents the 1 building that was replaced in 2011. Remaining life based on current age.

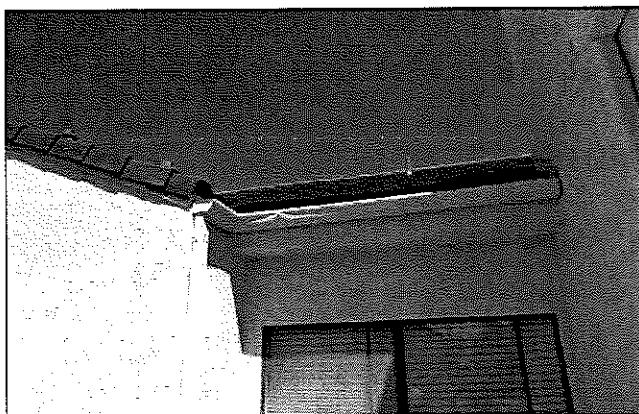
Comp # 120 Rain Gutters/Downspouts - Replace

No problems noted at the time of our site visit. We recommend funding to replace these gutters and downspouts approximately every 25 to 30 years.

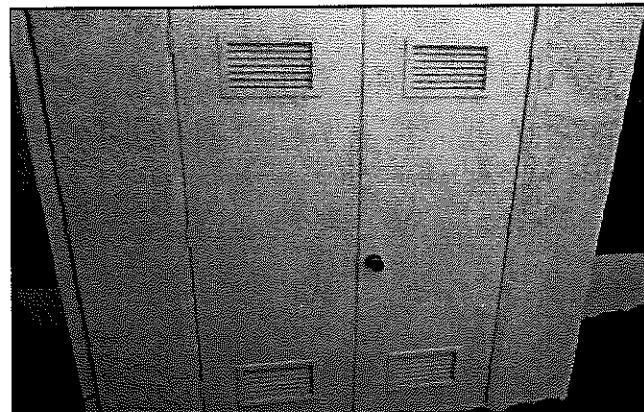
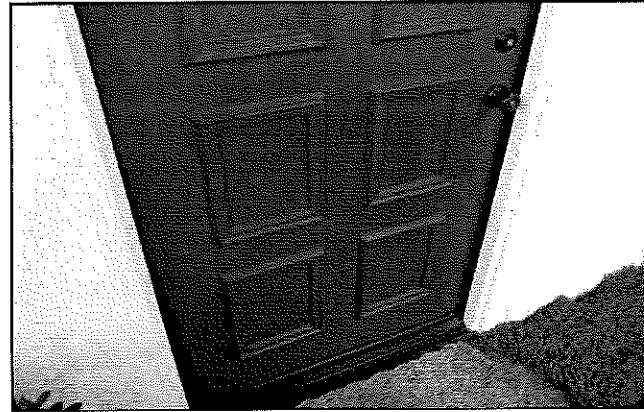
Comp # 202 Doors - Repaint

It was reported that these surfaces were repainted at the same time as the stucco surfaces in 2014. No problems or appearance concerns noted. We recommend funding to repaint these surfaces approximately every 5 years. Remaining life based on current condition.

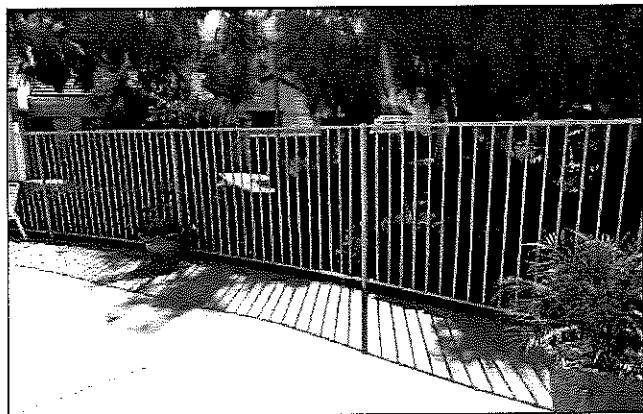
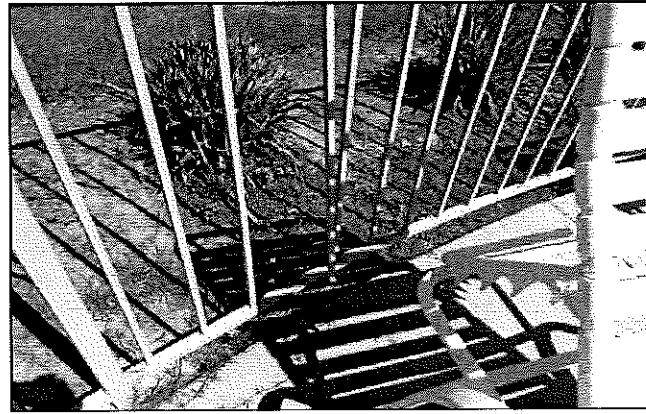
Comp # 207 Wrought Iron Fencing - Repaint

Client reported that the wrought iron surfaces were recently painted. We recommend funding to repaint these surfaces approximately every 4 to 5 years.

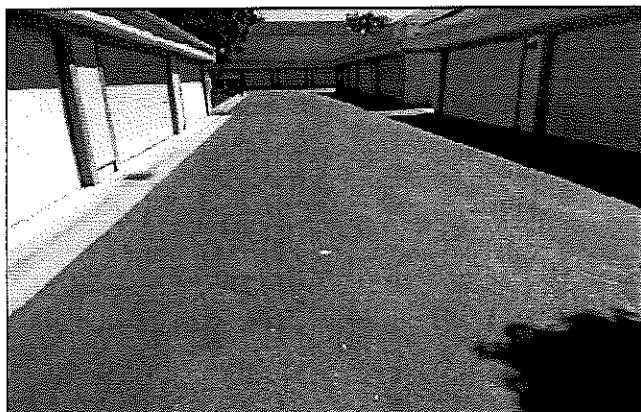
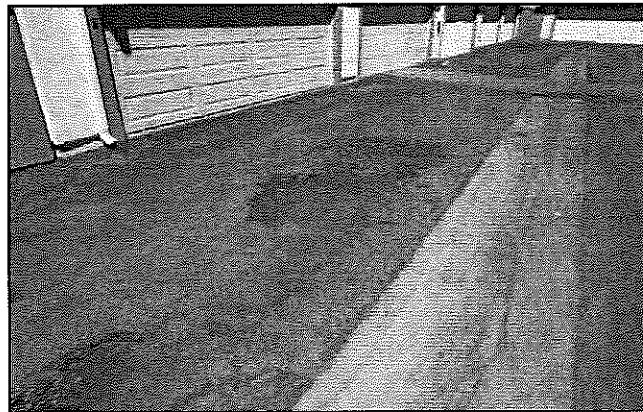
Comp # 401 Asphalt - Major Rehab

The client reports that the asphalt surfaces will be replaced prior to this reporting period (Will be completed late FY2014). For purposes of this report we have assumed the surfaces have been replaced and are in good condition. We recommend funding to perform a similar project approximately every 25 to 30 years. Maintain seal coat schedule to ensure a full life (see Comp# 402 Asphalt - Preventative Maintenance).

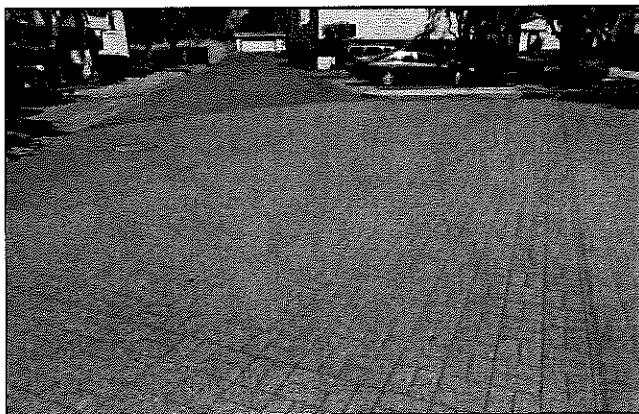
Comp # 405 Stamped Concrete - Repair/Replace

The client reported that a portion of the concrete surfaces will be removed during the asphalt replacement. Noted surface loss to the concrete surfaces although no structural problems noted. We recommend funding to replace this concrete in the next five years based on current condition.

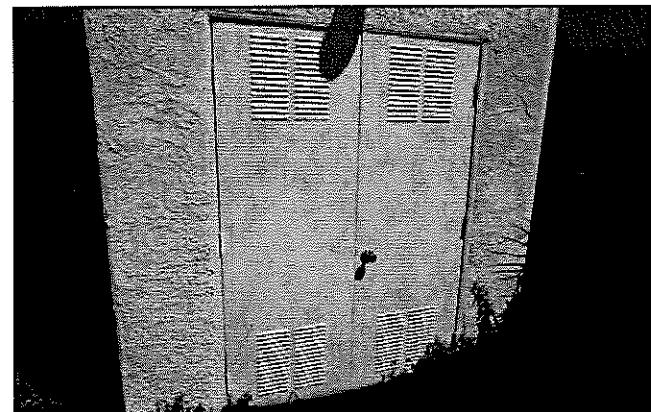
Comp # 503 Utility Doors - Replace

No significant rust or deterioration noted with the utility doors. These doors should typically experience a useful life of approximately 25 years. Expect to replace these doors approximately every 25 years. Remaining life based on current age and condition.

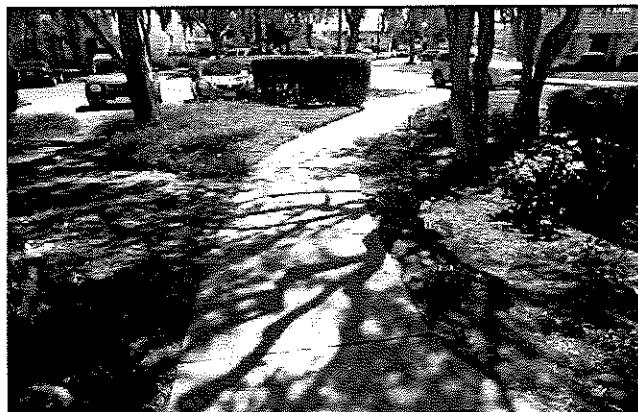
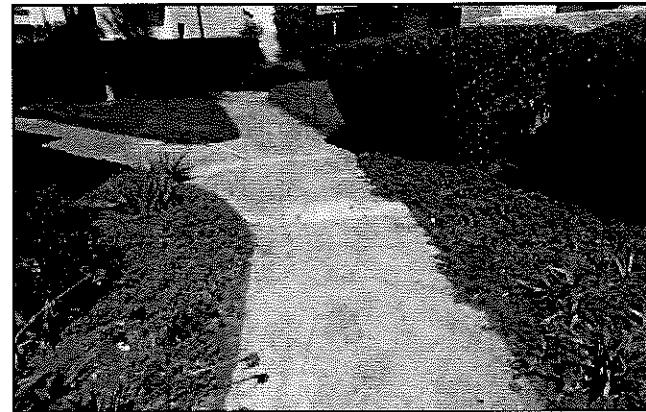
Comp # 601 Concrete Surfaces - Repair

Concrete is generally in good condition. No significant cracking or structural problems noted at the time of inspection. No expectation to completely replace the concrete surfaces. We recommend making local repairs as necessary as an operating expense and funding to make more significant repairs approximately every 10 years.

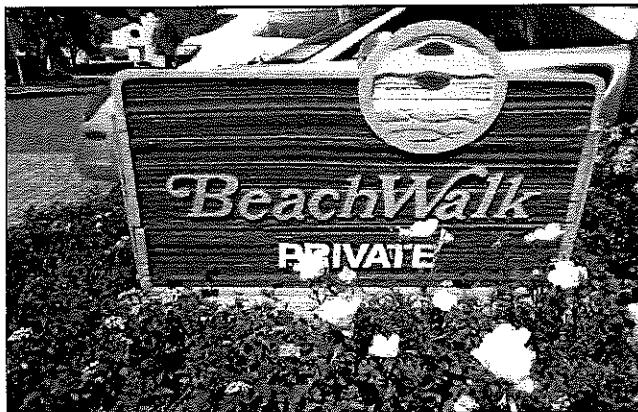
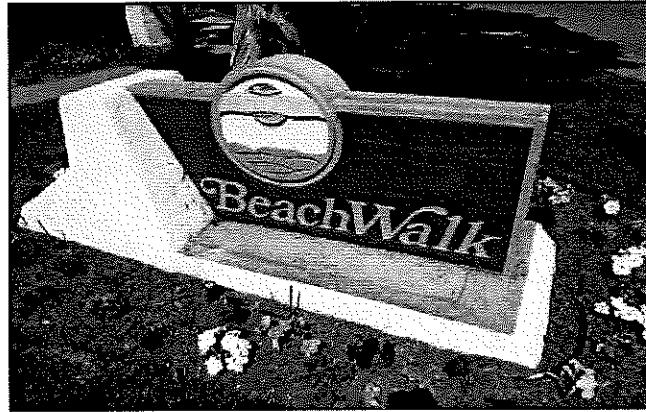
Comp # 801 Monument Signs - Replace

No problems or significant appearance concerns noted with the monument signs. We recommend funding to replace these monuments approximately every 15 years to maintain appearance and keep up with current decorative tastes. Repaint these signs when necessary as an operating expense. Remaining life based on current condition.

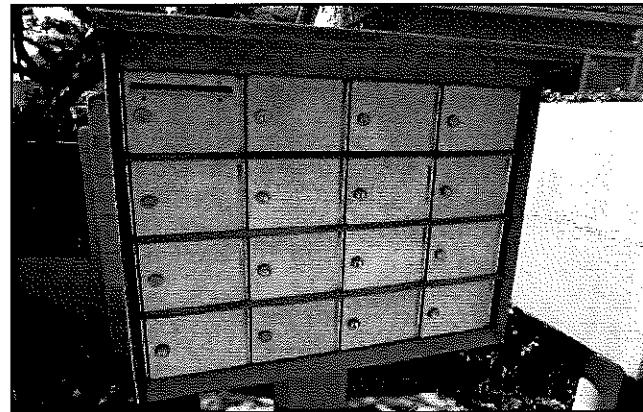
Comp # 803 Mailboxes - Replace

The mailboxes are older although generally in fair condition. No broken boxes or significant marking observed. These mailboxes should generally be replaced approximately every 18 years to maintain appearance and ensure proper function. Expect to replace these boxes in the next two years based on current age and condition.

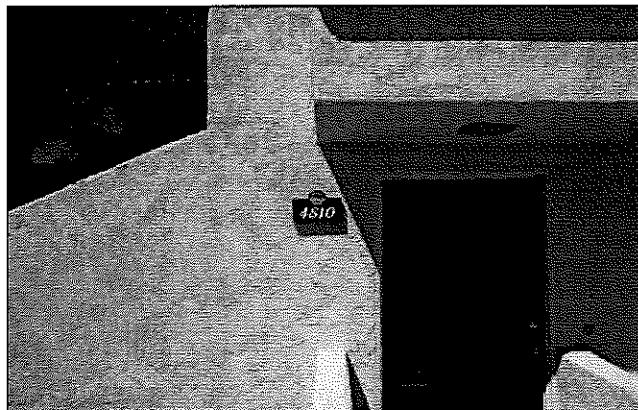
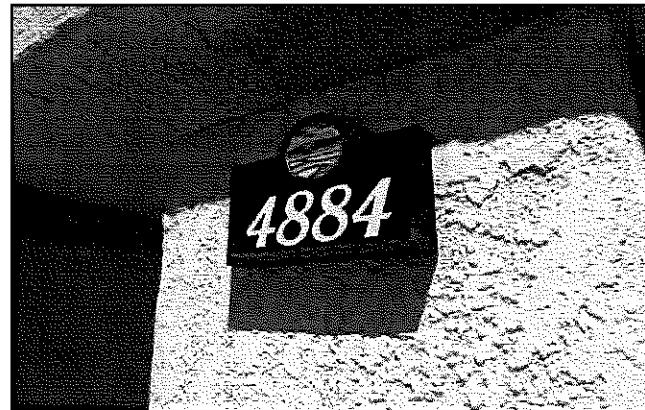
It was reported that these signs are replaced when necessary as an operating expense. No reserve funding necessary.

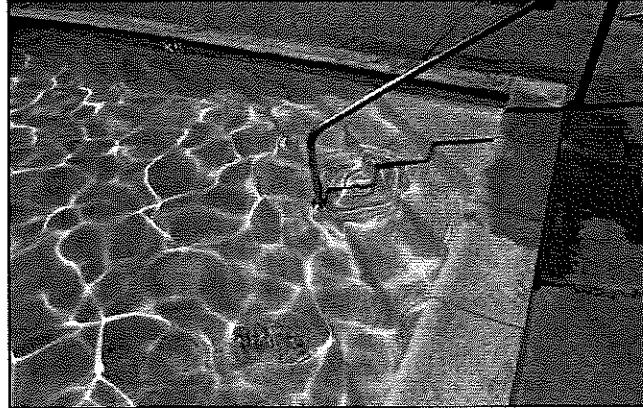
Comp # 1101 Pool - Resurface

Pool Masters reports the pool surfaces is older although in fair condition. No discoloration or surfaces loss noted or reported. We recommend funding to resurface this pool approximately every 10 to 12 years depending on use and wear. Remaining life based on reported condition.

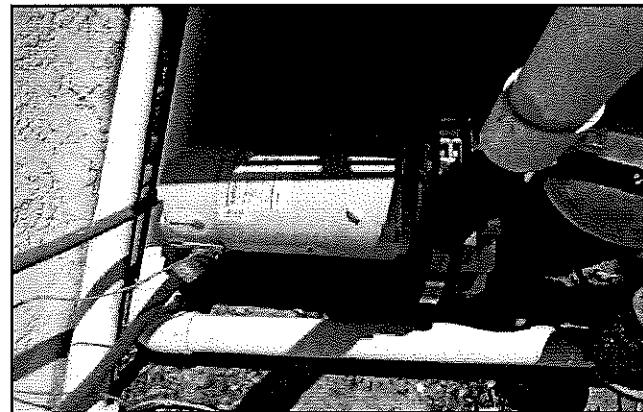
Comp # 1110 Pool Pump - Replace

Pool Masters reports that the motor was recently replaced on this pump. We recommend funding to completely replace this pump approximately every 7 years. Expect to replace this pump in the next 2 years based on current age and condition.

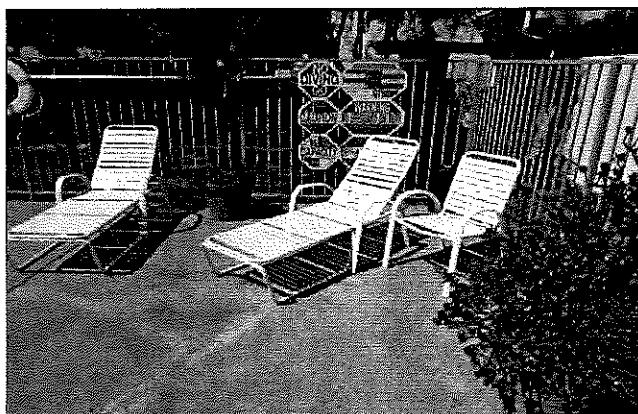
The pool furniture is in good condition. No broken pieces or evidence of sun damage noted during the site visit. We recommend funding for an allowance to replace this furniture approximately every 5 year. Remaining life based on current condition.

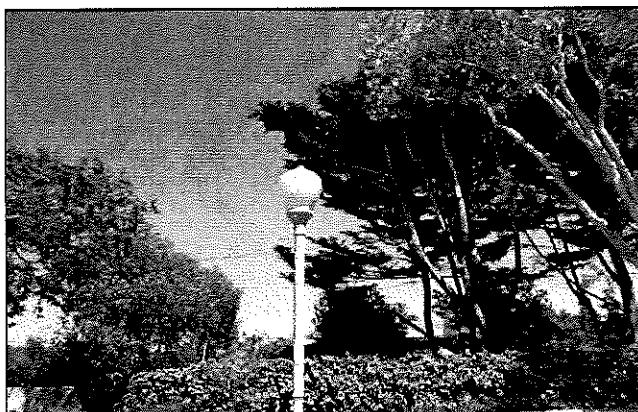
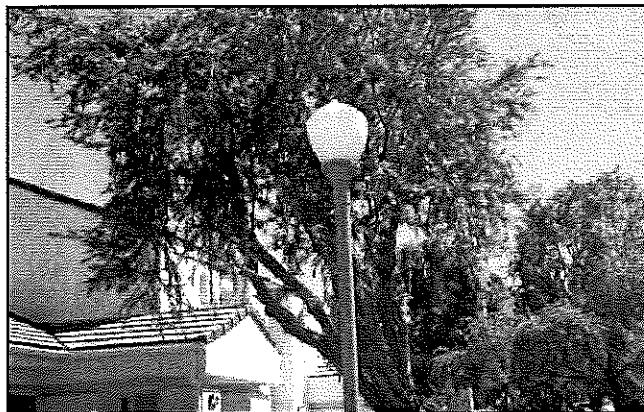
Comp # 1604 Pole Lights - Replace

Although functional these pole lights have typically exceeded their intended useful lives. Replacement should be expected in the near future based on current age and condition.

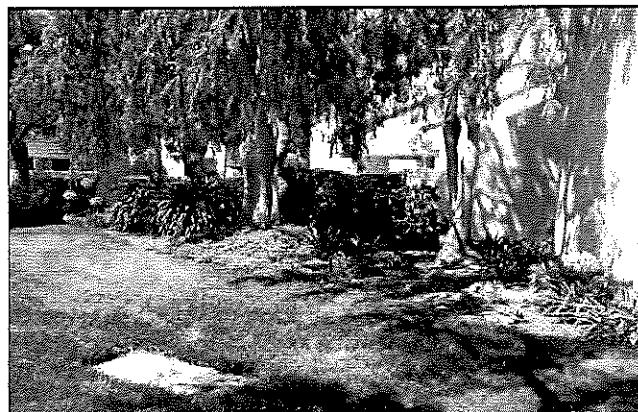
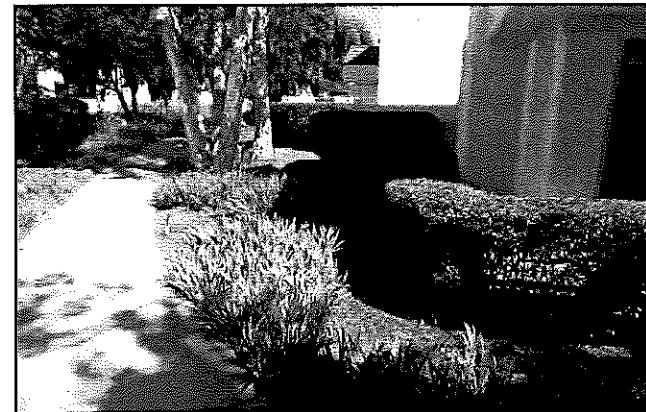
No appearance concerns noted with the landscaping during the site visit. No expectation to completely replace the landscaping. We recommend funding for an allowance to generally refurbish the landscaping and make upgrades to the irrigation system approximately every 10 years.

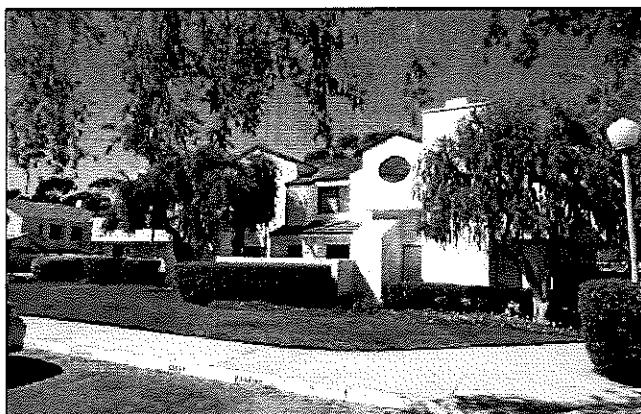
Although the necessity for termite treatment is difficult to predict we recommend funding to spot treat the buildings annually and performing a more extensive treatment approximately every 5 years.
