Riverview Ventura

Level 2 Reserve Study

Report Period - 7/1/2016 to 6/30/2017

Report prepared on – May 26, 2016

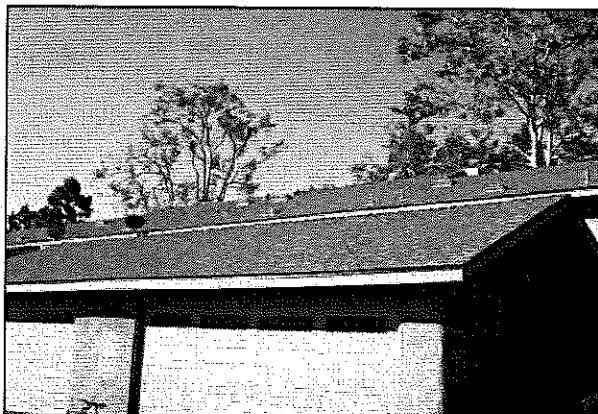
Comp # 105 Pitched Roof - Comp Shingle - Replace

All shingles are intact and in good condition with no problems noted at time of inspection. Typically this type of roofing material has a useful life of approximately 25 years. Inspect roofs regularly and make local repairs as necessary as an operating issue to ensure full life from this component. Remaining life based on current age.

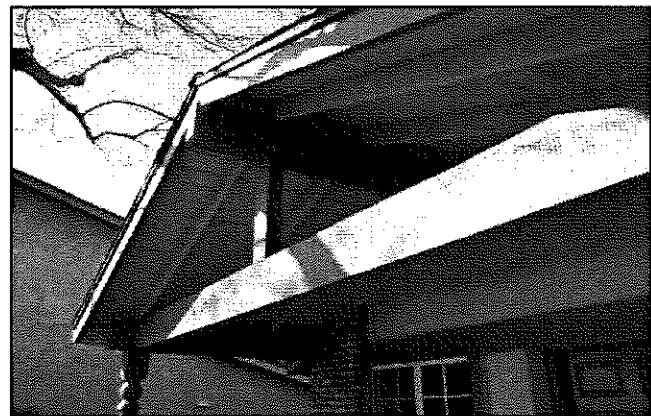
It was reported that the association partially paints the repairs the wood trim surfaces on an annual basis. At the clients request we have funded to repaint a portion of these buildings annually.

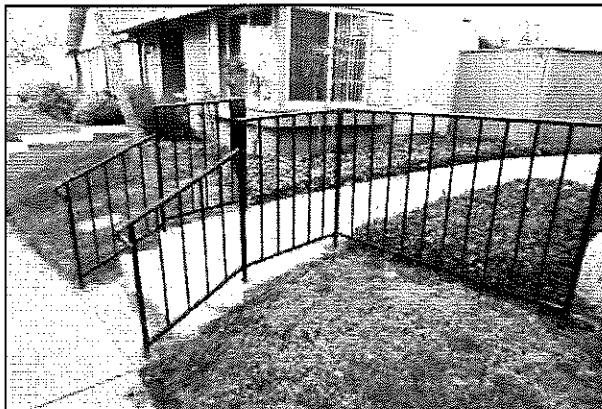
Comp # 207 Wrought Iron Fencing - Repaint

It was reported that the wrought iron fencing surfaces were repainted in 2013. No fading or flaking paint observed during the site visit. Expect to repaint these surfaces approximately every 5 years. Remaining life based on current age and condition.

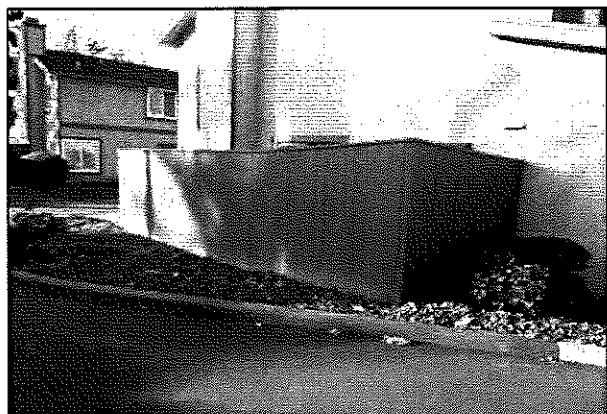
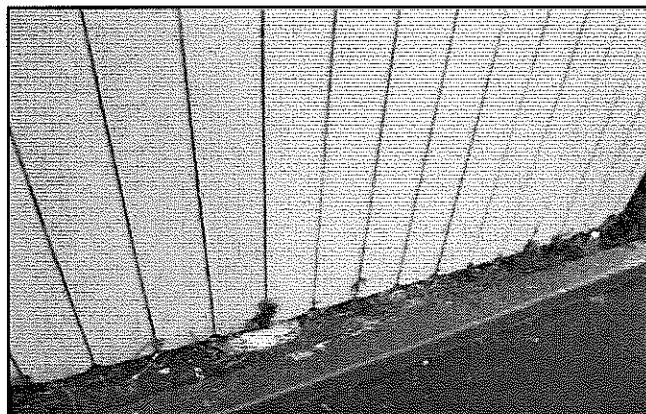
Comp # 209 Wood Fencing - Repaint

The painted wood fencing surfaces typically varies. Noted sections with fading and discoloration during the site visit. We recommend repainting all the fencing surfaces approximately every 5 to 6 years.

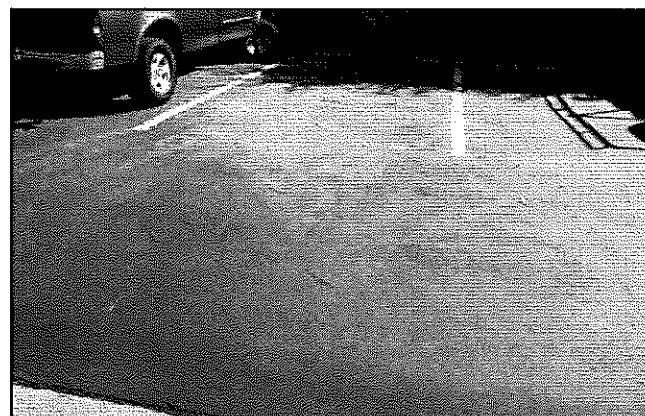
Comp # 401 Asphalt - Overlay

The asphalt streets are generally in good condition. Noted local cracking although no structural problems observed. The asphalt surfaces will generally experience a useful life of 20 to 25 years before a major rehab is required. Maintain seal coat schedule to ensure full useful life (see Comp# 402 Asphalt - Preventive Maintenance). Remaining life based on current condition.

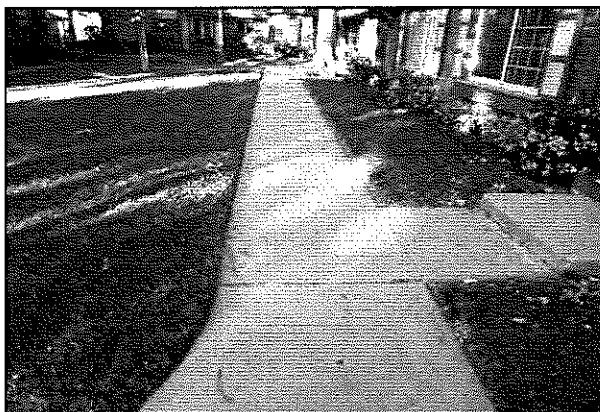
Comp # 403 Concrete - Repair/Replace

Noted local areas with moderate cracking at the time of the site visit. No expectation to completely replace the concrete surfaces. We recommend making local repairs when necessary as an operating expense and funding to make more significant repairs approximately every 10 years.

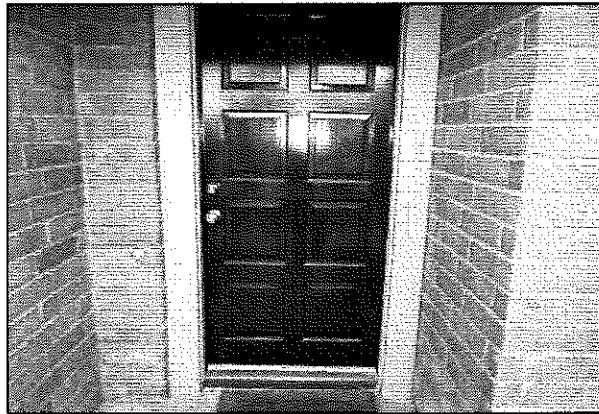
Comp # 501 Front Doors - Replace

The client requested that we fund for a door replacement allowance of approximately \$3,000 on an annual basis.

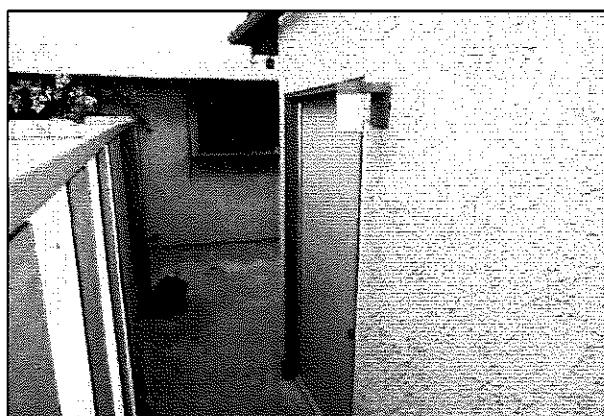
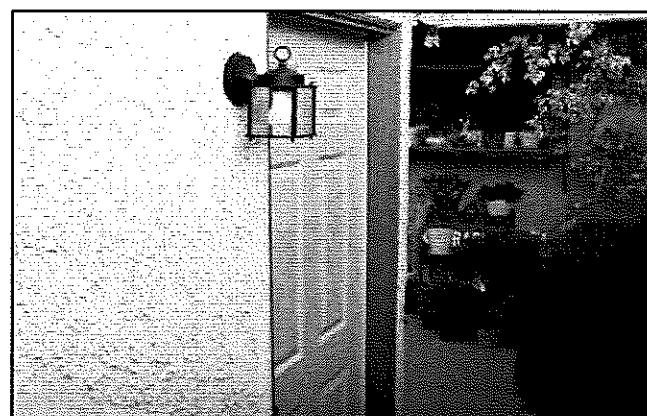
Comp # 503 Garage Side Doors - Replace

It was reported that the garage side doors are replaced when necessary as an operating expense. No reserve funding necessary.

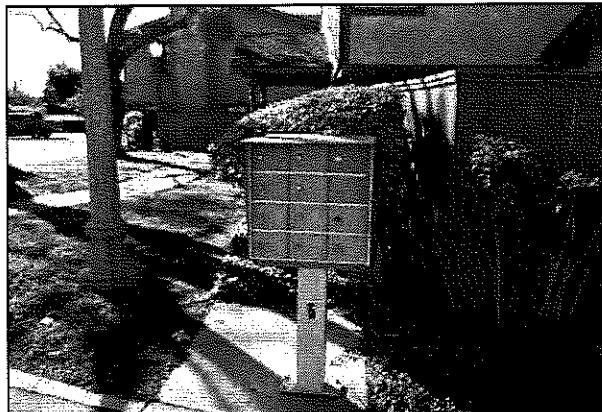
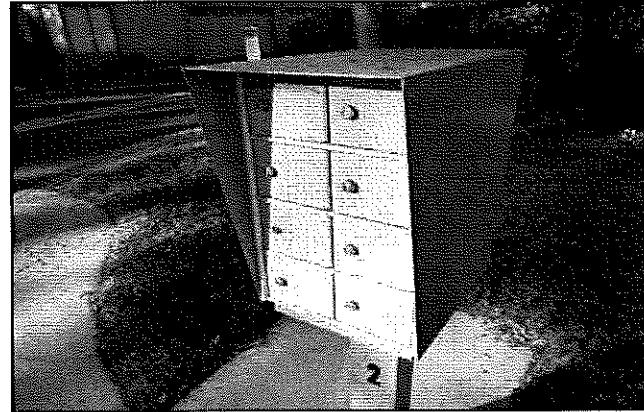
Comp # 803 Mailboxes - Replace

Noted fading and discoloration to these mailboxes. We recommend replacing these boxes approximately every 20 years to maintain appearance and ensure proper function. Expect to replace these boxes in the near future based on current age and condition.

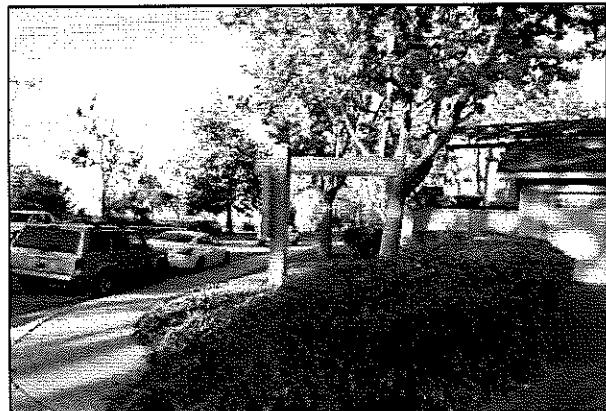
Comp # 808 Street Signs - Replace

The street signs are older and typically in poor condition. Noted local termite damage and areas of deterioration during the site visit. Expect to replace these signs in the near future based on current age and condition.

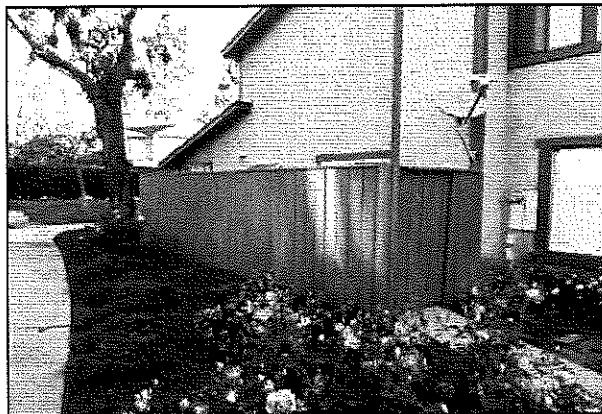
Comp # 1001 Wood Fencing - Replace

The age and condition of the wood fencing typically varies. The client reported that replacements have been made to this fencing in recent years. We recommend funding to replace all the wood fencing approximately every 16 years. Remaining life based on average condition.

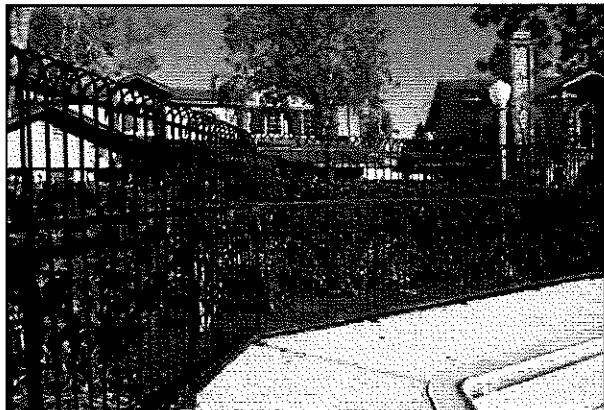
Noted local structural issues to the common area fencing. The majority of this fencing is in good to fair condition. Expect to make local repairs to this fencing when necessary as an operating expense and funding to completely replace this fencing approximately every 25 years.

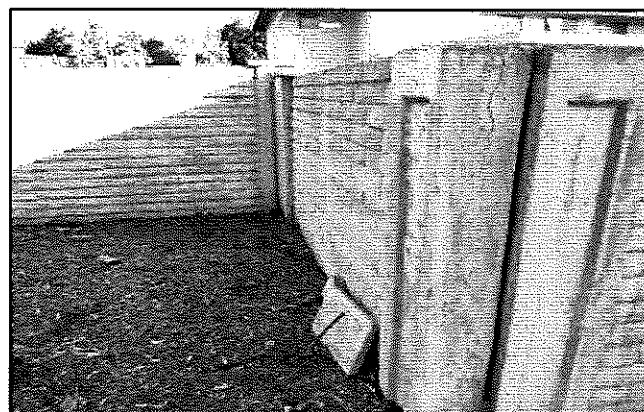
Comp # 1090 Concrete Wall - Repair

Noted local areas of cracking to the concrete wall however the wall appears to be structurally sound. We recommend funding to make repairs to this wall approximately every 10 years. Expect to perform this project in the near future based on current condition.

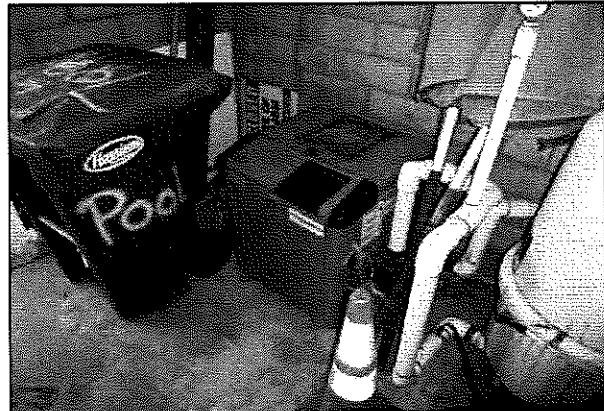
Comp # 1104 Pool Heater I - Replace

The pool heater is older and has generally exceeded its intended useful life. Replacement should be expected in the near future based on current age.

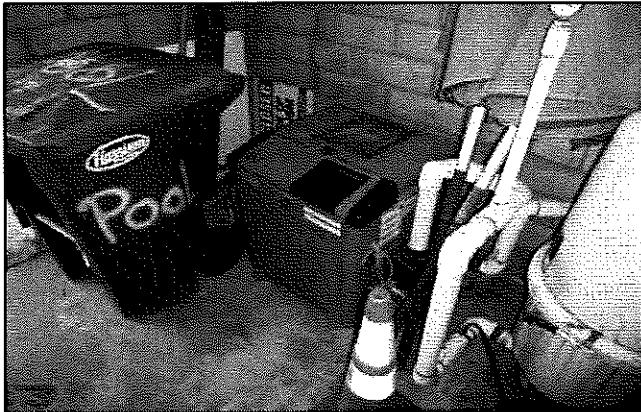
Comp # 1105 Spa Heaters - Replace

The spa heaters are older although appear to be functioning normally. Because these heaters have to maintain a higher water temperature they will typically experience a shorter useful life. Expect to replace these heater approximately every 6 years.

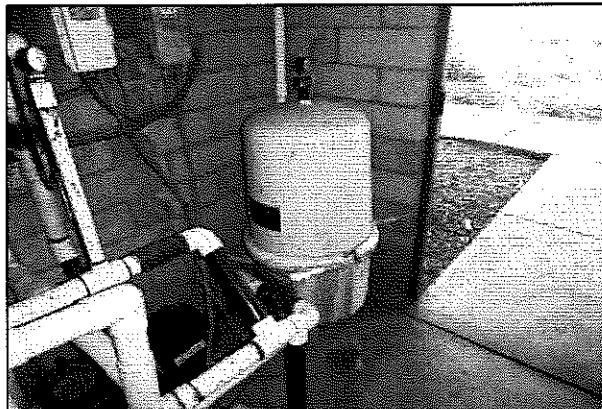
Comp # 1107 Pool Filter I - Replace

No problem or evidence of significant leaks observed with the pool filter. This filter should experience a useful life of approximately 12 years. Remaining life based on current condition.

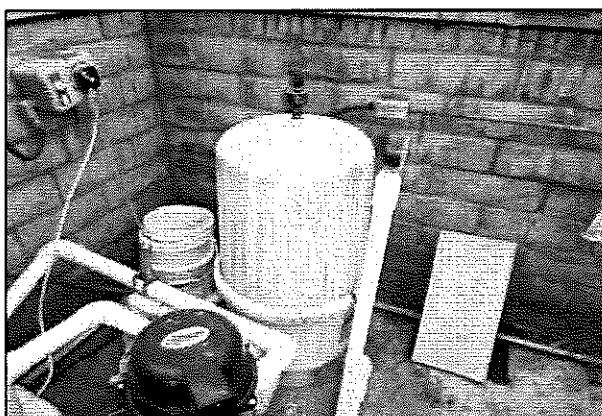
Comp # 1108 Spa Filter II - Replace

This filter is older and typically exceeded its intended useful life. Replacement should be expected in the near future based on current age and condition.

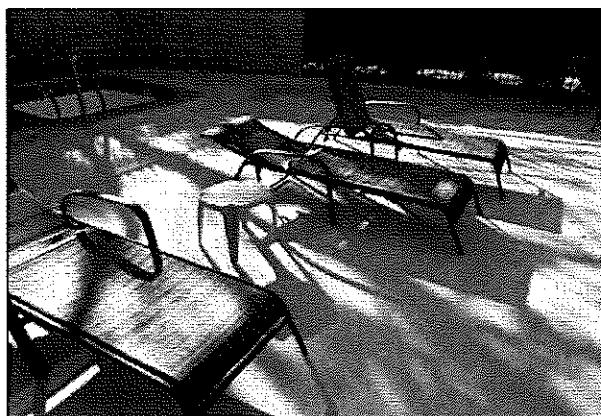
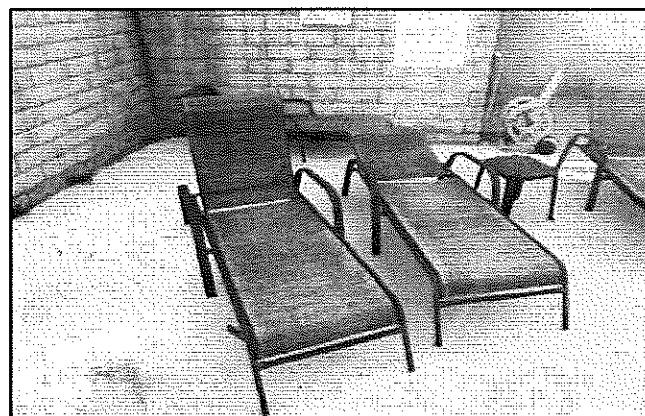
Comp # 1121 Pool Furniture - Replace

The pool furniture is older and in fair to poor condition. Noted fading and thinning material to the chaise lounge chairs. This furniture should typically be replaced approximately every 5 years to maintain appearance and function.

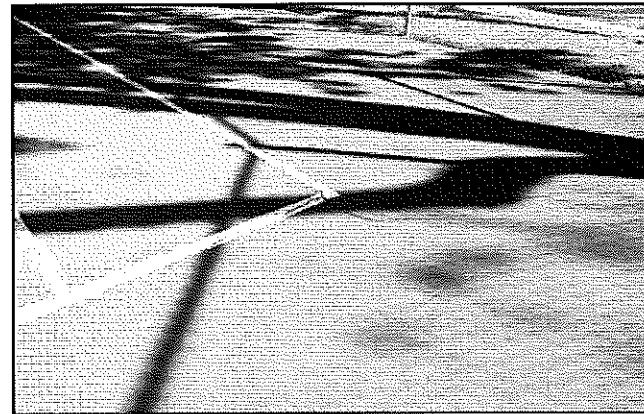
Comp # 1201 Tennis Court - Resurface

Tennis court surface is generally in fair to poor condition. Noted moderate cracking although not surface loss observed. We recommend funding to resurface this court approximately every 8 years. Remaining life based on current condition.

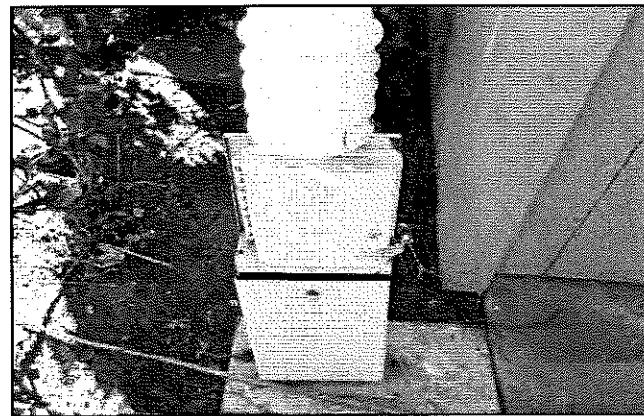
Comp # 1703 Irrigation Clocks - Partial Replace

No problems noted or reported with the irrigation time clocks. The client reported that two of the clocks were replaced in 2013. No expectation to replace all the irrigation clocks at the same time. We recommend funding to replace two clocks approximately every three years.

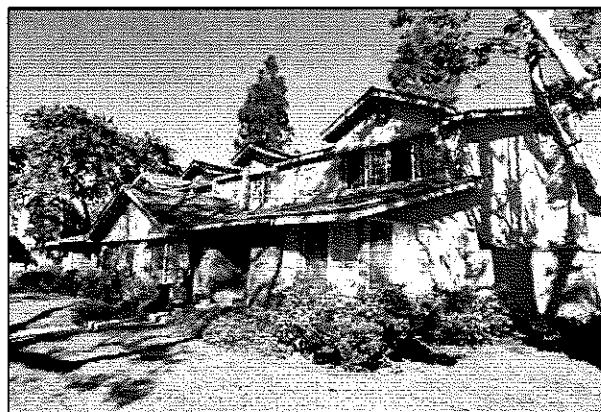
Comp # 1790 Plumbing - Repairs

The client reported the association has been experience plumbing issues in recent years. At the clients request we have funded for an allowance to make repairs to the plumbing approximately every 10 years.

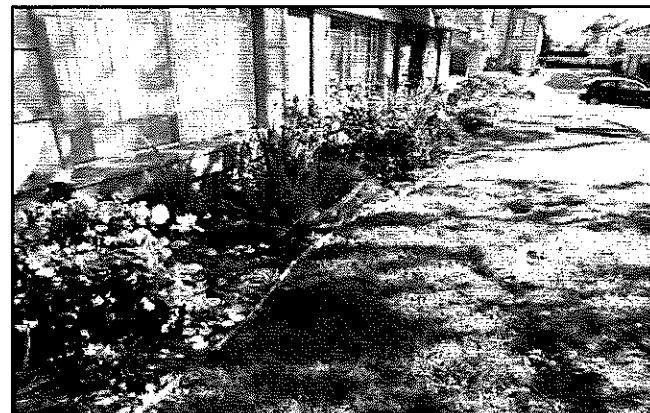
Comp # 1812 Landscaping - Renovate

The client reported that local replacements were made at the pool areas however also reported that the association plans to perform a more extensive renovation project in the near future. No expectation to completely replace the landscaping. We recommend funding for an allowance to renovate the landscaping and make upgrades/replacements to the irrigation approximately every 10 years.

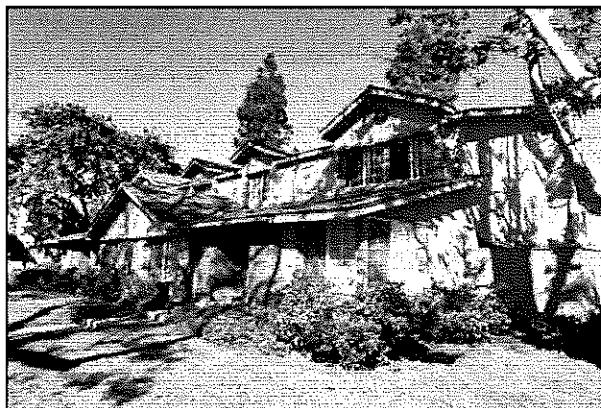
Comp # 2101 Termite Treatment

Although the necessity for termite treatment is difficult to predict we recommend funding to perform significant treatment to the community buildings approximately every 5 years. Expect to make local spot treatments when necessary as an operating expense.
