**Electrical Power & Safety Audit Report**  
**AT**  
**FM INDIA SUPPLY CHAIN PVT LTD**  
**(Pune MCF)**  
RP7F+CNT, karanjvihire, Pune, Maharashtra 410501

**CONDUCTED & SUBMITTED BY**  
**Network Techlab India Limited**  
41, Sarvodaya Industrial Estate, Opp. Paper Box,  
Off. Mahakali Caves Road,  
Andheri (East), Mumbai - 400093

| Project Name | : | MCF, Pune |

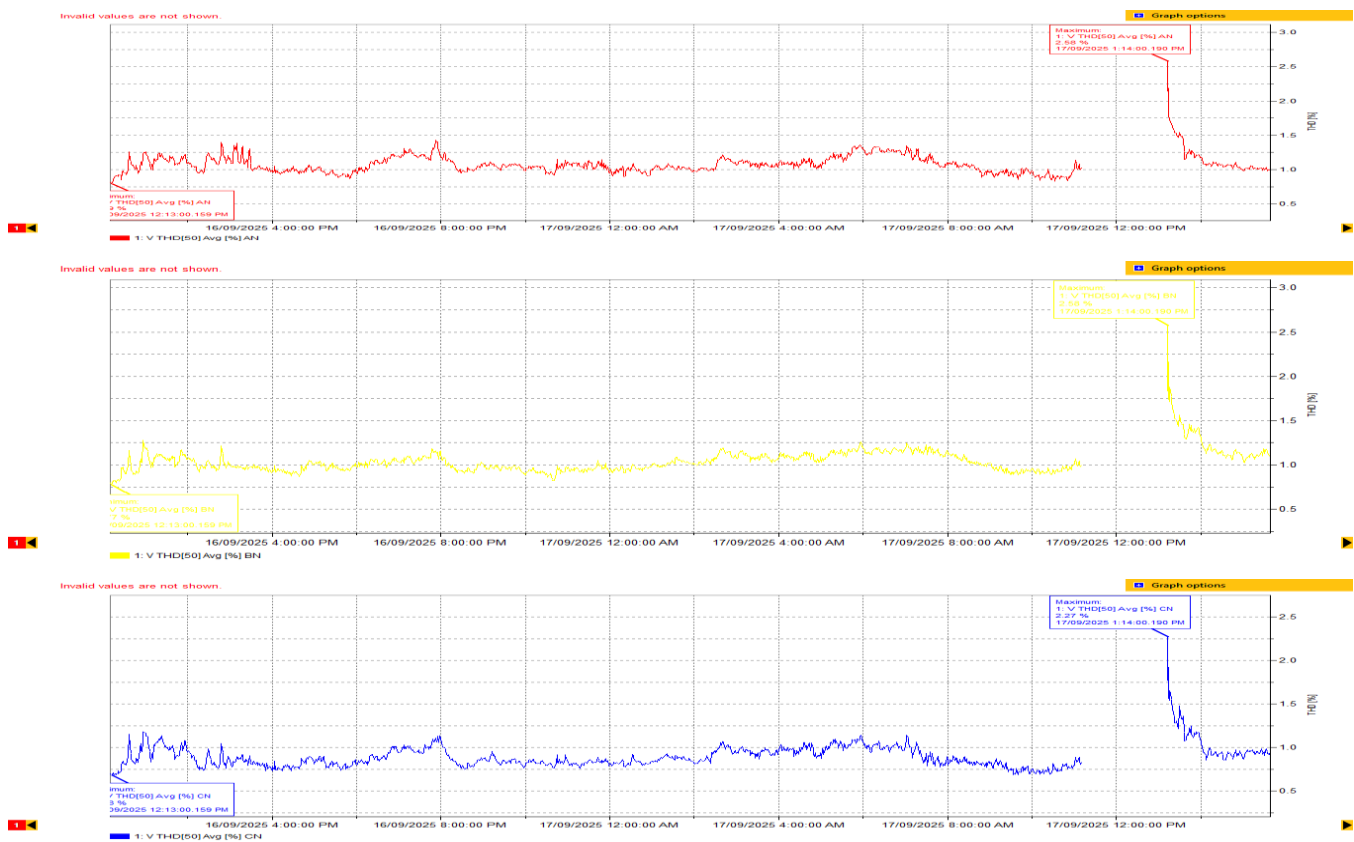
## Voltage Harmonics (Main Incomer)

It is observed that Voltage harmonics are within standard permissible limit.

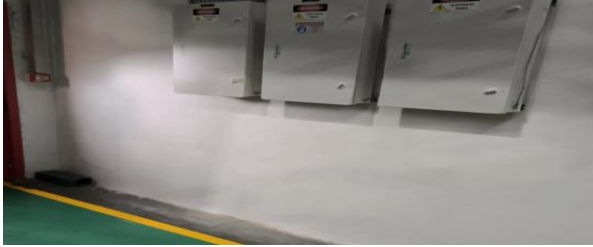
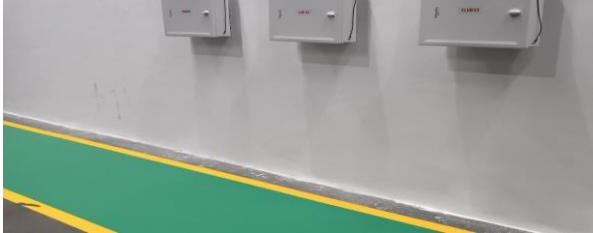
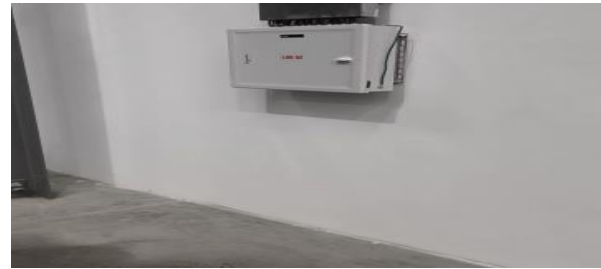
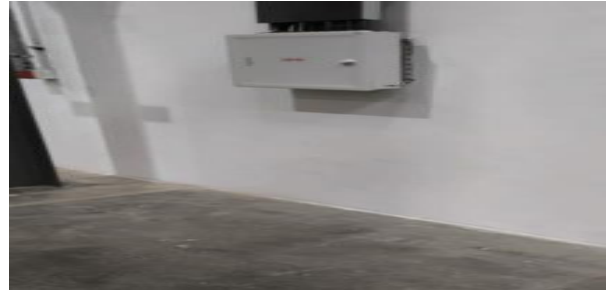
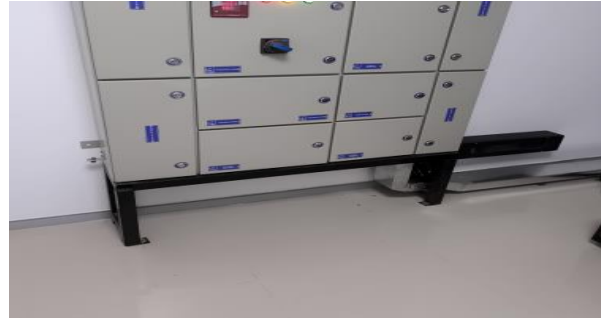
| <b>Location: - Warehouse</b> | | <p>Warehouse</p> <p>Warehouse Toilet Area</p> <p>Warehouse LDB-2</p> <p>Warehouse LDB-4</p> <p>UPS Room</p> |

| <b>Risk Category: - R2</b> | | |
| <b>Finding: -</b><br>Found that Insulation mat is not placed near Electrical Panels/DB's. | | |

| <b>Recommendation: -</b><br>It is recommended to place the Insulation mat near all Electrical Panels/DB's | | |

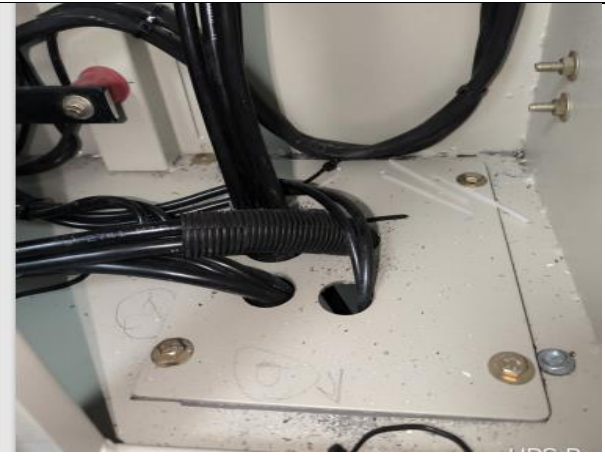
| <b>Location: - MDB UPS Panel</b> | |

| <b>Risk Category: - R2</b> | |
| <b>Finding: -</b><br>Found that cable inserted without using glands . | |

| <b>Recommendation: -</b><br>It is recommended to use cable glands of proper size during entry or exit of cables from panels/DB | |

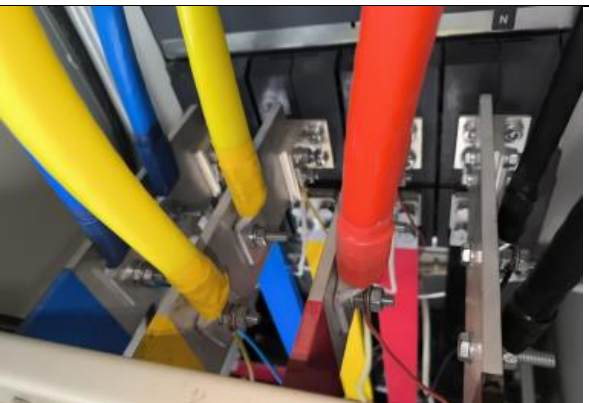
| <b>Location: - Main LT Panel- Main Incomer</b> | |

| <b>Risk Category: - R1</b> | |
| <b>Finding: -</b><br>Found that cables are terminated without using lugs. | |

| <b>Recommendation: -</b><br>It is recommended to connect the cables using proper rating/size lugs | |

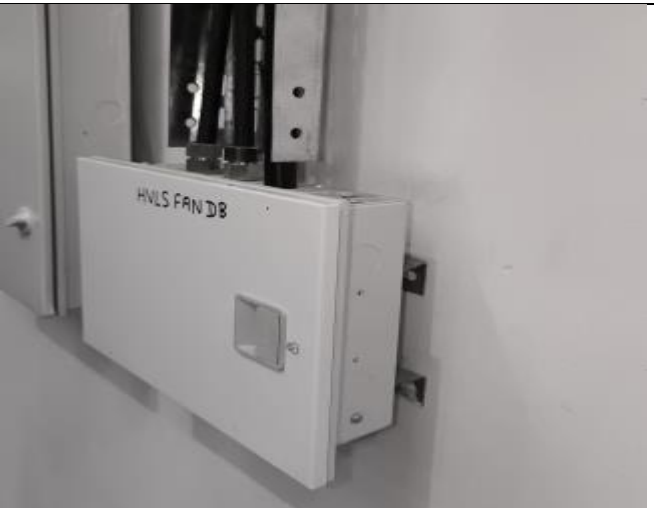
| <b>Location: - Dock7 Area HVLS Fan DB</b> | |

| <b>Risk Category: - R1</b> | |
| <b>Finding: -</b><br>Found body earthing not provided to DB | |

| <b>Recommendation: -</b><br>It is recommended to provide earthing to electrical DB | |

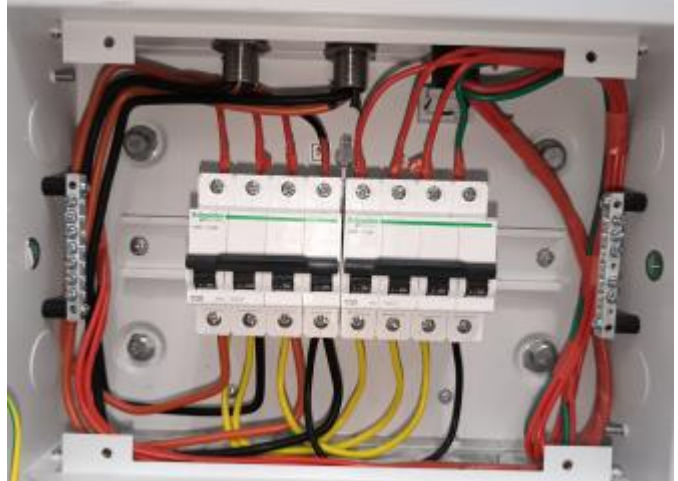
| <b>Location: - Dock-7 Area</b> | |

| <b>Risk Category: -R2</b> | |
| <b>Finding: -</b><br>Found 2Run, 2C X10Sq.mm cable used for 3Phase supply instead of 4C cable. | |

| <b>Recommendation: -</b><br>It is recommended to use 4C X10Sq.mm cable for 3Phase cable. | |

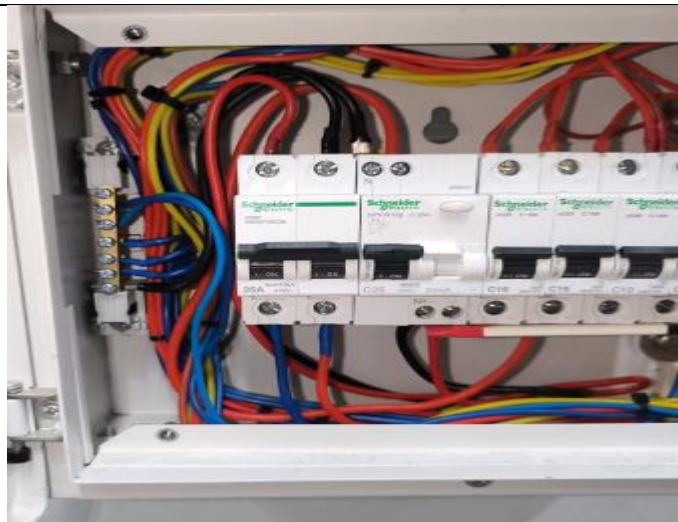
| <b>Location: - Dock-3 Area</b> | |

| <b>Risk Category: -R1</b> | |
| <b>Finding: -</b><br>Found Phase & Neutral sequence interchanged in MCB . | |

| <b>Recommendation: -</b><br>It is recommended to correct the wiring by properly connecting the Phase and Neutral as per standard polarity | |

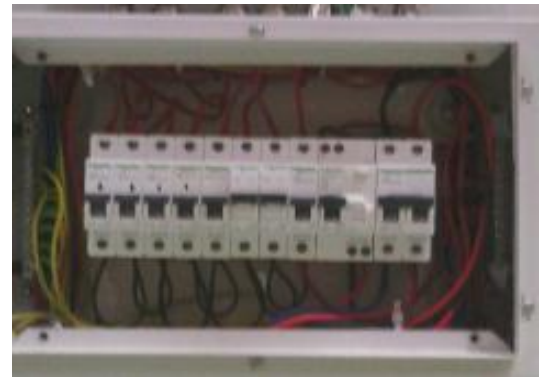
| Measure Location | ELDB-4 MCB |

| Risk Category | Alert |

In the above thermo gram the temperature difference between Max and Min ( $\Delta T$ ) is 6.3°C. As per NFPA and NETA guidelines the above thermo gram is classified **Alert category**. It is recommended to check for Improper crimping, lug mismatch, or absence of lugs. Also recommended to check for tightness of the cable termination.

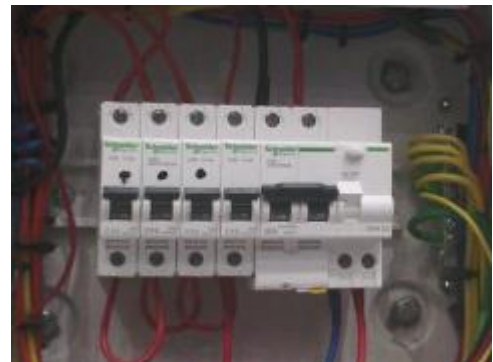
| Measure Location | ELDB-3 MAIN I/C |

| Risk Category | Alert |

In the above thermo gram the temperature difference between Max and Min ( $\Delta T$ ) is 5.1°C. As per NFPA and NETA guidelines the above thermo gram is classified **Alert category**. It is recommended to check for Improper crimping, lug mismatch. Also recommended to check for tightness of the cable termination.

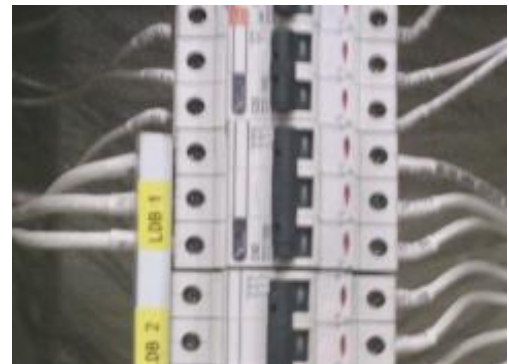
| Measure Location | O/G MCB (LDB1) |

| Risk Category | Alert |

In the above thermo gram the temperature difference between Max and Min ( $\Delta T$ ) is 5.6°C. As per NFPA and NETA guidelines the above thermo gram is classified **Alert category**. It is recommended to check for Improper crimping, lug mismatch, or absence of lugs. Also recommended to check for tightness of the cable termination.
