# Geotechnical Site Investigation Report

**RE:** Proposed apartment building at:

**1 Vine Street, Heidelberg**

**File Number:** 170552

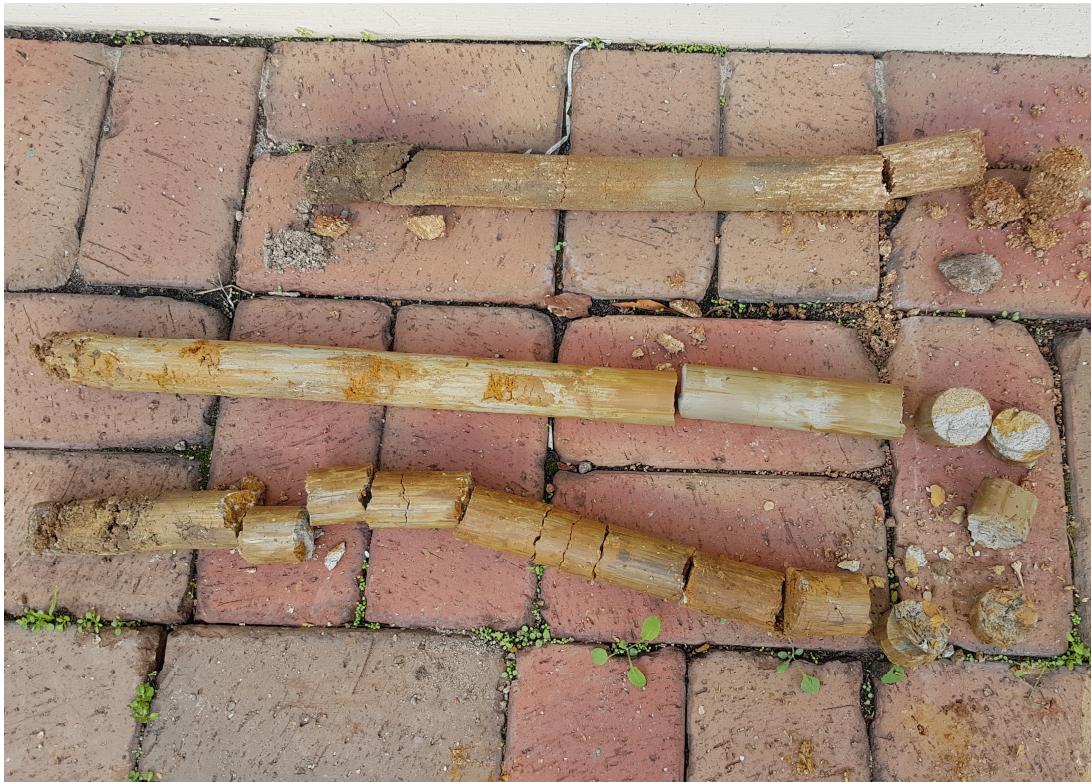
Recovered SPT samples from top to bottom: 1.00m, 2.50m, 4.00m

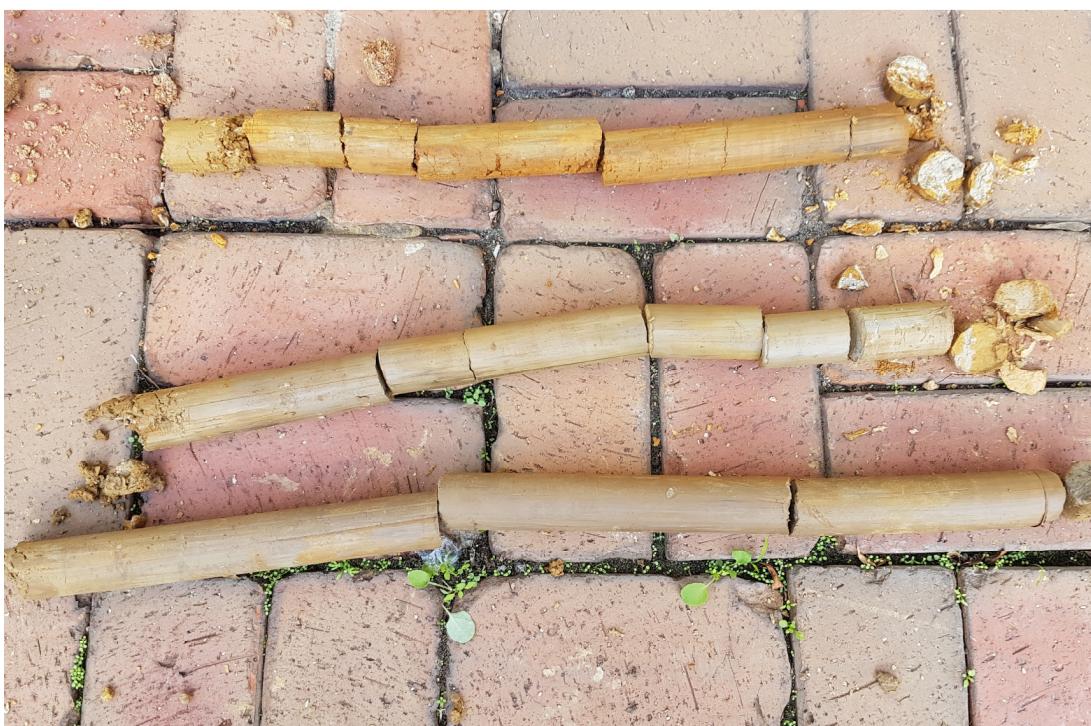
Recovered SPT samples from top to bottom: 5.50m, 7.00m, 8.50m

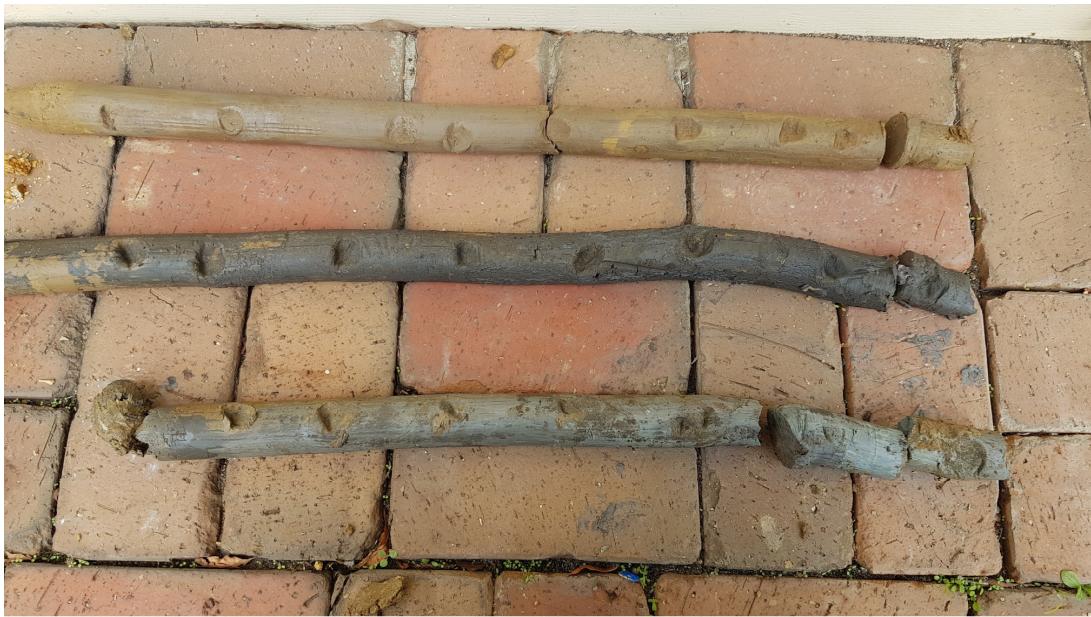
Recovered SPT samples from top to bottom: 10.00m, 11.50m, 13.00m. Note the thumb prints to show the firmness / softness of the clay.

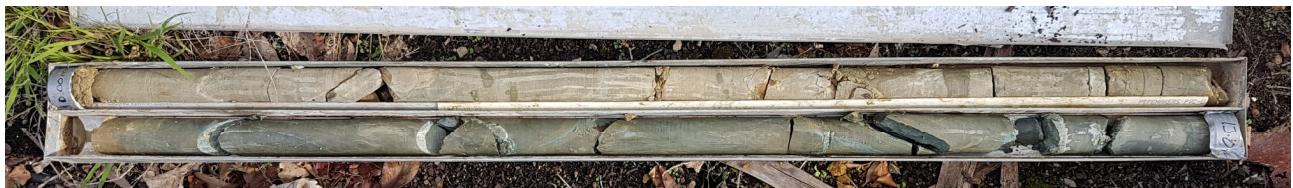
Sample recovered from 10.0m to 13.0m.

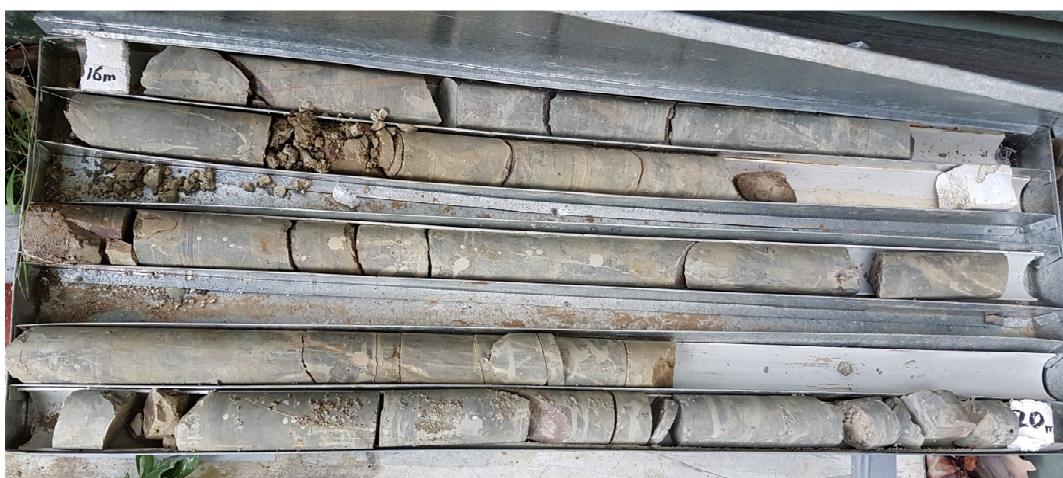
Sample recovered from 13.0m to 16.0m.

Sample recovered from 16.0m to 20.0m.

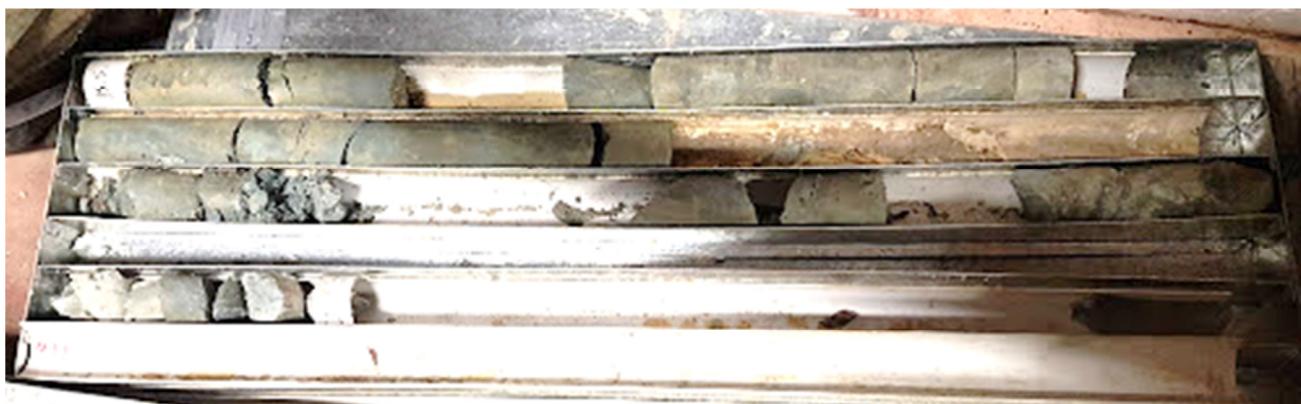
### **Borehole 3**

Note that this photograph was taken after samples for lab testing were removed.
