## Home Inspection Report

**2881**

**Cordell**

**Memphis, TN 38118**

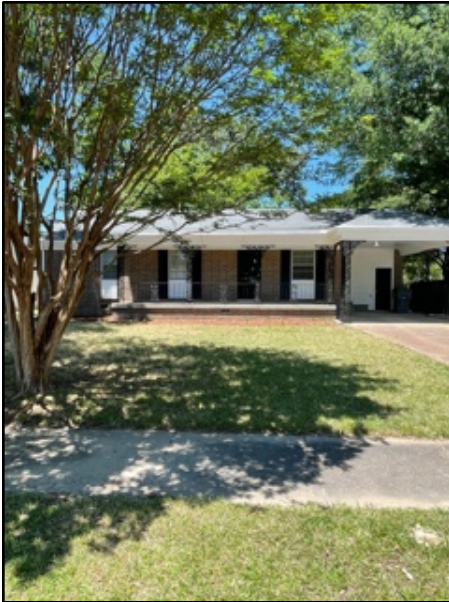
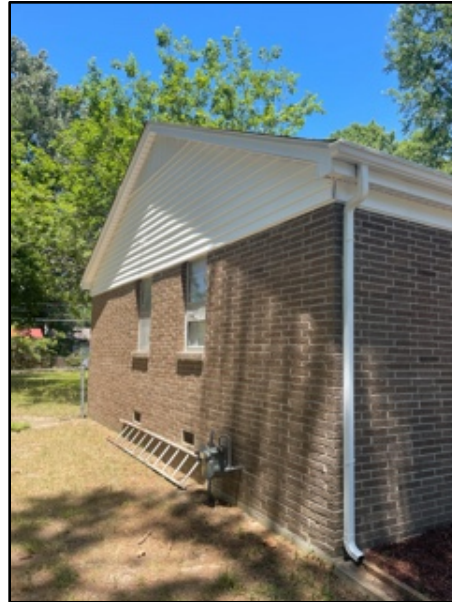
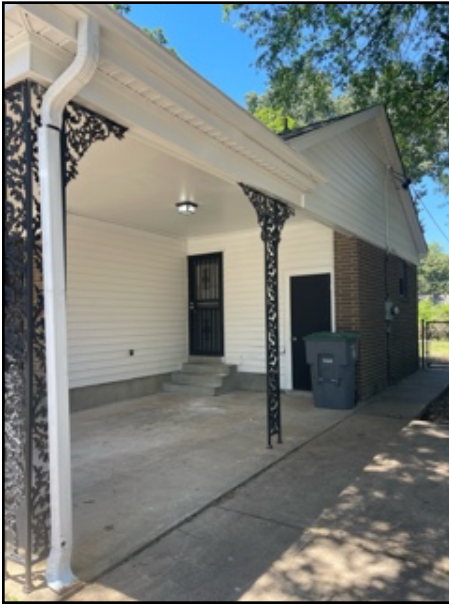
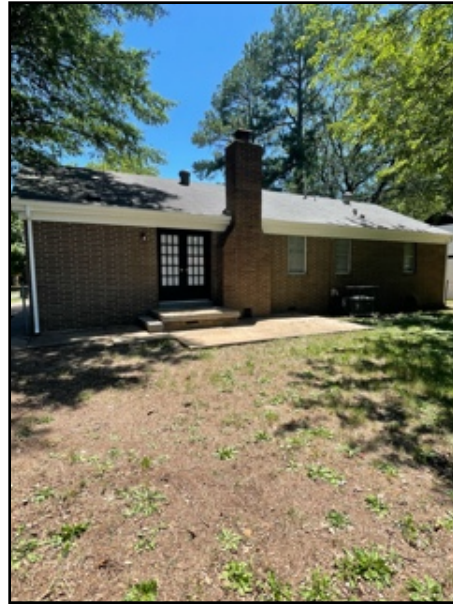
Comment 2:  
General pictures of exterior.

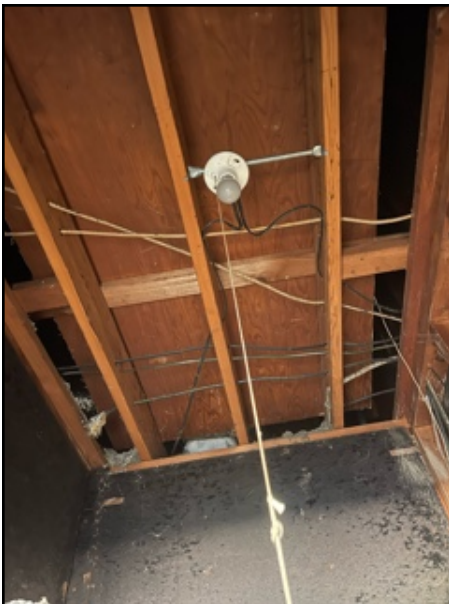
Figure 3-1

Comment 3:  
Overhead light not working in storage room.

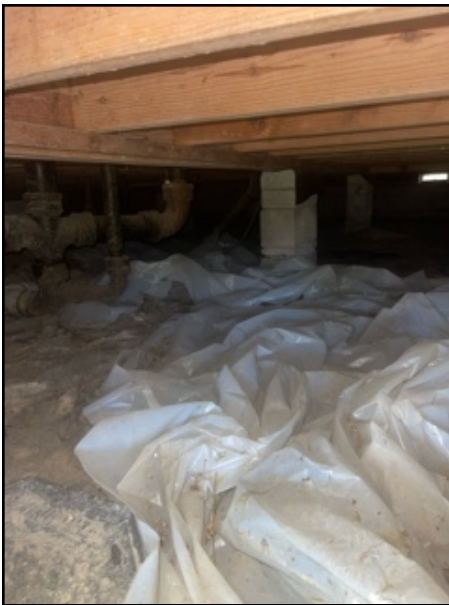
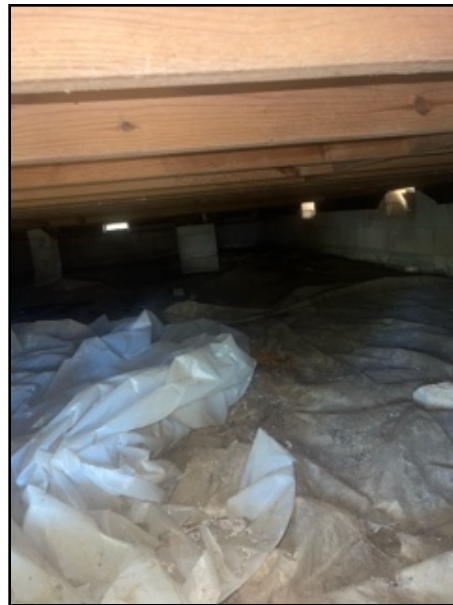
Comment 5:  
Foundation was in satisfactory condition at time of inspection.

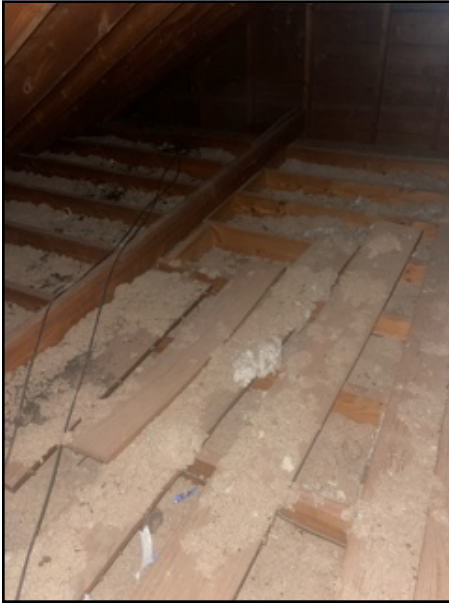
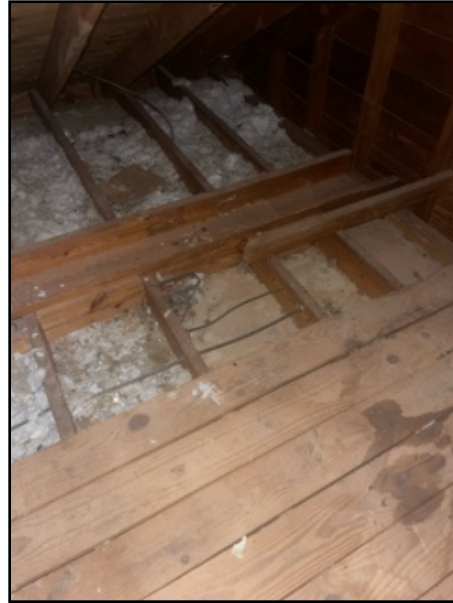
Attic is in good condition.. Framing is sound and there is no evidence of leaks

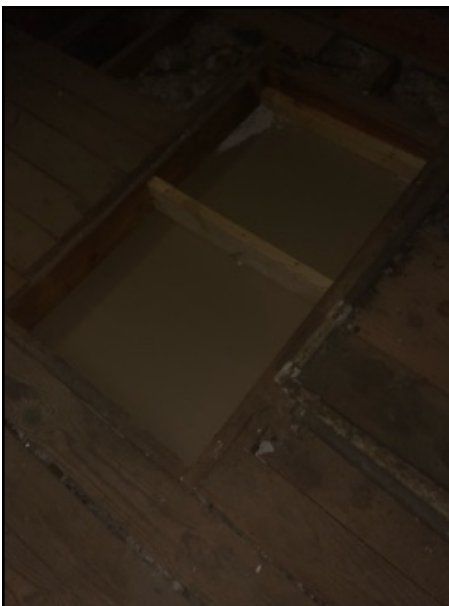
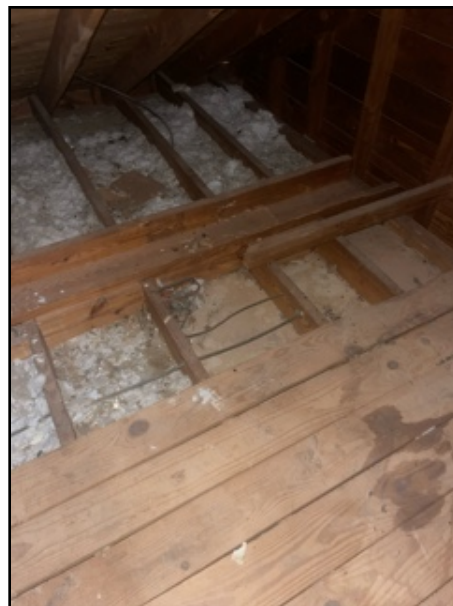
Some insulation missing as noted by pictures.

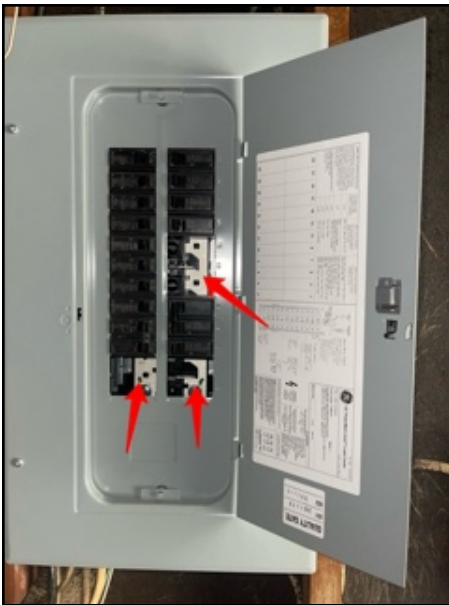
Figure 9-1

Empty breaker slots need to be covered for safety.

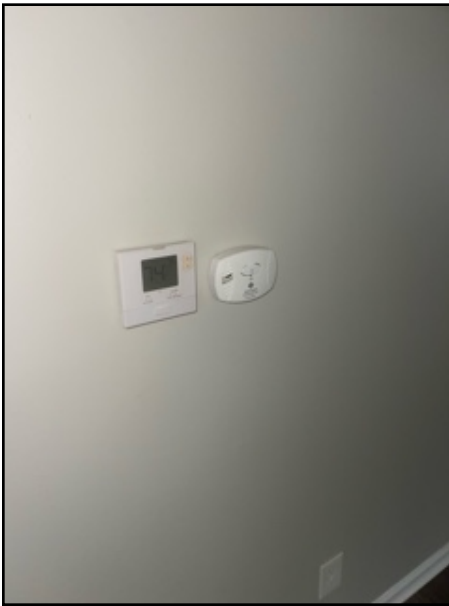
Figure 10-1

Carbon monoxide detector is installed.

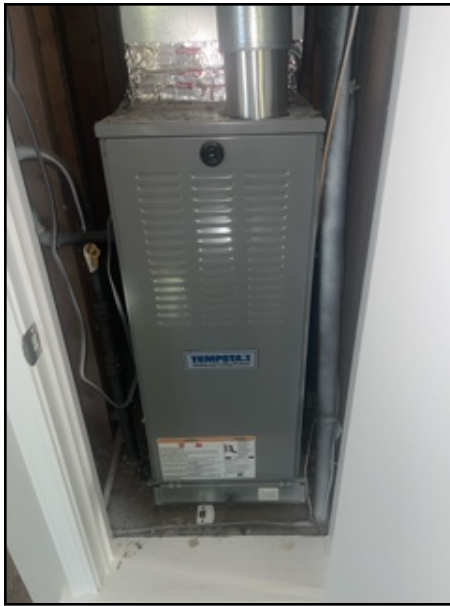
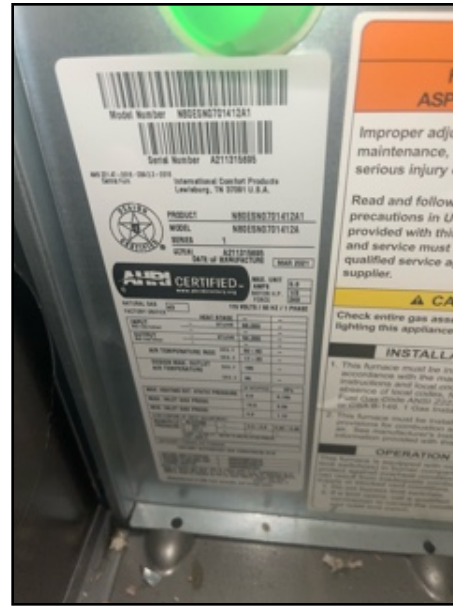
Heat operating as intended.

Register temps above 100 degrees

Furnaces over 10 years old should be checked, cleaned and serviced yearly by a licensed contractor.

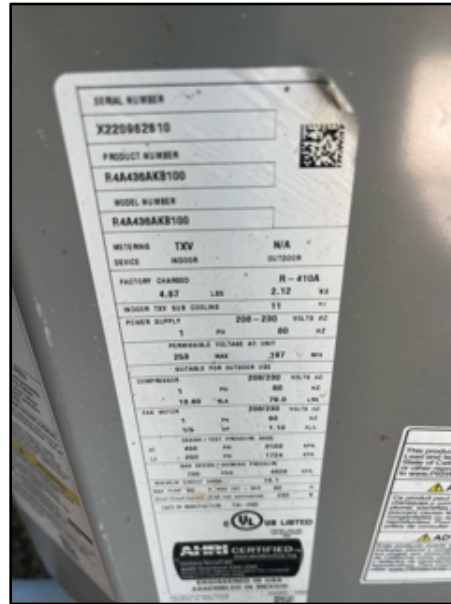
Figure 12-2

| Condenser Make: | Carrier |
| Condenser Approximate Age: | Two years old |

Air conditioners over 10 years old and heat pumps over 5 years old should be checked, cleaned and serviced yearly by a licensed contractor.

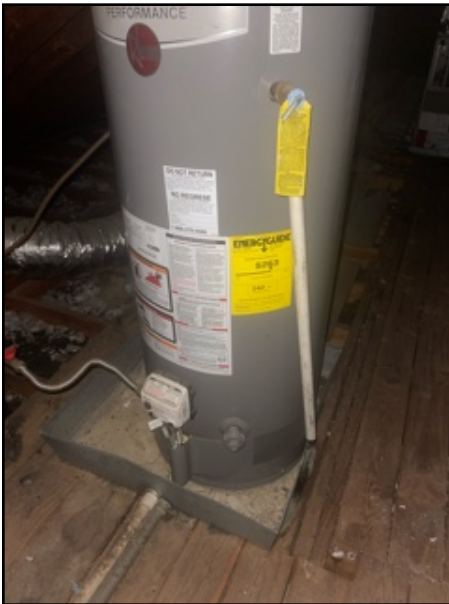
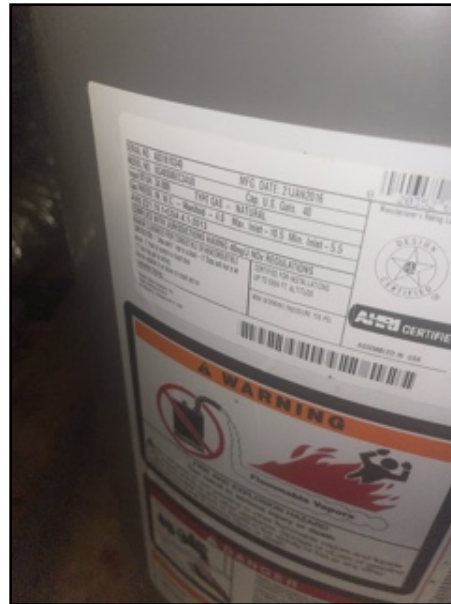
Comment 13:  
Hot water temperature 117°.

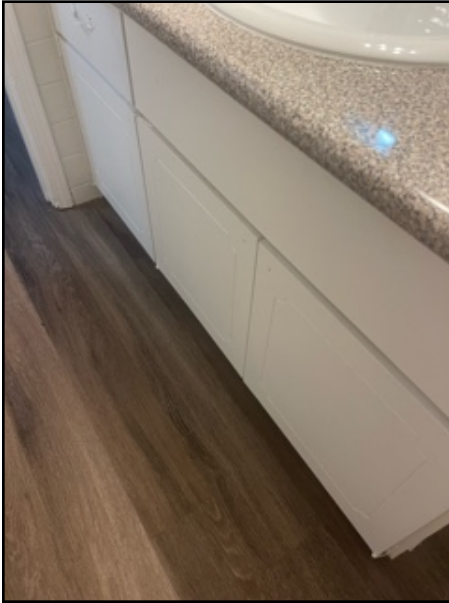
Figure 15-1

Knobs or handles need to be installed on vanity and hall bathroom.

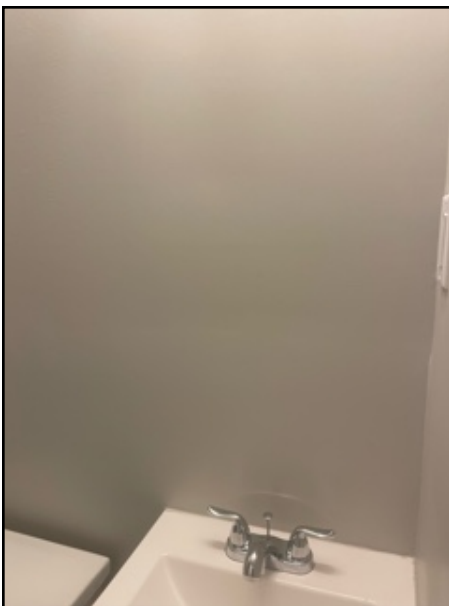
Figure 16-1

No mirror installed in master bathroom.

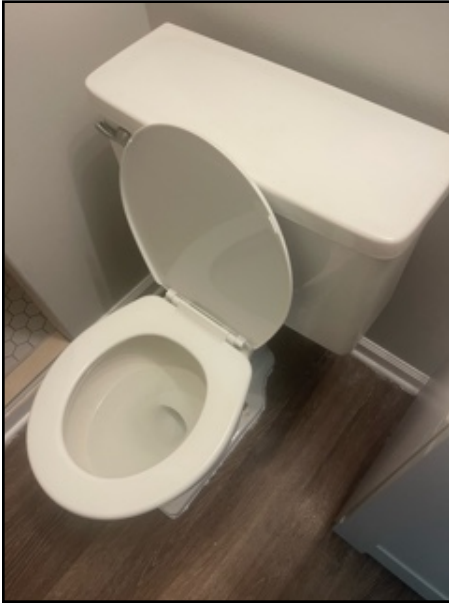
Figure 17-1

Comment 17:  
Toilet will not flush in master bathroom.

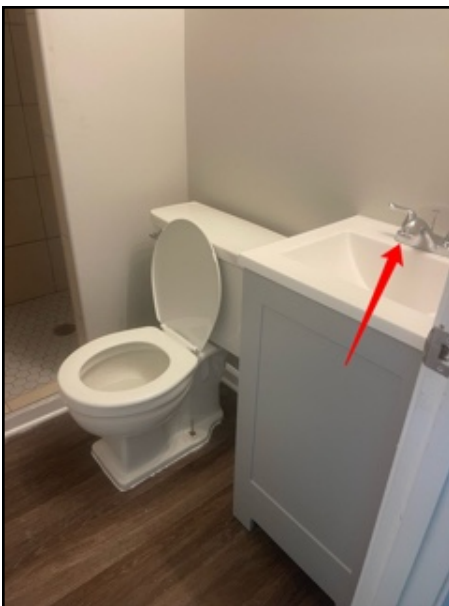
Figure 18-1

Comment 18:  
No water pressure in master bathroom sink.

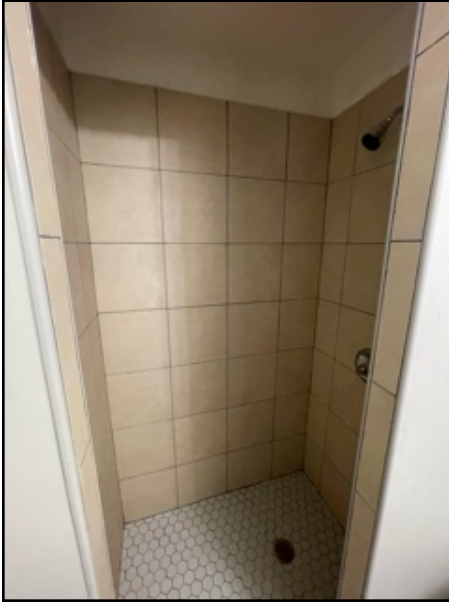
Figure 19-1

Shower water in master bathroom only gets lukewarm Further evaluation needed by Plumber.

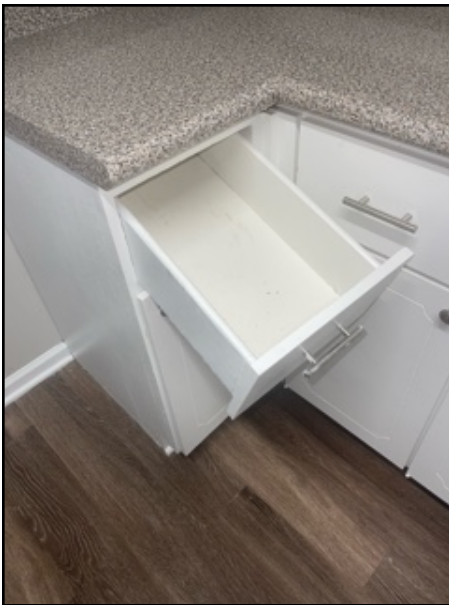
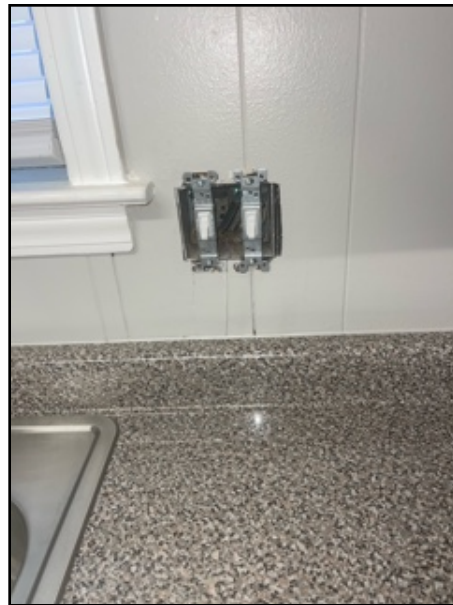
Drawer guide and double switch cover needed in kitchen.

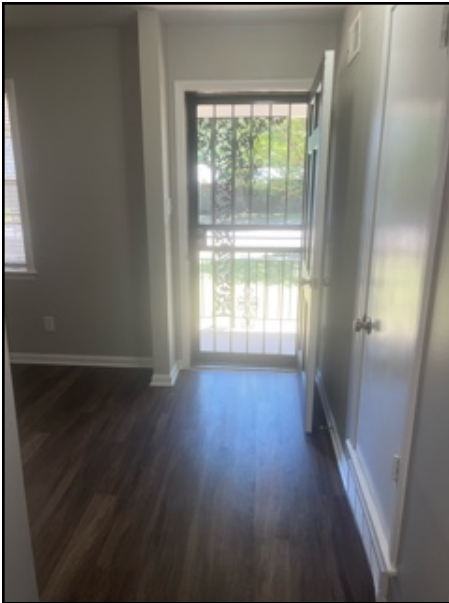
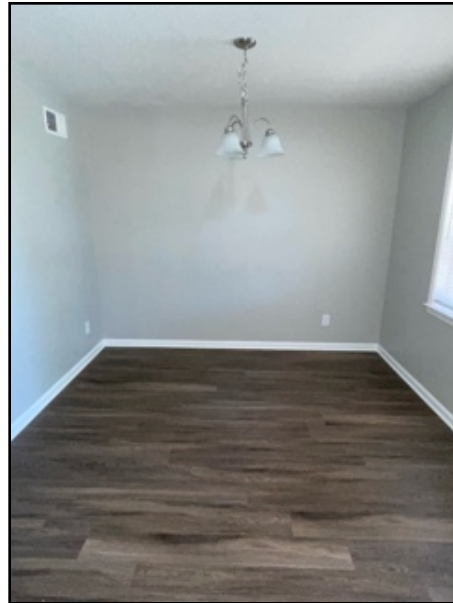
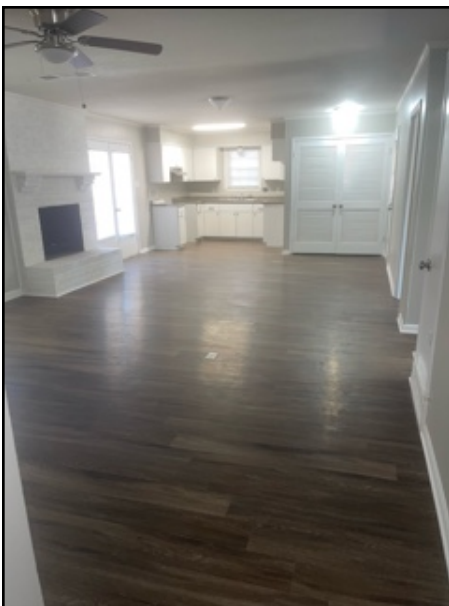
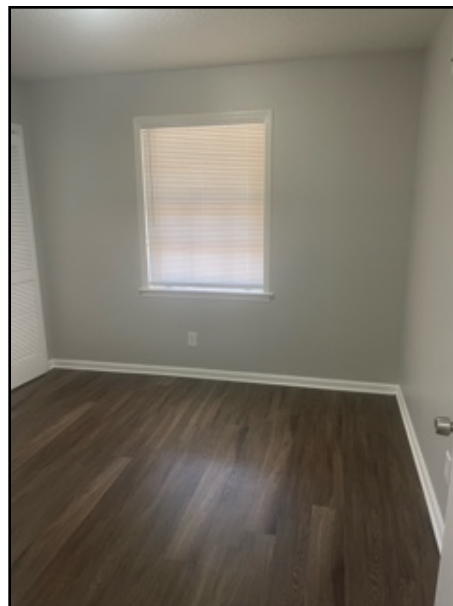
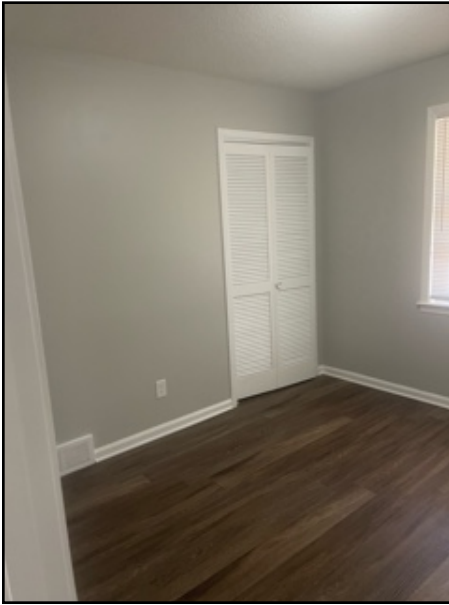
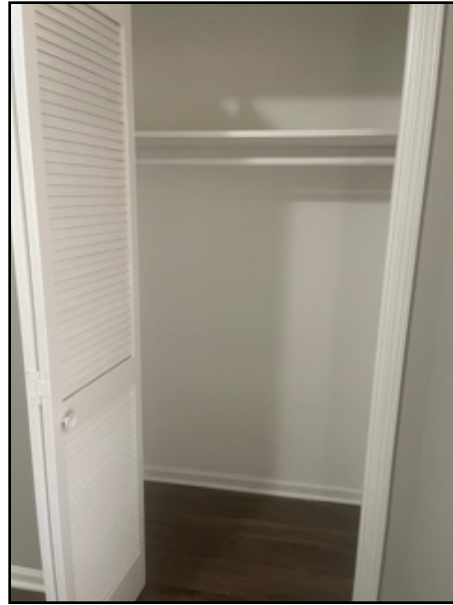
Comment 23:  
General pictures of Living room, dining area, bedrooms and closets.

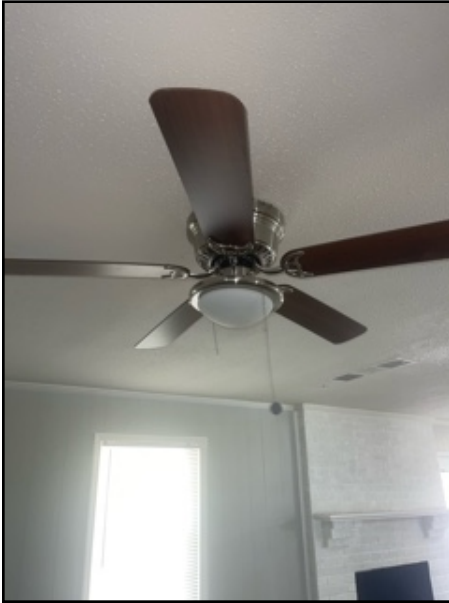
Figure 24-1

Comment 24:  
Ceiling fan not working in living room.

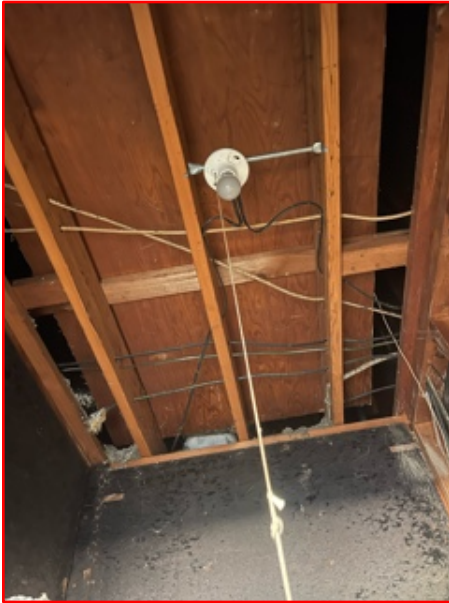
Figure 3-1

1) Overhead light not working in storage room.

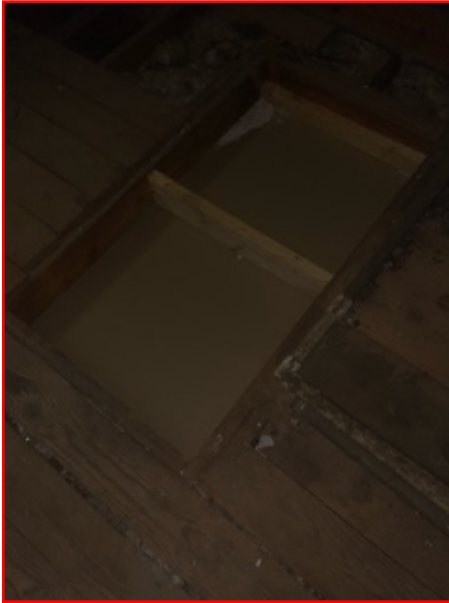
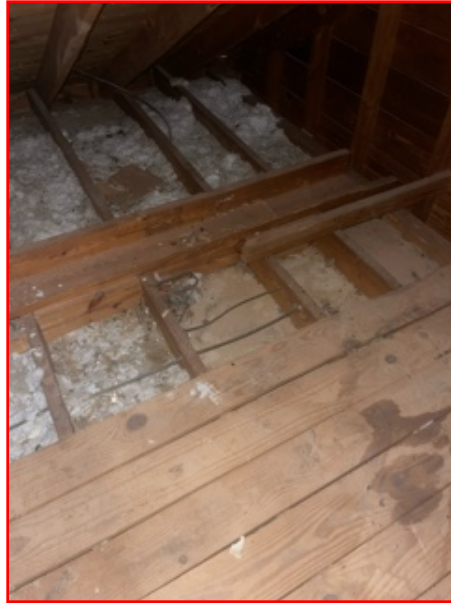
3) Some insulation missing as noted by pictures.

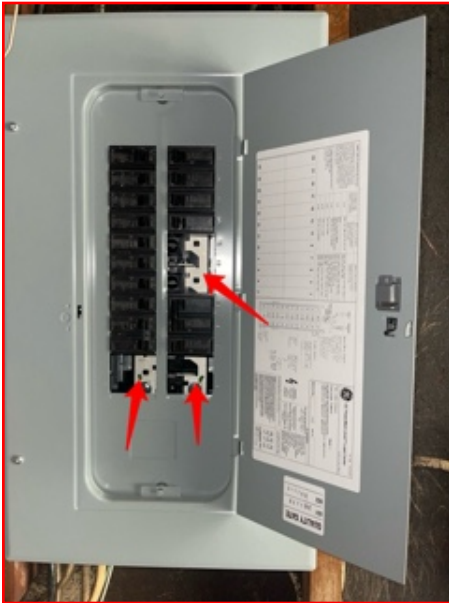
Figure 9-1

4) Empty breaker slots need to be covered for safety.

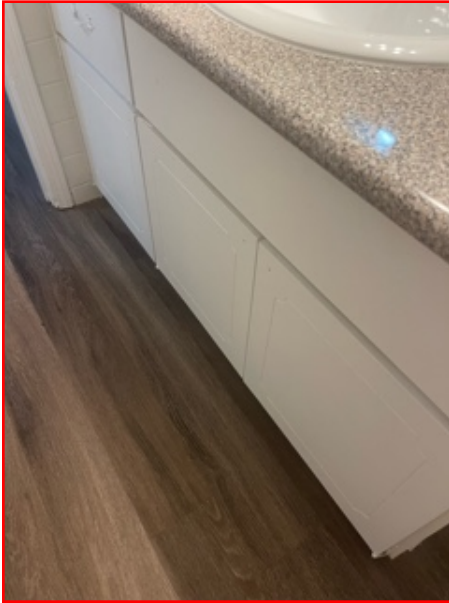
Figure 15-1

5) Knobs or handles need to be installed on vanity and hall bathroom.

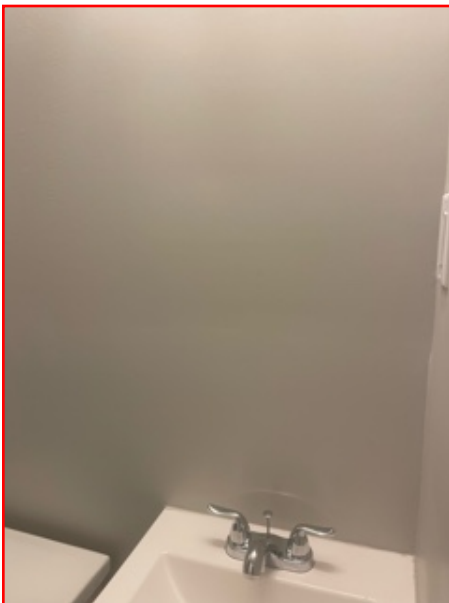
Figure 16-1

6) No mirror installed in master bathroom.

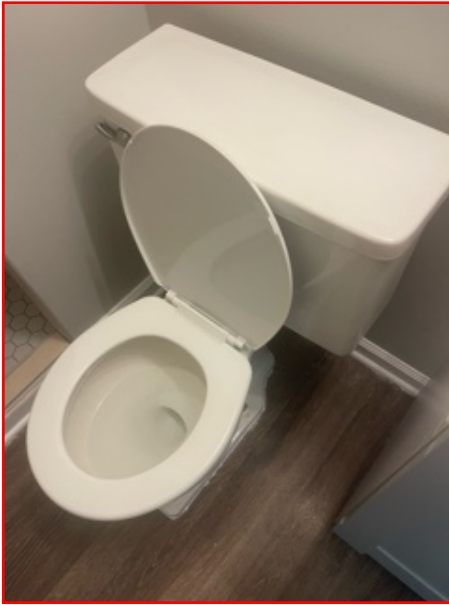
Figure 17-1

7) Toilet will not flush in master bathroom.

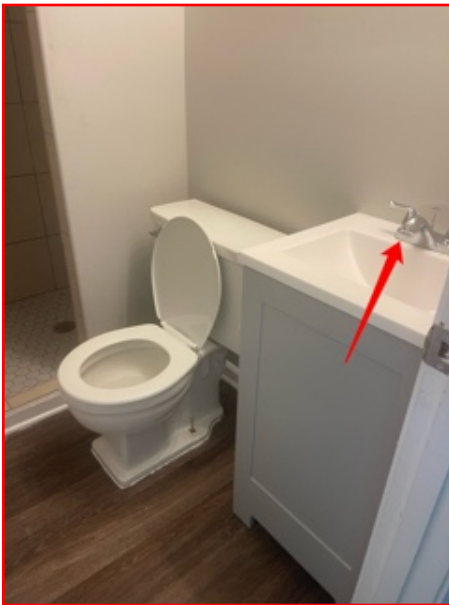
Figure 18-1

8) No water pressure in master bathroom sink.

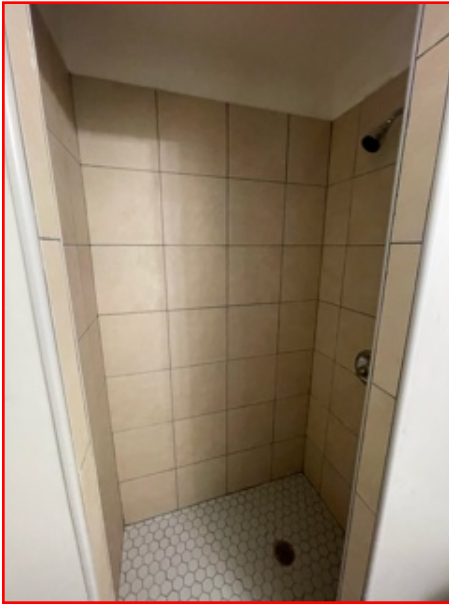
Figure 19-1

9) Shower water in master bathroom only gets lukewarm Further evaluation needed by Plumber.

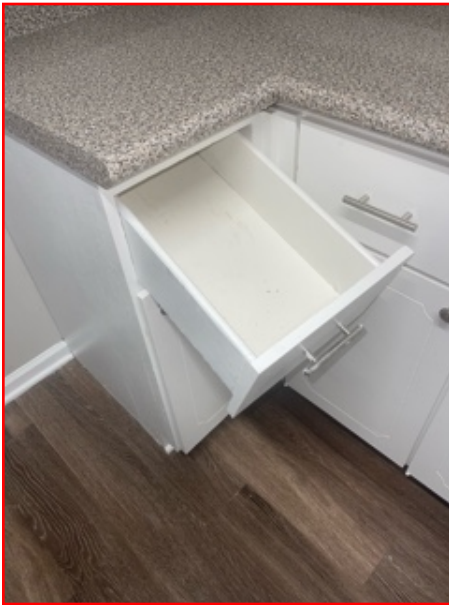
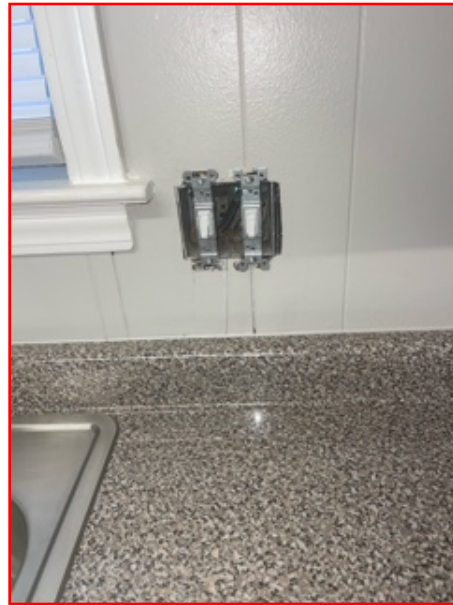
10) Drawer guide and double switch cover needed in kitchen.

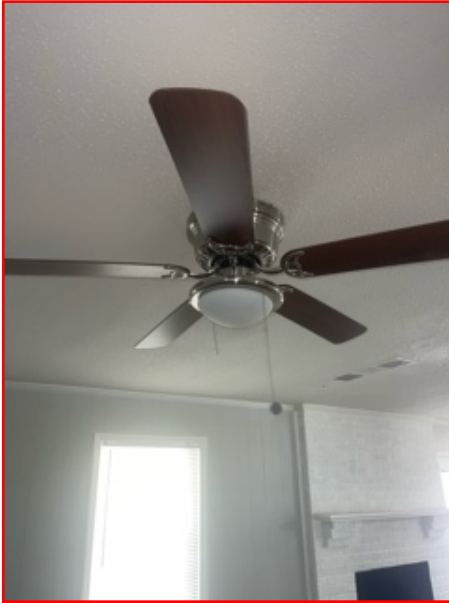
Figure 24-1

11) Ceiling fan not working in living room.
