URBANGRID REAL ESTATE CONSULTANCIES

# HOME CONDITION AUDIT REPORT (SNAGGING)

**Mr. Rizwan**  
V085, Talia The Valley By Emaar  
Al Ain Road, Dubai, U.A.E

21-October-2025

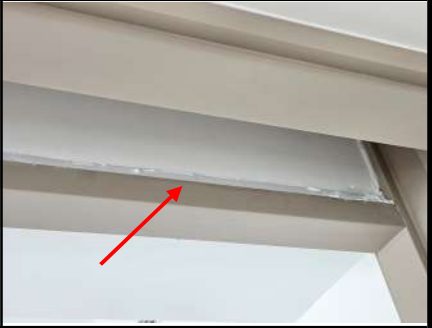
| Sl. No | Location | Category | Defect | Status | Level of Severity | Reference |
|---|---|---|---|---|---|---|
| 1 | Ground Floor Bedroom | Civil | Poor detailing of the silicon seal above the door frame | Open | 2 | |

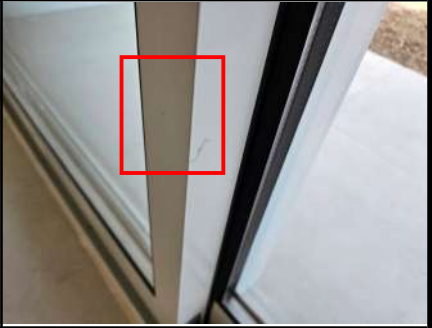
| Sl. No | Location | Category | Defect | Status | Level of Severity | Reference |
|---|---|---|---|---|---|---|
| 2 | Ground Floor Bedroom | Civil | Scratches to the aluminum door frame | Open | 2 | |

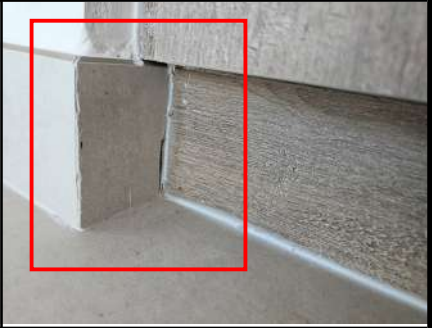
| Sl. No | Location | Category | Defect | Status | Level of Severity | Reference |
|---|---|---|---|---|---|---|
| 3 | Ground Floor Bedroom | Civil | Poor application of grouting and sealant at the skirting level | Open | 2 | |

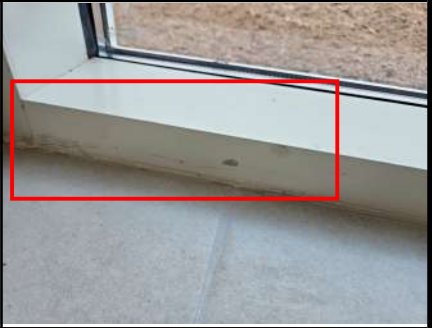
| Sl. No | Location | Category | Defect | Status | Level of Severity | Reference |
|---|---|---|---|---|---|---|
| 4 | Ground Floor Bedroom | Civil | Scuff and stain marks to the aluminum frame | Open | 2 | |

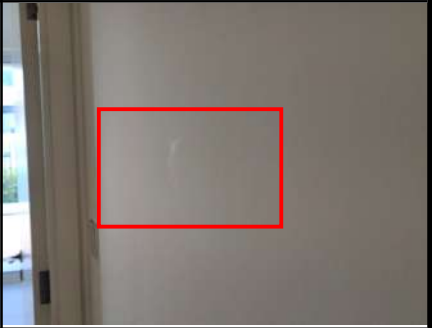
| Sl. No | Location | Category | Defect | Status | Level of Severity | Reference |
|---|---|---|---|---|---|---|
| 5 | Ground Floor Corridor | Civil | Inconsistent paint marks to the wall paint finish in the corridor | Open | 2 | |

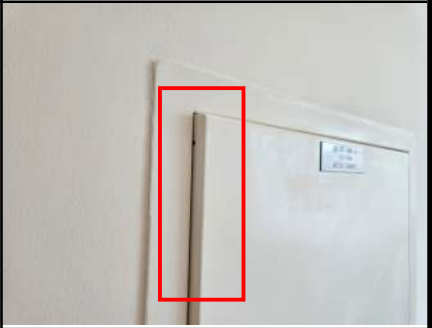
| Sl. No | Location | Category | Defect | Status | Level of Severity | Reference |
|---|---|---|---|---|---|---|
| 6 | Ground Floor Corridor | Civil | The DB door was difficult to close and required excessive force to be fully shut | Open | 2 | |

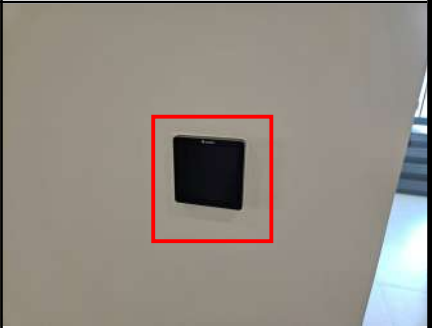
| Sl. No | Location | Category | Defect | Status | Level of Severity | Reference |
|---|---|---|---|---|---|---|
| 7 | Ground Floor Corridor | Civil | The AC controller unit in the corridor was non-operational at the time of inspection | Open | 4 | |

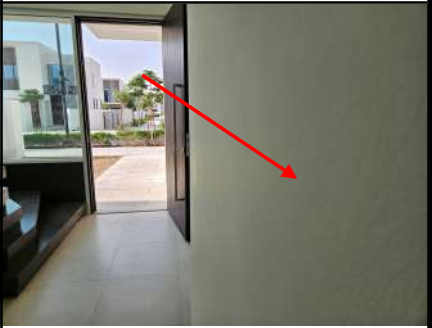
| Sl. No | Location | Category | Defect | Status | Level of Severity | Reference |
|---|---|---|---|---|---|---|
| 8 | Entrance | Civil | Inconsistent paint marks to the wall paint finish | Open | 2 | |

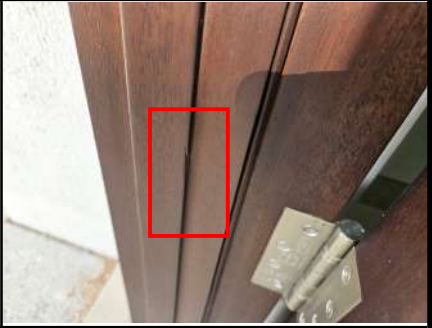
| Sl. No | Location | Category | Defect | Status | Level of Severity | Reference |
|---|---|---|---|---|---|---|
| 9 | Entrance | Civil | Minor damage to the door frame surface finish | Open | 2 | |

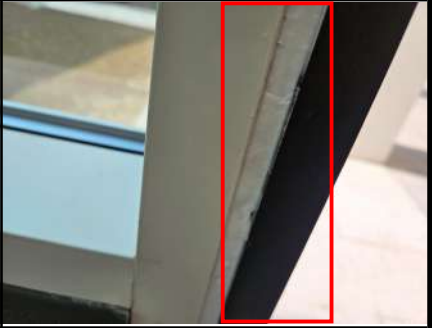
| Sl. No | Location | Category | Defect | Status | Level of Severity | Reference |
|---|---|---|---|---|---|---|
| 10 | Entrance | Civil | Poor detailing of the silicon seal along the vertical line between the door frame and wall | Open | 2 | |

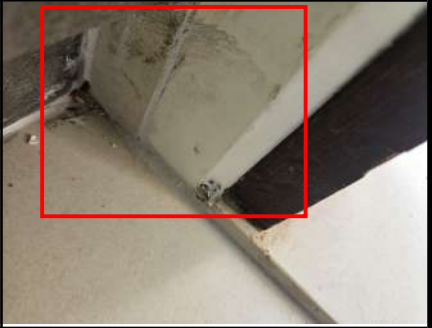
| Sl. No | Location | Category | Defect | Status | Level of Severity | Reference |
|---|---|---|---|---|---|---|
| 11 | Entrance | Civil | Sealant at door frame base was poorly finished | Open | 2 | |

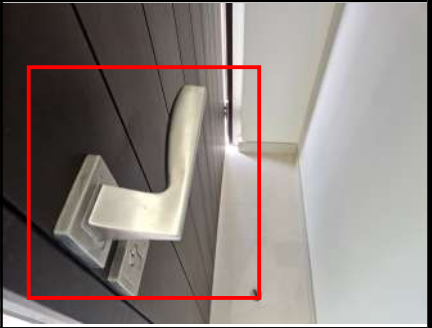
| Sl. No | Location | Category | Defect | Status | Level of Severity | Reference |
|---|---|---|---|---|---|---|
| 12 | Entrance | Civil | The entrance door handle was slightly loose | Open | 2 | |

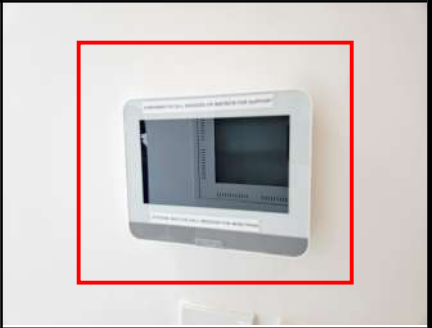
| Sl. No | Location | Category | Defect | Status | Level of Severity | Reference |
|---|---|---|---|---|---|---|
| 13 | Entrance | MEP | The intercom system was non-operational at the time of inspection | Open | 4 | |

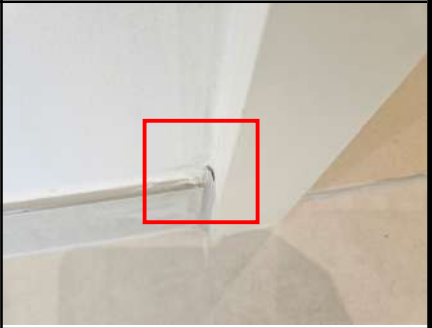
| Sl. No | Location | Category | Defect | Status | Level of Severity | Reference |
|---|---|---|---|---|---|---|
| 14 | Ground Floor Bathroom | Civil | Visible gap between the door frame and skirting finish | Open | 2 | |

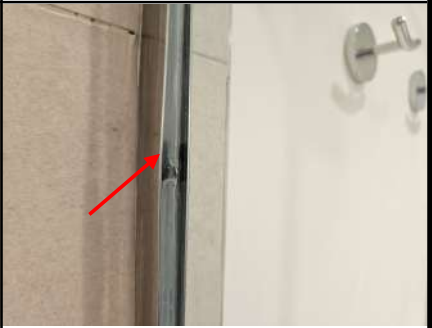
| Sl. No | Location | Category | Defect | Status | Level of Severity | Reference |
|---|---|---|---|---|---|---|
| 15 | Ground Floor Bathroom | Civil | Damaged silicon seal to the shower door | Open | 3 | |

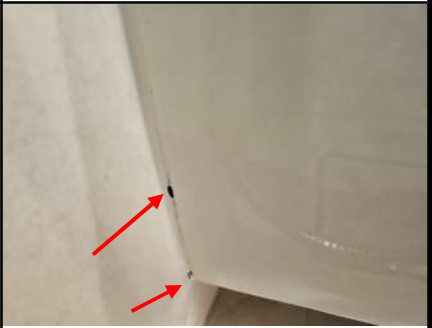
| Sl. No | Location | Category | Defect | Status | Level of Severity | Reference |
|---|---|---|---|---|---|---|
| 16 | Ground Floor Bathroom | Civil | Incomplete silicon seal around the toilet with visible gaps | Open | 2 | |

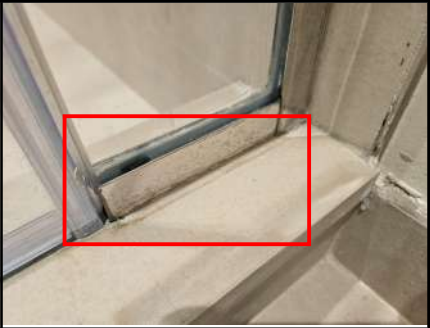
| Sl. No | Location | Category | Defect | Status | Level of Severity | Reference |
|---|---|---|---|---|---|---|
| 17 | Ground Floor Bathroom | Civil | Shower door base was discolored. The area requires deep cleaning. | Open | 1 | |

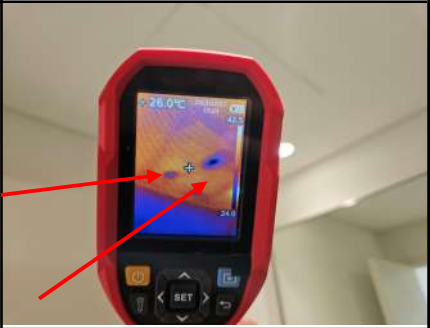
| Sl. No | Location | Category | Defect | Status | Level of Severity | Reference |
|---|---|---|---|---|---|---|
| 18 | Ground Floor Bathroom | MEP | Heat spots detected near the ceiling light in the bathroom, indicating potential exposed wiring in the ceiling void | Open | 3 | |

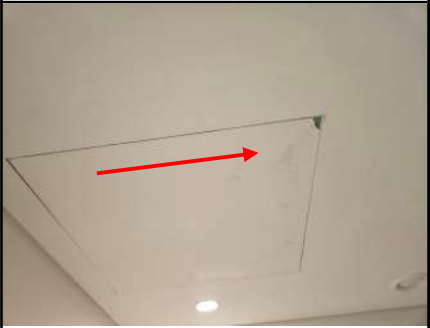
| Sl. No | Location | Category | Defect | Status | Level of Severity | Reference |
|---|---|---|---|---|---|---|
| 19 | Ground Floor Bathroom | Civil | Paint touch ups to the ceiling access panel | Open | 2 | |

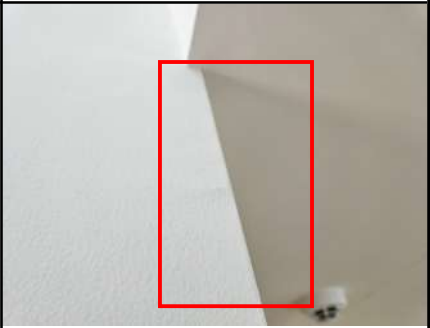
| Sl. No | Location | Category | Defect | Status | Level of Severity | Reference |
|---|---|---|---|---|---|---|
| 20 | Kitchen | Civil | Inconsistent wall paint finish | Open | 1 | |

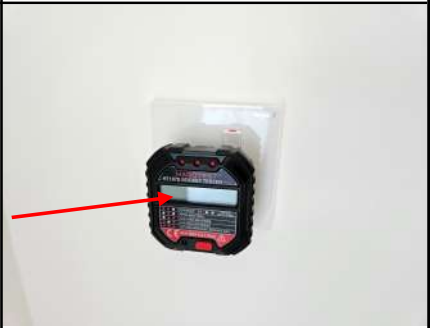
| Sl. No | Location | Category | Defect | Status | Level of Severity | Reference |
|---|---|---|---|---|---|---|
| 21 | Kitchen | MEP | One electrical socket in the fridge area was non-operational as tested with the use of a socket tester | Open | 4 | |

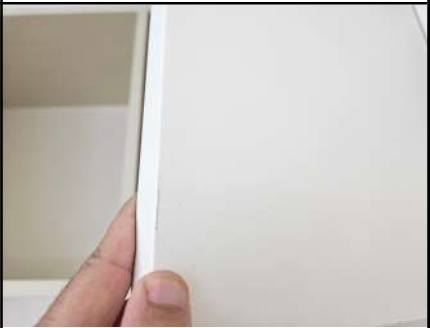
| Sl. No | Location | Category | Defect | Status | Level of Severity | Reference |
|---|---|---|---|---|---|---|
| 22 | Kitchen | Civil | Minor stain marks to the wall paint near the kitchen cabinet | Open | 2 | |

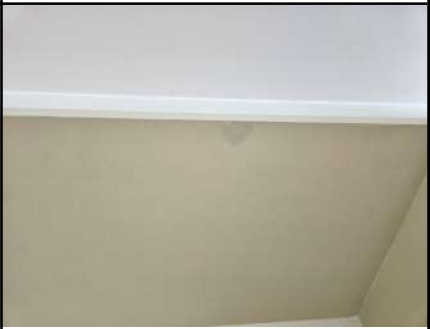
| Sl. No | Location | Category | Defect | Status | Level of Severity | Reference |
|---|---|---|---|---|---|---|
| 23 | Kitchen | Civil | Discolored patch observed beneath cabinet cornice | Open | 2 | |

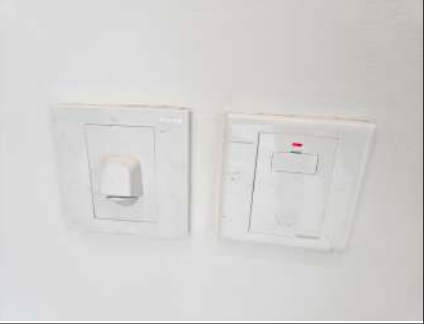
| Sl. No | Location | Category | Defect | Status | Level of Severity | Reference |
|---|---|---|---|---|---|---|
| 24 | Kitchen | Civil | The switch outlets were unclean and observed with stain marks | Open | 1 | |

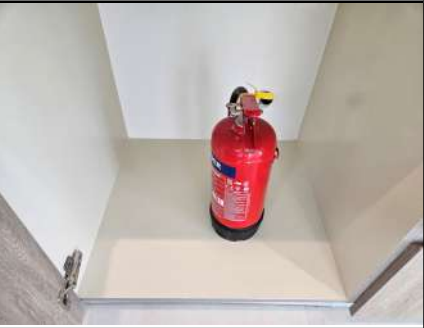
- The **fire extinguisher** and **fire blanket** were found stored inside a kitchen cabinet, which does not comply with **local civil defense requirements**. They must be wall-mounted and readily accessible.

| Sl. No | Location | Category | Defect | Status | Level of Severity | Reference |
|---|---|---|---|---|---|---|
| 25 | Kitchen | MEP | Fire extinguisher was placed inside the kitchen cabinet. Additionally, fire blanket was missing.<br><br>They should both be available and wall mounted to comply with local regulations | Open | 4 | |

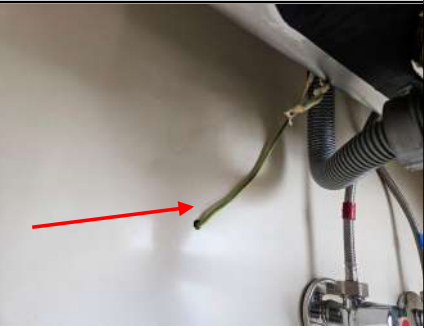
| Sl. No | Location | Category | Defect | Status | Level of Severity | Reference |
|---|---|---|---|---|---|---|
| 26 | Kitchen | MEP | Loose earthing wire observed below kitchen sink; connection to designated earthing point required and to be verified by a qualified electrician | Open | 4 | |

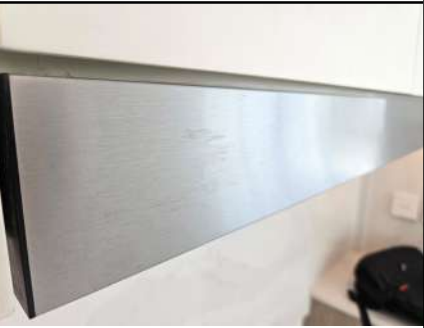
| Sl. No | Location | Category | Defect | Status | Level of Severity | Reference |
|---|---|---|---|---|---|---|
| 27 | Kitchen | Civil | Minor scratches to the kitchen extract hood | Open | 1 | |

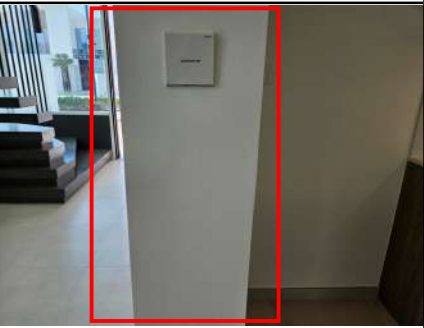
| Sl. No | Location | Category | Defect | Status | Level of Severity | Reference |
|---|---|---|---|---|---|---|
| 28 | Kitchen | Civil | Wall width found inconsistent, appearing wider at the upper section. This is likely due to uneven plastering requiring surface correction and re-finishing. | Open | 2 | |

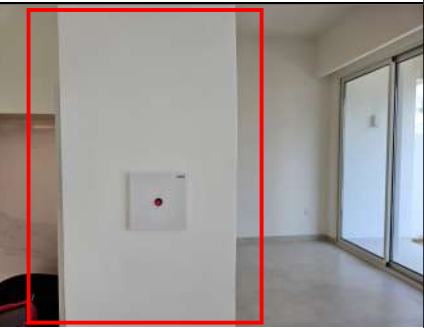
| Sl. No | Location | Category | Defect | Status | Level of Severity | Reference |
|---|---|---|---|---|---|---|
| 29 | Kitchen | Civil | Wall width found inconsistent, appearing wider at the upper section. This is likely due to uneven plastering requiring surface correction and re-finishing. | Open | 2 | |

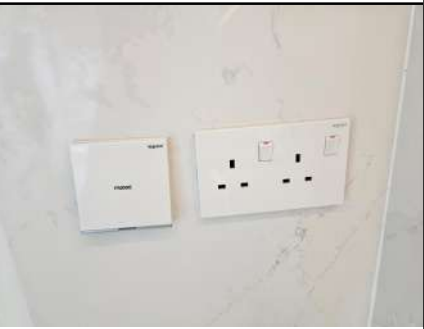
| Sl. No | Location | Category | Defect | Status | Level of Severity | Reference |
|---|---|---|---|---|---|---|
| 30 | Kitchen | Civil | The electrical sockets and the fridge switch were not properly aligned at the same level, creating aesthetic issue | Open | 2 | |

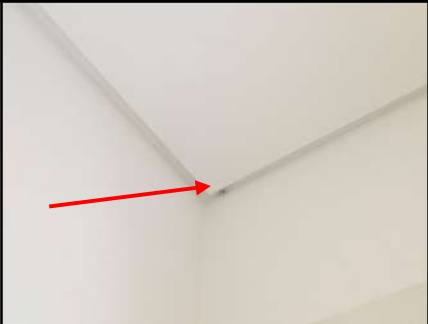
| Sl. No | Location | Category | Defect | Status | Level of Severity | Reference |
|---|---|---|---|---|---|---|
| 31 | Laundry Room | Civil | Presence of small spiders and ants observed in laundry room. The area requires pest control treatment and sealing of possible entry points | Open | 4 | |

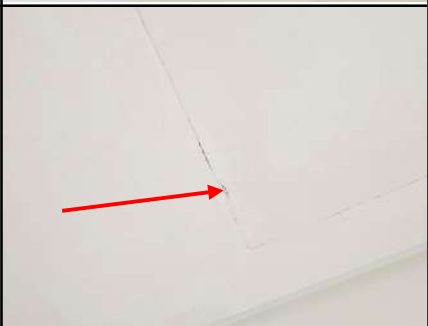
| Sl. No | Location | Category | Defect | Status | Level of Severity | Reference |
|---|---|---|---|---|---|---|
| 32 | Laundry Room | Civil | The ceiling paint finish was not properly detailed near the access panel | Open | 2 | |

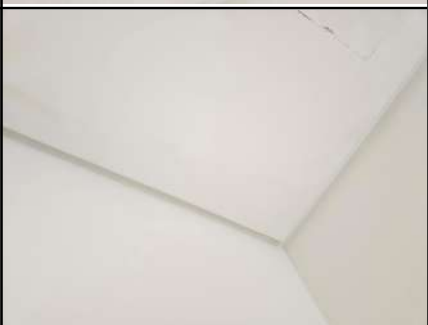
| Sl. No | Location | Category | Defect | Status | Level of Severity | Reference |
|---|---|---|---|---|---|---|
| 33 | Laundry Room | Civil | Signs of dampness observed on laundry room ceiling paint. Thermal imaging confirmed moisture presence.<br><br>Source to be identified and rectified before repainting. | Open | 4 | |

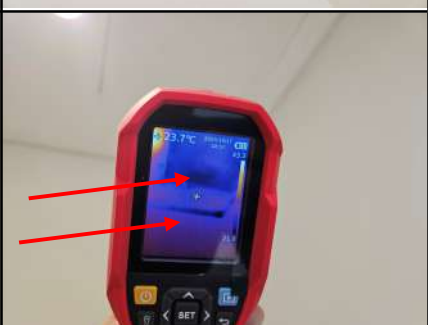
| Sl. No | Location | Category | Defect | Status | Level of Severity | Reference |
|---|---|---|---|---|---|---|
| 34 | Laundry Room | MEP | Signs of dampness observed on laundry room ceiling paint. Thermal imaging confirmed moisture presence.<br><br>Source to be identified and rectified before repainting. | Open | 4 | |

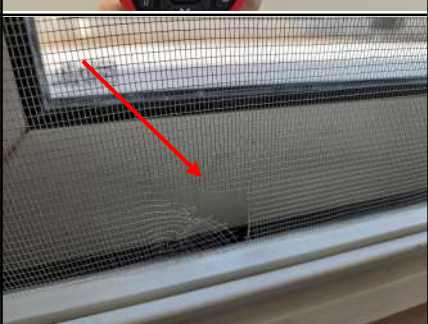
| Sl. No | Location | Category | Defect | Status | Level of Severity | Reference |
|---|---|---|---|---|---|---|
| 35 | Living Room | Civil | Mesh screen door found damaged, with torn mesh and visible surface heavy scratches to the door frames.<br><br>Replacement of complete mesh door unit is recommended to restore proper function and appearance. | Open | 3 | |

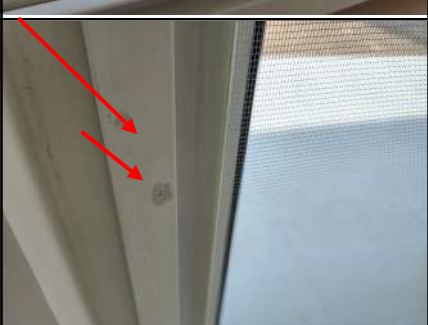
| Sl. No | Location | Category | Defect | Status | Level of Severity | Reference |
|---|---|---|---|---|---|---|
| 36 | Living Room | Civil | Mesh screen door found damaged, with torn mesh and visible surface heavy scratches to the door frames.<br><br>Replacement of complete mesh door unit is recommended to restore proper function and appearance. | Open | 3 | |

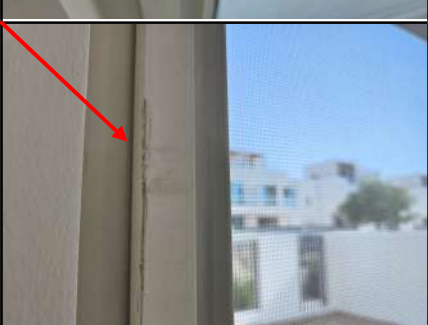
| Sl. No | Location | Category | Defect | Status | Level of Severity | Reference |
|---|---|---|---|---|---|---|
| 37 | Living Room | Civil | Mesh screen door found damaged, with torn mesh and visible surface heavy scratches to the door frames.<br><br>Replacement of complete mesh door unit is recommended to restore proper function and appearance. | Open | 3 | |

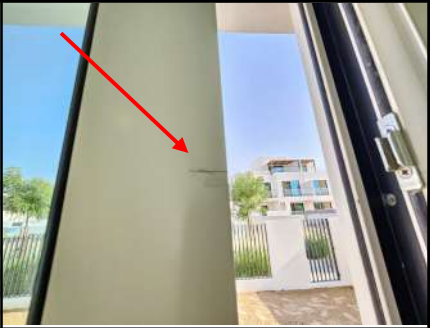
| Sl. No | Location | Category | Defect | Status | Level of Severity | Reference |
|---|---|---|---|---|---|---|
| 38 | Living Room | Civil | Scratches to the garden door aluminum frame | Open | 2 | |

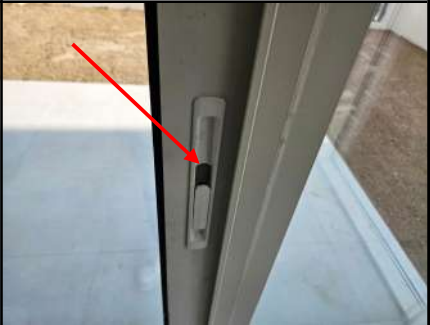
| Sl. No | Location | Category | Defect | Status | Level of Severity | Reference |
|---|---|---|---|---|---|---|
| 39 | Living Room | Civil | The garden door lock was non-operational | Open | 3 | |

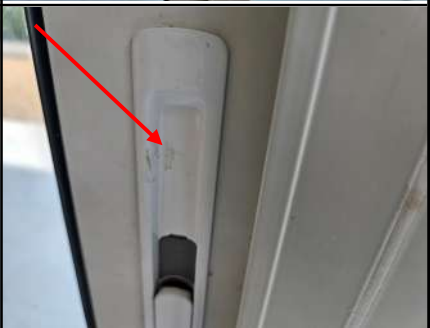
| Sl. No | Location | Category | Defect | Status | Level of Severity | Reference |
|---|---|---|---|---|---|---|
| 40 | Living Room | Civil | The garden door lock was scratched and discolored | Open | 2 | |

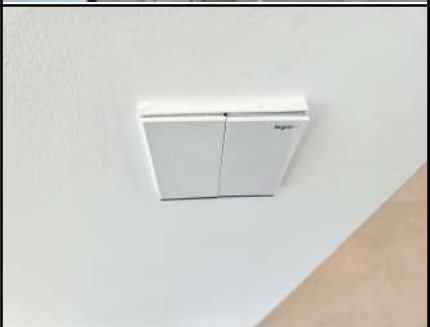
| Sl. No | Location | Category | Defect | Status | Level of Severity | Reference |
|---|---|---|---|---|---|---|
| 41 | Living Room | Civil | The light switch controllers were loose and requires adjustments | Open | 2 | |

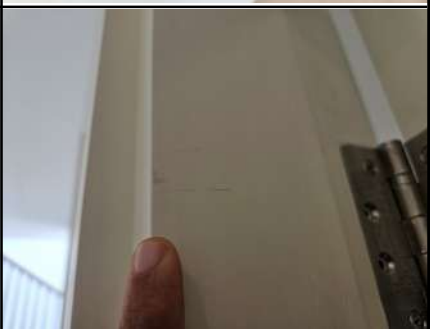
| Sl. No | Location | Category | Defect | Status | Level of Severity | Reference |
|---|---|---|---|---|---|---|
| 42 | Maid's Room | Civil | Scratches to the door frame surface finish | Open | 2 | |

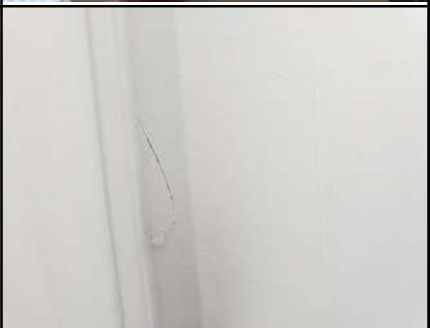
| Sl. No | Location | Category | Defect | Status | Level of Severity | Reference |
|---|---|---|---|---|---|---|
| 43 | Maid's Room | Civil | Hairline crack observed on wall corner | Open | 2 | |

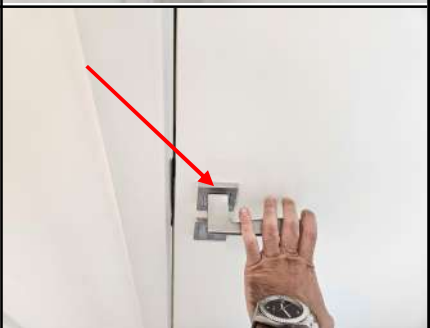
| Sl. No | Location | Category | Defect | Status | Level of Severity | Reference |
|---|---|---|---|---|---|---|
| 44 | Maid's Room | Civil | Maid's room door misaligned; door latch requires strong push to engage. Adjustment of lockset and door alignment recommended for smooth operation. | Open | 3 | |

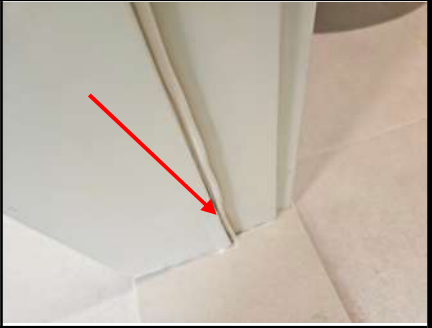
| Sl. No | Location | Category | Defect | Status | Level of Severity | Reference |
|---|---|---|---|---|---|---|
| 45 | Maid's Room | Civil | Loose application of the sealant to the door frame of the maid's bathroom | Open | 3 | |

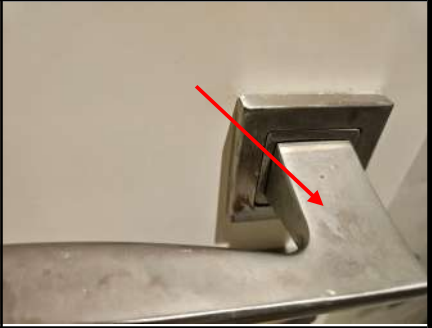
| Sl. No | Location | Category | Defect | Status | Level of Severity | Reference |
|---|---|---|---|---|---|---|
| 46 | Maid's Room | Civil | Door handle plate was scratched | Open | 2 | |

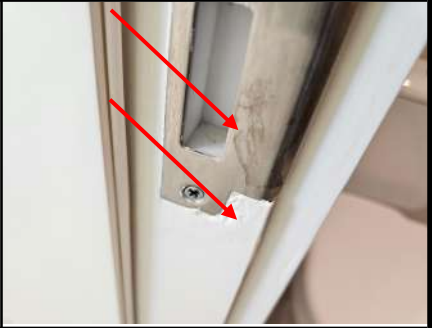
| Sl. No | Location | Category | Defect | Status | Level of Severity | Reference |
|---|---|---|---|---|---|---|
| 47 | Maid's Room | Civil | Door latch plate scratched with chipped paint around fixing area | Open | 2 | |

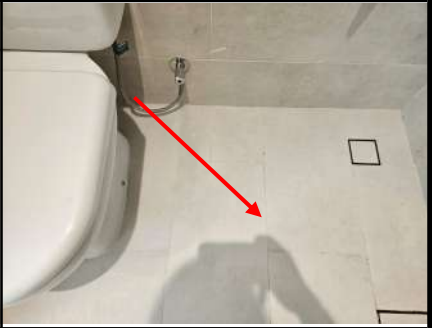
| Sl. No | Location | Category | Defect | Status | Level of Severity | Reference |
|---|---|---|---|---|---|---|
| 48 | Maid's Room | Civil | Shower floor slope in maid's bathroom inadequate. The water not fully draining and accumulating near toilet area | Open | 3 | |

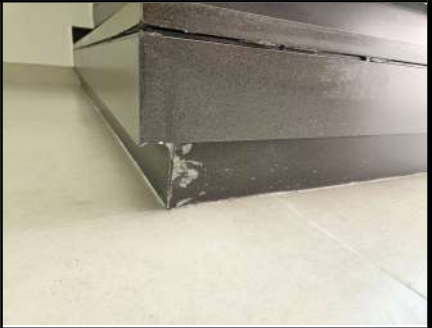
| Sl. No | Location | Category | Defect | Status | Level of Severity | Reference |
|---|---|---|---|---|---|---|
| 49 | Staircase | Civil | Poor detailing and finishes to the stair tread corner with chipped and stained surfaces | Open | 2 | |

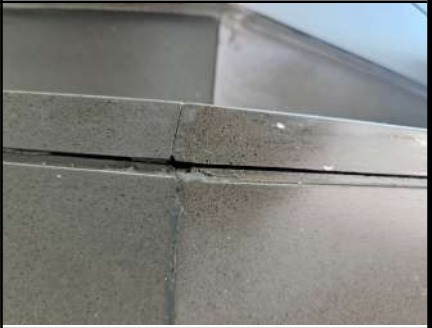
| Sl. No | Location | Category | Defect | Status | Level of Severity | Reference |
|---|---|---|---|---|---|---|
| 50 | Staircase | Civil | Poor detailing and finishes to the stair tread corner with chipped and stained surfaces | Open | 2 | |

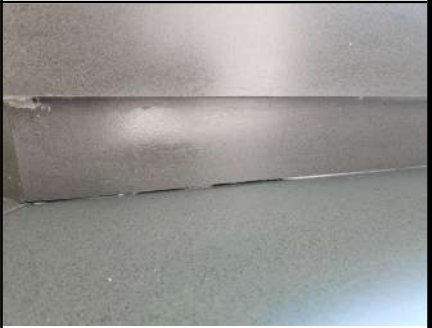
| Sl. No | Location | Category | Defect | Status | Level of Severity | Reference |
|---|---|---|---|---|---|---|
| 51 | Staircase | Civil | Poor detailing and finishes to the stair tread corner with chipped and stained surfaces | Open | 2 | |

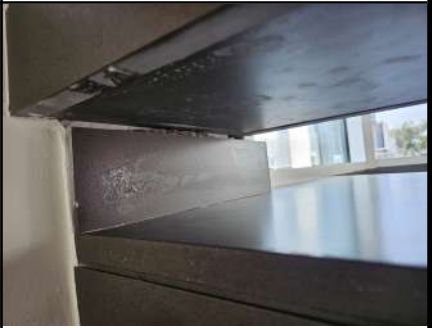
| Sl. No | Location | Category | Defect | Status | Level of Severity | Reference |
|---|---|---|---|---|---|---|
| 52 | Staircase | Civil | Gap observed below stair tread and wall finish. | Open | 3 | |

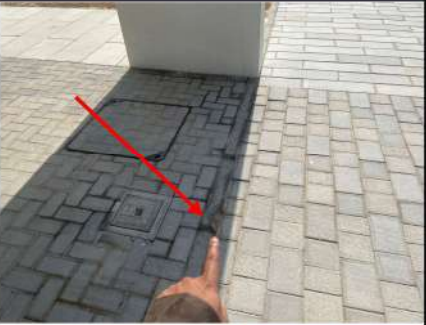
| Sl. No | Location | Category | Defect | Status | Level of Severity | Reference |
|---|---|---|---|---|---|---|
| 53 | Garage Area | Civil | Damaged pavement tile observed | Open | 3 | |

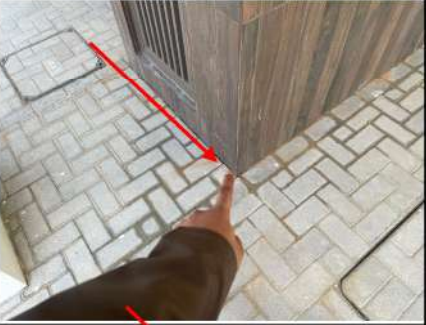
| Sl. No | Location | Category | Defect | Status | Level of Severity | Reference |
|---|---|---|---|---|---|---|
| 54 | Garage Area | Civil | Missing sand infill observed between pavement tiles. Recommended to infill the entire area once again. | Open | 2 | |

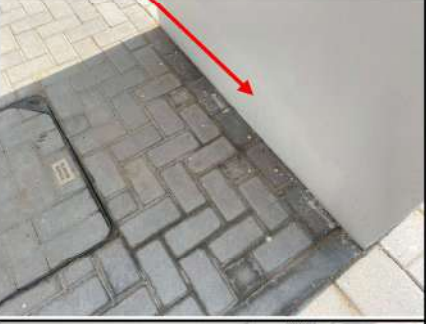
| Sl. No | Location | Category | Defect | Status | Level of Severity | Reference |
|---|---|---|---|---|---|---|
| 55 | Garage Area | Civil | Visible brush strokes observed on the wall and paint splatter observed on the floor | Open | 2 | |

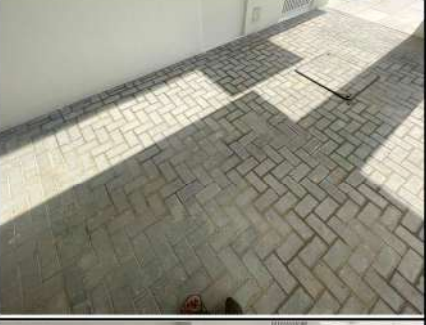
| Sl. No | Location | Category | Defect | Status | Level of Severity | Reference |
|---|---|---|---|---|---|---|
| 56 | Garage Area | Civil | Missing sand infill observed between pavement tiles. | Open | 2 | |

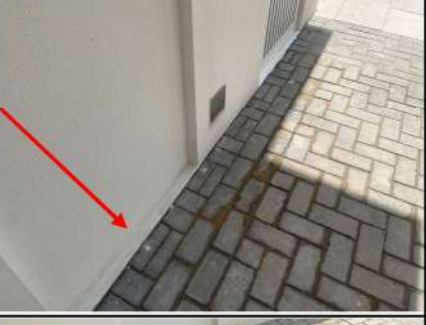
| Sl. No | Location | Category | Defect | Status | Level of Severity | Reference |
|---|---|---|---|---|---|---|
| 57 | Garage Area | Civil | Poor wall paint finishes observed to garage wall | Open | 2 | |

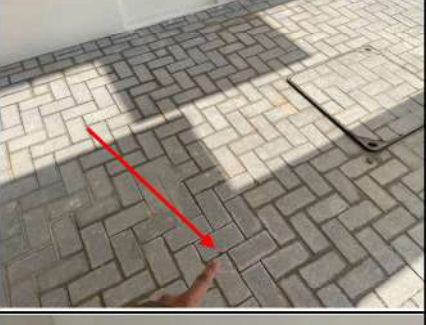
| Sl. No | Location | Category | Defect | Status | Level of Severity | Reference |
|---|---|---|---|---|---|---|
| 58 | Garage Area | Civil | Minor chip observed on pavement tile | Open | 2 | |

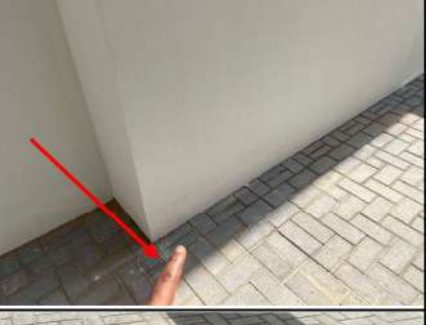
| Sl. No | Location | Category | Defect | Status | Level of Severity | Reference |
|---|---|---|---|---|---|---|
| 59 | Garage Area | Civil | Visible paint marks on pavement tile | Open | 2 | |

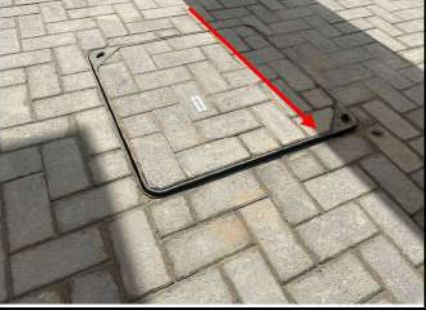
| Sl. No | Location | Category | Defect | Status | Level of Severity | Reference |
|---|---|---|---|---|---|---|
| 60 | Garage Area | Civil | Uneven level observed to manhole cover | Open | 2 | |

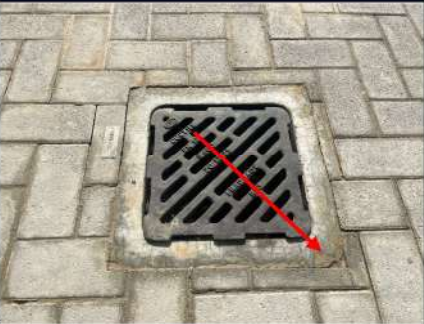
| Sl. No | Location | Category | Defect | Status | Level of Severity | Reference |
|---|---|---|---|---|---|---|
| 61 | Garage Area | Civil | Visible crack marks observed around cement plaster around manhole | Open | 2 | |

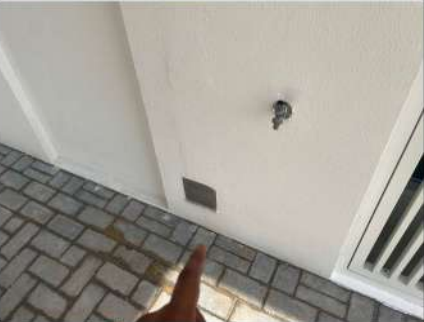
| Sl. No | Location | Category | Defect | Status | Level of Severity | Reference |
|---|---|---|---|---|---|---|
| 62 | Garage Area | Civil | Uneven wall plaster finish observed on the wall | Open | 3 | |

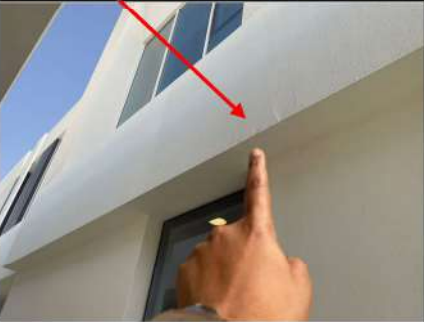
| Sl. No | Location | Category | Defect | Status | Level of Severity | Reference |
|---|---|---|---|---|---|---|
| 63 | Garage Area | Civil | Uneven wall plaster finish observed on the wall | Open | 2 | |

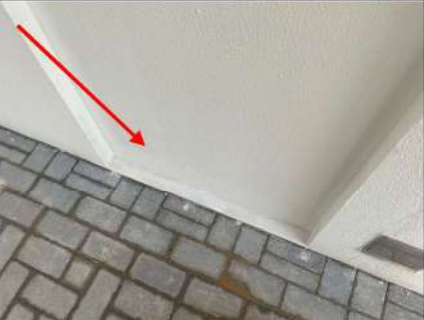
| Sl. No | Location | Category | Defect | Status | Level of Severity | Reference |
|---|---|---|---|---|---|---|
| 64 | Garage Area | Civil | Poor wall paint finishes and paint splatter observed on the wall | Open | 2 | |

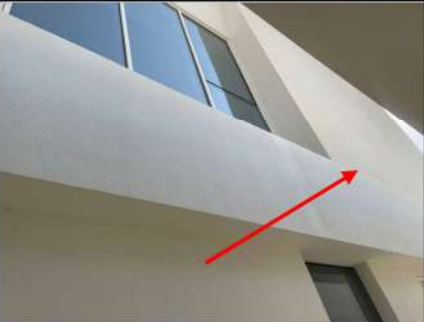
| Sl. No | Location | Category | Defect | Status | Level of Severity | Reference |
|---|---|---|---|---|---|---|
| 65 | Garage Area | Civil | Incomplete wall paint finishes noted to the façade | Open | 3 | |

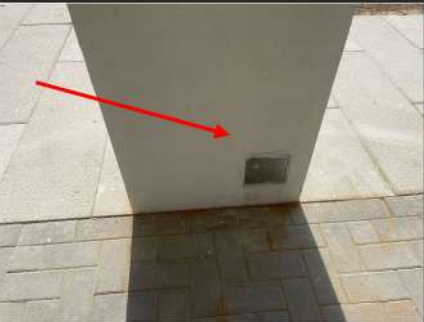
| Sl. No | Location | Category | Defect | Status | Level of Severity | Reference |
|---|---|---|---|---|---|---|
| 66 | Garage Area | Civil | Visible paint stains and poor wall paint finishes noted | Open | 2 | |

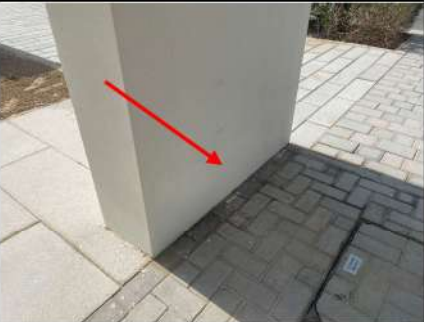
| Sl. No | Location | Category | Defect | Status | Level of Severity | Reference |
|---|---|---|---|---|---|---|
| 67 | Garage Area | Civil | Poor wall paint finishes observed on the column | Open | 3 | |

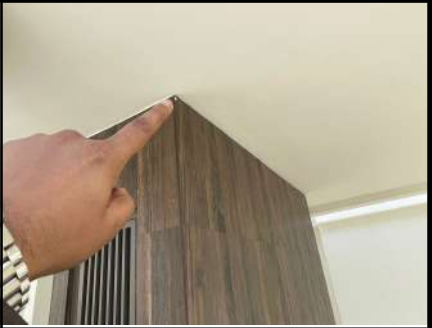
| Sl. No | Location | Category | Defect | Status | Level of Severity | Reference |
|---|---|---|---|---|---|---|
| 68 | Garage Area | Civil | Minor chip noted to wall tile | Open | 2 | |

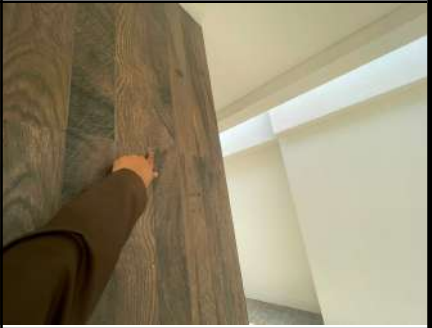
| Sl. No | Location | Category | Defect | Status | Level of Severity | Reference |
|---|---|---|---|---|---|---|
| 69 | Garage Area | Civil | Minor chip noted to wall tile | Open | 2 | |

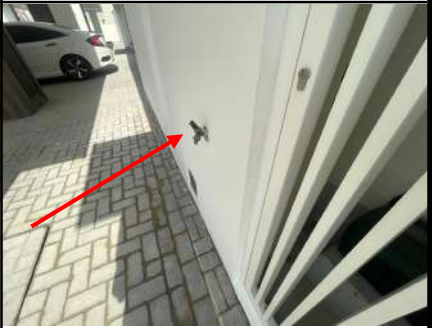
| Sl. No | Location | Category | Defect | Status | Level of Severity | Reference |
|---|---|---|---|---|---|---|
| 70 | Garage Area | Plumbing | Missing water tap handle installation spotted | Open | 3 | |

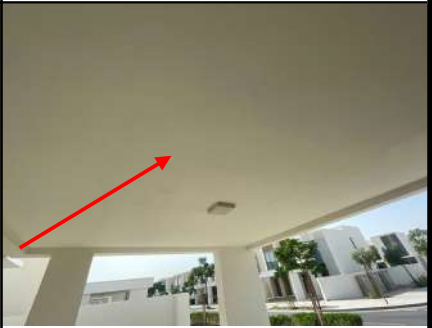
| Sl. No | Location | Category | Defect | Status | Level of Severity | Reference |
|---|---|---|---|---|---|---|
| 71 | Garage Area | Civil | Undulation observed to garage ceiling finish | Open | 2 | |

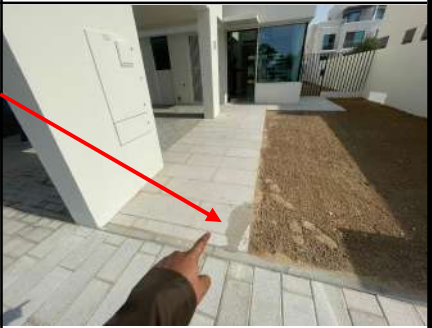
| Sl. No | Location | Category | Defect | Status | Level of Severity | Reference |
|---|---|---|---|---|---|---|
| 72 | Sidewalk | Civil | Visible stains observed to sidewalk paving | Open | 2 | |

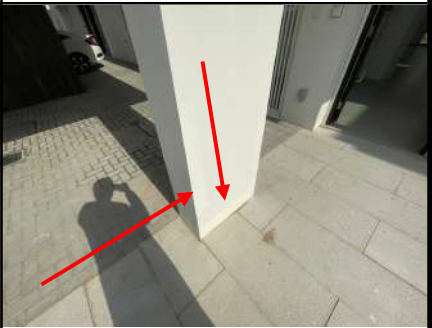
| Sl. No | Location | Category | Defect | Status | Level of Severity | Reference |
|---|---|---|---|---|---|---|
| 73 | Sidewalk | Civil | Visible brush strokes observed on the wall | Open | 2 | |

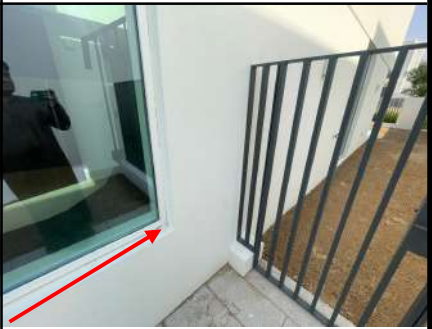
| Sl. No | Location | Category | Defect | Status | Level of Severity | Reference |
|---|---|---|---|---|---|---|
| 74 | Sidewalk | Civil | Poor silicon detailing observed around glass panels | Open | 2 | |

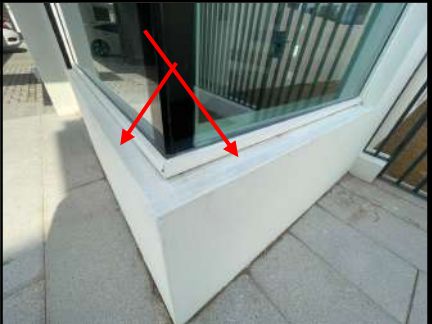
| Sl. No | Location | Category | Defect | Status | Level of Severity | Reference |
|---|---|---|---|---|---|---|
| 75 | Sidewalk | Civil | Ensure neat wall paint finishes | Open | 2 | |

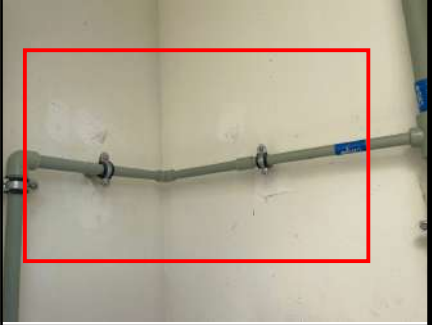
| Sl. No | Location | Category | Defect | Status | Level of Severity | Reference |
|---|---|---|---|---|---|---|
| 76 | Pump Room | Civil | Visible brush strokes and patches observed on the wall | Open | 3 | |

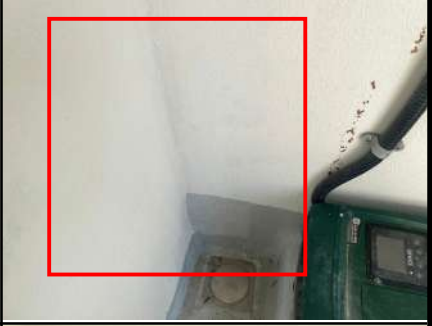
| Sl. No | Location | Category | Defect | Status | Level of Severity | Reference |
|---|---|---|---|---|---|---|
| 77 | Pump Room | Civil | Visible brush strokes and patches observed on the wall | Open | 3 | |

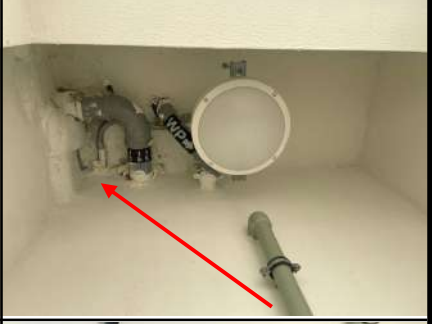
| Sl. No | Location | Category | Defect | Status | Level of Severity | Reference |
|---|---|---|---|---|---|---|
| 78 | Pump Room | Civil | Poor wall paint finishes observed on the ceiling | Open | 3 | |

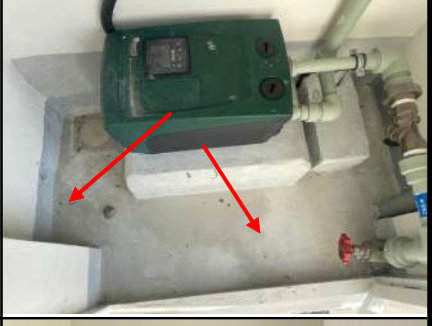
| Sl. No | Location | Category | Defect | Status | Level of Severity | Reference |
|---|---|---|---|---|---|---|
| 79 | Pump Room | Civil | Poor epoxy floor paint finishes observed to pump room flooring | Open | 3 | |

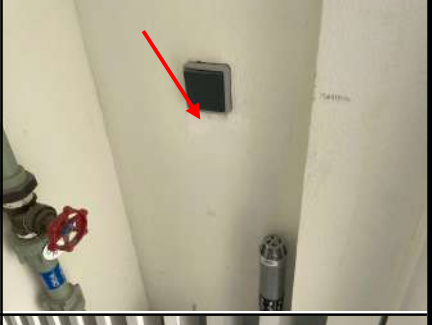
| Sl. No | Location | Category | Defect | Status | Level of Severity | Reference |
|---|---|---|---|---|---|---|
| 80 | Pump Room | Civil | Poor wall paint finishes observed near electrical installation | Open | 2 | |

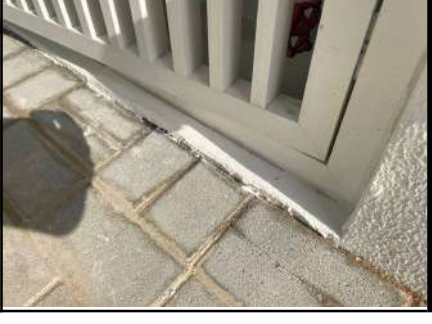
| Sl. No | Location | Category | Defect | Status | Level of Severity | Reference |
|---|---|---|---|---|---|---|
| 81 | Pump Room | Civil | Poor paint finishes noted to floor near the pump room gate | Open | 2 | |

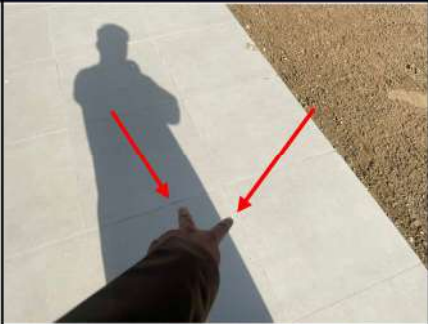
| Sl. No | Location | Category | Defect | Status | Level of Severity | Reference |
|---|---|---|---|---|---|---|
| 82 | Backyard | Civil | Stepping noted to flooring tiles in the backyard | Open | 2 | |

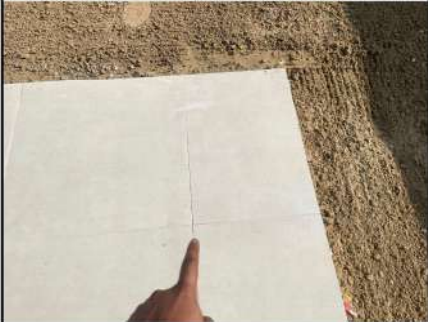
| Sl. No | Location | Category | Defect | Status | Level of Severity | Reference |
|---|---|---|---|---|---|---|
| 83 | Backyard | Civil | Improper grouting observed to floor tiles in the backyard | Open | 2 | |

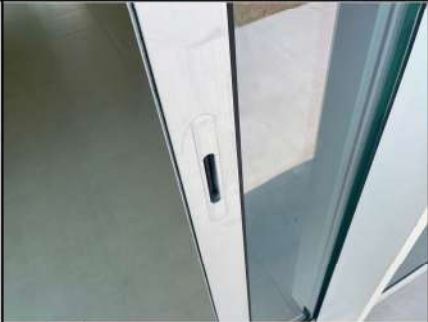
| Sl. No | Location | Category | Defect | Status | Level of Severity | Reference |
|---|---|---|---|---|---|---|
| 84 | Backyard | Civil | Minor stains noted to sliding door frame | Open | 2 | |

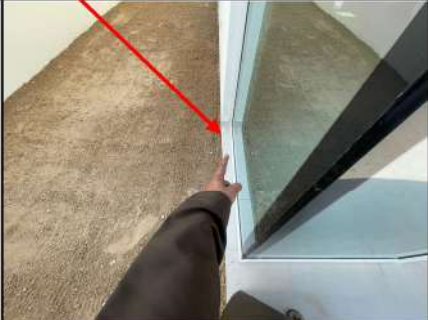
| Sl. No | Location | Category | Defect | Status | Level of Severity | Reference |
|---|---|---|---|---|---|---|
| 85 | Backyard | Civil | Poor wall paint finishes observed in the window sill | Open | 2 | |

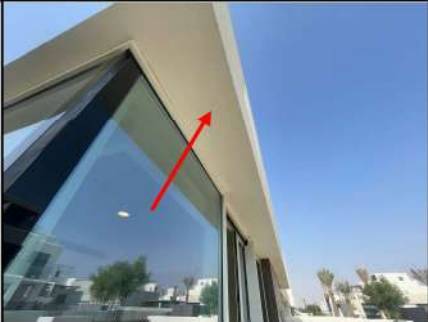
| Sl. No | Location | Category | Defect | Status | Level of Severity | Reference |
|---|---|---|---|---|---|---|
| 86 | Backyard | Civil | Poor paint finishes noted to soffit slab | Open | 2 | |

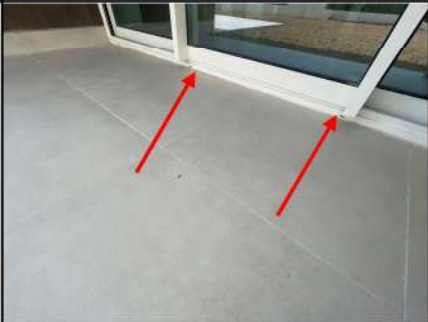
| Sl. No | Location | Category | Defect | Status | Level of Severity | Reference |
|---|---|---|---|---|---|---|
| 87 | Backyard | Civil | Missing weephole covers observed to aluminum window frame | Open | 2 | |

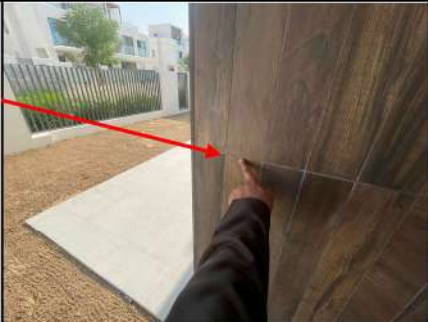
| Sl. No | Location | Category | Defect | Status | Level of Severity | Reference |
|---|---|---|---|---|---|---|
| 88 | Backyard | Civil | Missing grout detailing noted to wall tiles | Open | 2 | |

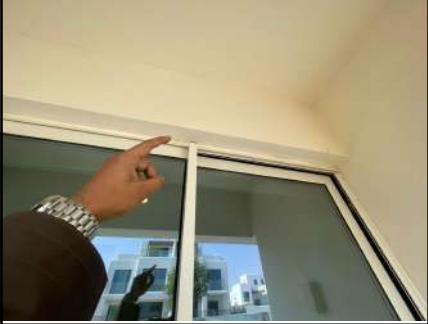
| Sl. No | Location | Category | Defect | Status | Level of Severity | Reference |
|---|---|---|---|---|---|---|
| 89 | Backyard | Civil | Poor wall paint finishes to window sill | Open | 2 | |

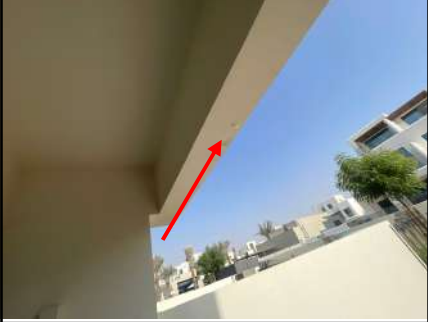
| Sl. No | Location | Category | Defect | Status | Level of Severity | Reference |
|---|---|---|---|---|---|---|
| 90 | Backyard | Civil | Visible stains noted to soffit | Open | 2 | |

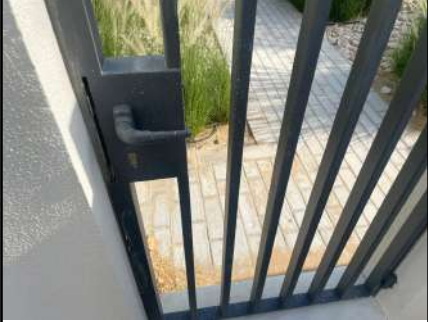
| Sl. No | Location | Category | Defect | Status | Level of Severity | Reference |
|---|---|---|---|---|---|---|
| 91 | Backyard | Civil | Visible paint splatter observed on backyard gate | Open | 2 | |

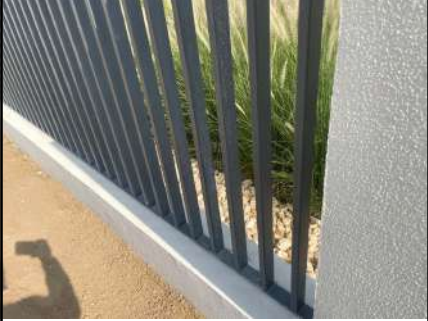
| Sl. No | Location | Category | Defect | Status | Level of Severity | Reference |
|---|---|---|---|---|---|---|
| 92 | Backyard | Civil | Visible paint stains observed on the backyard aluminum works | Open | 2 | |

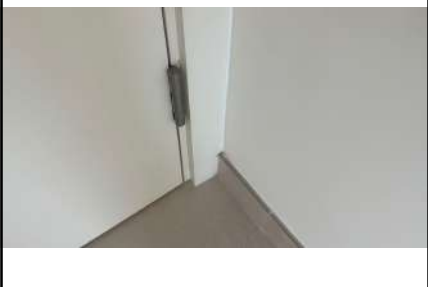
| Sl. No | Location | Category | Defect | Status | Level of Severity | Reference |
|---|---|---|---|---|---|---|
| 93 | First Floor Master Bedroom | Civil | Improper grout application observed on skirting tile to architrave | Open | 2 | |

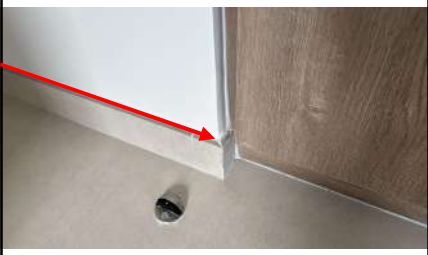
| Sl. No | Location | Category | Defect | Status | Level of Severity | Reference |
|---|---|---|---|---|---|---|
| 94 | First Floor Master Bedroom | Civil | Chipped skirting tile corner | Open | 2 | |

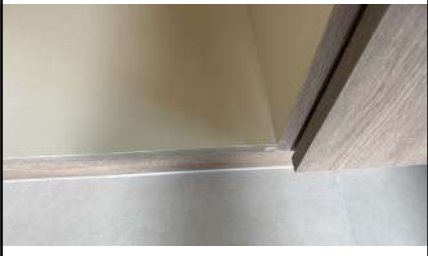
| Sl. No | Location | Category | Defect | Status | Level of Severity | Reference |
|---|---|---|---|---|---|---|
| 95 | First Floor Master Bedroom | Civil | Chipped panel noted inside the wardrobe | Open | 2 | |

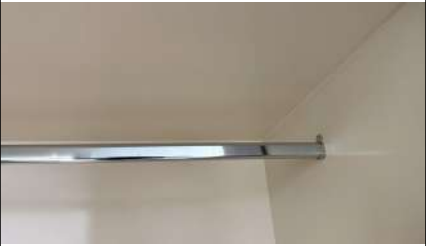
| Sl. No | Location | Category | Defect | Status | Level of Severity | Reference |
|---|---|---|---|---|---|---|
| 96 | First Floor Master Bedroom | Civil | Scratches on wardrobe hanging rod | Open | 2 | |

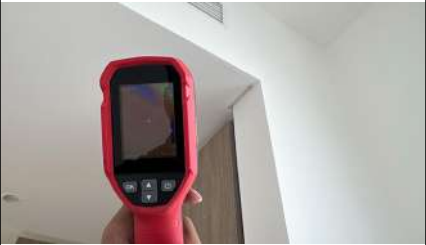
The thermal imaging inspection revealed **moisture intrusion** and temperature anomalies in several locations, particularly in the **laundry room, master bedroom ceiling, and powder room ceiling**. These findings indicate possible water ingress from concealed plumbing or roof membrane defects. Moisture-related issues, if unaddressed, can lead to long-term deterioration, mold formation, and electrical hazards.

| Sl. No | Location | Category | Defect | Status | Level of Severity | Reference |
|---|---|---|---|---|---|---|
| 97 | First Floor Master Bedroom | Civil | Thermal imaging indicates the signs of water ingress on ceiling | Open | 4 | |

1. **Moisture intrusion and waterproofing repairs** in ceilings and wet areas.
2. **Rectification of electrical safety hazards** and re-testing of all sockets, switches, and intercom units.
3. **Reworking of tile installations** showing hollow sounds, uneven levels, or chipped edges.
4. **Reapplication of sealants and grouting** throughout skirting, frames, and sanitary fittings.
5. **Repainting and surface refinishing** to correct visible inconsistencies, stains, and poor detailing.
6. **Fire safety compliance** through proper mounting of firefighting equipment.
7. **Comprehensive cleaning, pest control, and final detailing** before reinspection.

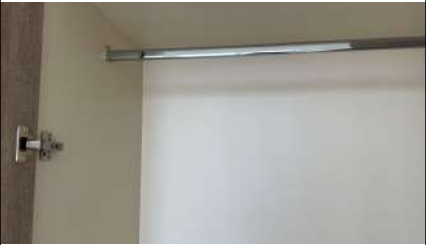
| Sl. No | Location | Category | Defect | Status | Level of Severity | Reference |
|---|---|---|---|---|---|---|
| 98 | First Floor Master Bedroom | Civil | Stains noted on panel inside the wardrobe | Open | 2 | |

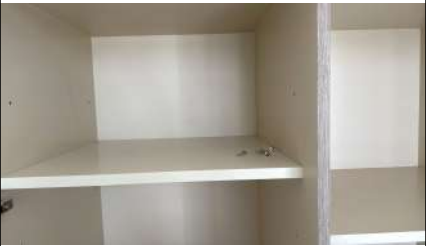
| Sl. No | Location | Category | Defect | Status | Level of Severity | Reference |
|---|---|---|---|---|---|---|
| 99 | First Floor Master Bedroom | Civil | Remove all the unwanted screws which is stored inside the wardrobe | Open | 1 | |

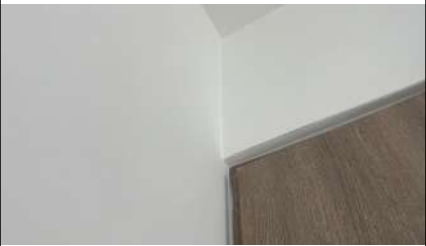
| Sl. No | Location | Category | Defect | Status | Level of Severity | Reference |
|---|---|---|---|---|---|---|
| 100 | First Floor Master Bedroom | Civil | Hairline crack spotted on wall surface | Open | 2 | |

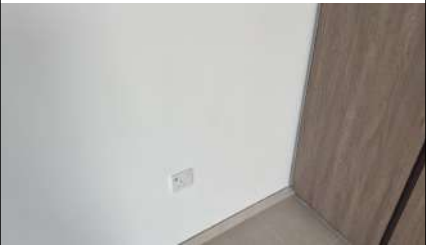
| Sl. No | Location | Category | Defect | Status | Level of Severity | Reference |
|---|---|---|---|---|---|---|
| 101 | First Floor Master Bedroom | Civil | Paint variation noticed on wall surface | Open | 2 | |

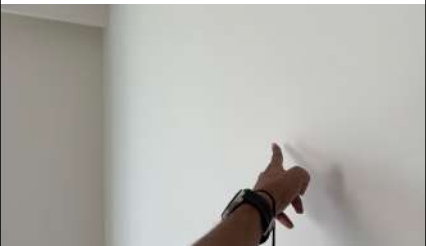
| Sl. No | Location | Category | Defect | Status | Level of Severity | Reference |
|---|---|---|---|---|---|---|
| 102 | First Floor Master Bedroom | Civil | Hairline crack spotted on wall surface | Open | 2 | |

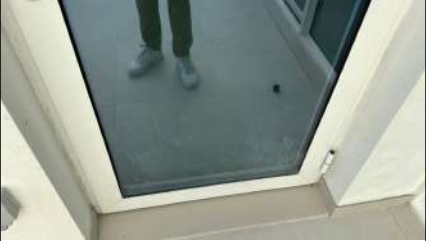
| Sl. No | Location | Category | Defect | Status | Level of Severity | Reference |
|---|---|---|---|---|---|---|
| 104 | First Floor Master Bedroom (Balcony) | Civil | Dirt and scratches on balcony door glazing | Open | 2 | |

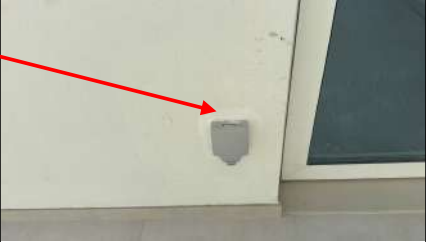
| Sl. No | Location | Category | Defect | Status | Level of Severity | Reference |
|---|---|---|---|---|---|---|
| 105 | First Floor Master Bedroom (Balcony) | Civil | Paint variation noticed on wall surface | Open | 3 | |

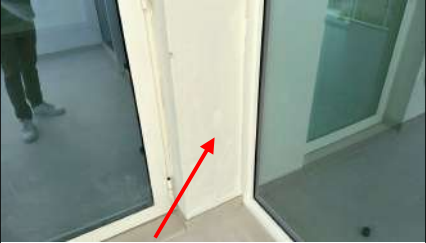
| Sl. No | Location | Category | Defect | Status | Level of Severity | Reference |
|---|---|---|---|---|---|---|
| 106 | First Floor Master Bedroom (Balcony) | Civil | Paint variation noticed on wall surface | Open | 3 | |

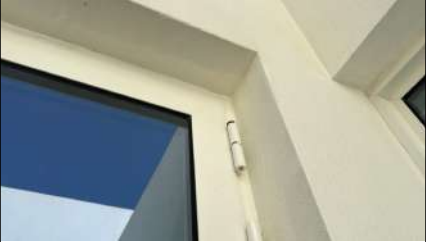
| Sl. No | Location | Category | Defect | Status | Level of Severity | Reference |
|---|---|---|---|---|---|---|
| 107 | First Floor Master Bedroom (Balcony) | Civil | Loose fixation of balcony door hinge cap cover | Open | 2 | |

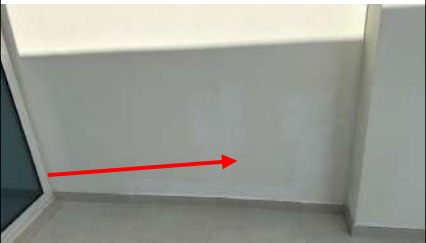
| Sl. No | Location | Category | Defect | Status | Level of Severity | Reference |
|---|---|---|---|---|---|---|
| 109 | First Floor Master Bedroom (Balcony) | Civil | Paint variation noticed on wall surface | Open | 3 | |

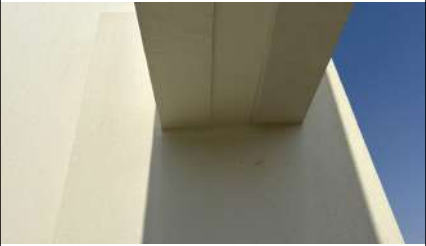
| Sl. No | Location | Category | Defect | Status | Level of Severity | Reference |
|---|---|---|---|---|---|---|
| 110 | First Floor Master Bedroom (Balcony) | Civil | Paint variation noticed on wall surface | Open | 3 | |

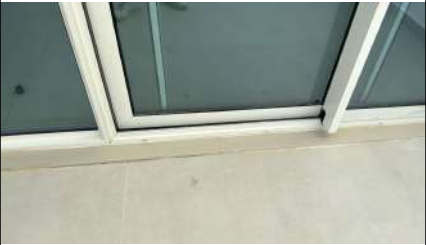
| Sl. No | Location | Category | Defect | Status | Level of Severity | Reference |
|---|---|---|---|---|---|---|
| 111 | First Floor Master Bedroom (Balcony) | Civil | Missing sliding door weep hole covers | Open | 2 | |

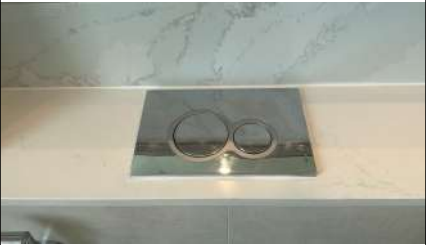
| Sl. No | Location | Category | Defect | Status | Level of Severity | Reference |
|---|---|---|---|---|---|---|
| 112 | First Floor Master Bedroom (Bathroom) | Plumbing | Scratches on commode flush tap surface | Open | 2 | |

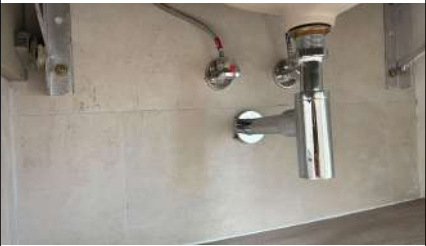
| Sl. No | Location | Category | Defect | Status | Level of Severity | Reference |
|---|---|---|---|---|---|---|
| 113 | First Floor Master Bedroom (Bathroom) | Civil | Damaged wall tile noted around the vanity sink drain pipe termination | Open | 2 | |

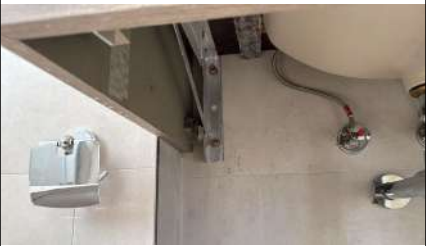
| Sl. No | Location | Category | Defect | Status | Level of Severity | Reference |
|---|---|---|---|---|---|---|
| 114 | First Floor Master Bedroom (Bathroom) | Civil | Remove all the wooden pieces near to vanity cabinet clamps | Open | 2 | |
