URBANGRID REAL ESTATE CONSULTANCIES

# HOME CONDITION AUDIT REPORT (SNAGGING)

**Mr. Rizwan**  
V085, Talia The Valley By Emaar  
Al Ain Road, Dubai, U.A.E

21-October-2025

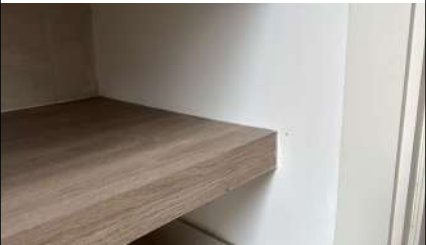
| Sl. No | Location | Category | Defect | Status | Level of Severity | Reference |
|---|---|---|---|---|---|---|
| 115 | First Floor Master Bedroom (Bathroom) | Civil | Chipped panel edge observed on vanity cabinet | Open | 2 | |

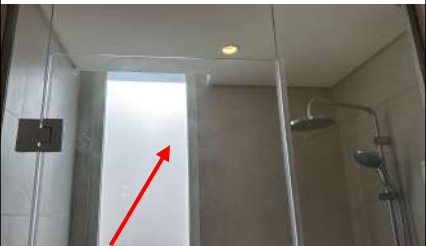
| Sl. No | Location | Category | Defect | Status | Level of Severity | Reference |
|---|---|---|---|---|---|---|
| 116 | First Floor Master Bedroom (Bathroom) | Civil | Scratches on shower partition glass surface | Open | 2 | |

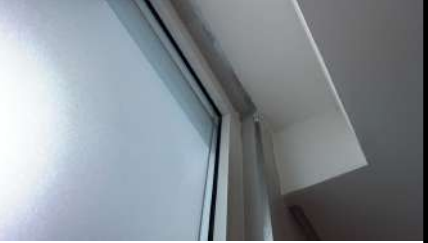
| Sl. No | Location | Category | Defect | Status | Level of Severity | Reference |
|---|---|---|---|---|---|---|
| 117 | First Floor Master Bedroom (Bathroom) | Civil | Paint overrun to wall tile | Open | 2 | |

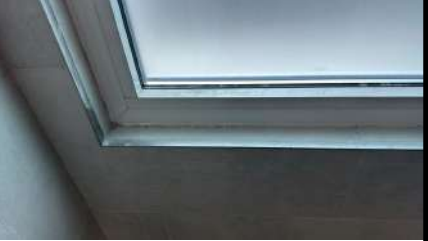
| Sl. No | Location | Category | Defect | Status | Level of Severity | Reference |
|---|---|---|---|---|---|---|
| 118 | First Floor Master Bedroom (Bathroom) | Civil | Poor quality finishing observed on sealant application around the fixed glass frame | Open | 2 | |

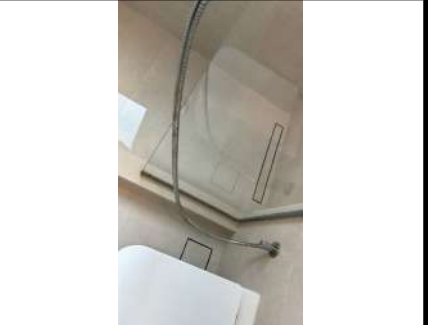
| Sl. No | Location | Category | Defect | Status | Level of Severity | Reference |
|---|---|---|---|---|---|---|
| 119 | First Floor Master Bedroom (Bathroom) | Plumbing | Rusted bidet spray flexible hose connection wire | Open | 2 | |

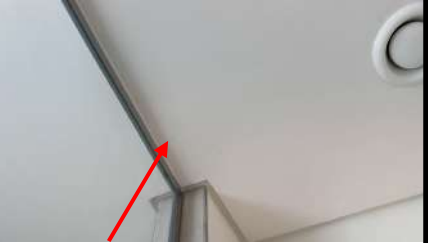
| Sl. No | Location | Category | Defect | Status | Level of Severity | Reference |
|---|---|---|---|---|---|---|
| 120 | First Floor Master Bedroom (Bathroom) | Civil | Water leakage stains spotted on ceiling surface | Open | 4 | |

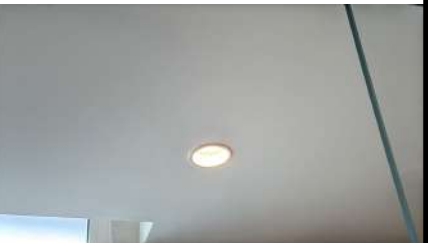
| Sl. No | Location | Category | Defect | Status | Level of Severity | Reference |
|---|---|---|---|---|---|---|
| 121 | First Floor Master Bedroom (Bathroom) | Electrical | Visible gaps were noted around the ceiling spotlights | Open | 2 | |

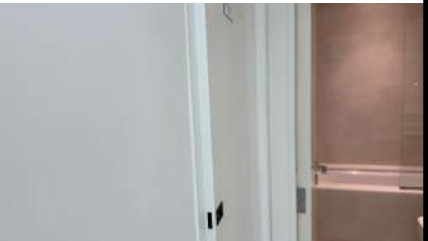
| Sl. No | Location | Category | Defect | Status | Level of Severity | Reference |
|---|---|---|---|---|---|---|
| 122 | Passage | Civil | Cracks were observed around the distribution board panel | Open | 2 | |

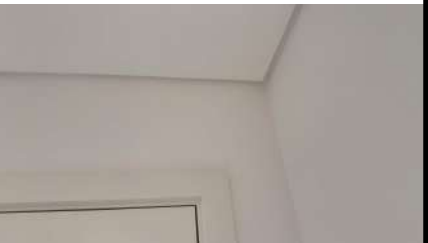
| Sl. No | Location | Category | Defect | Status | Level of Severity | Reference |
|---|---|---|---|---|---|---|
| 123 | First Floor Powder Room | Civil | Stains noted on wall surface | Open | 2 | |

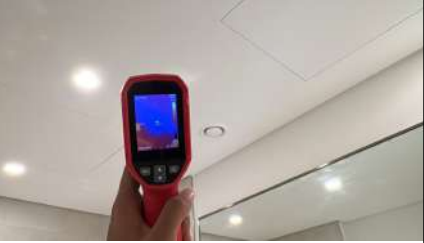
| Sl. No | Location | Category | Defect | Status | Level of Severity | Reference |
|---|---|---|---|---|---|---|
| 124 | First Floor Powder Room | Civil | Thermal imaging indicates the signs of water ingress on ceiling | Open | 4 | |

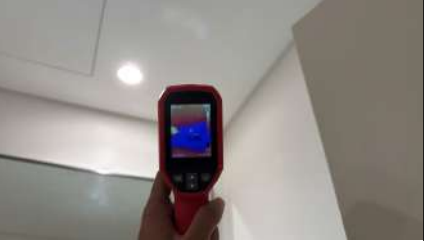
| Sl. No | Location | Category | Defect | Status | Level of Severity | Reference |
|---|---|---|---|---|---|---|
| 125 | First Floor Powder Room | Civil | Thermal imaging indicates the signs of water ingress on ceiling | Open | 4 | |

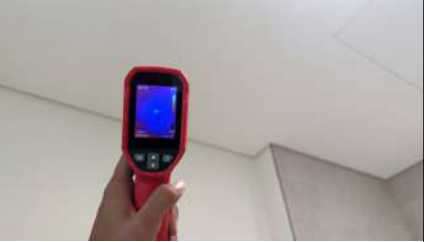
| Sl. No | Location | Category | Defect | Status | Level of Severity | Reference |
|---|---|---|---|---|---|---|
| 126 | First Floor Powder Room | Civil | Thermal imaging indicates the signs of water ingress on ceiling | Open | 4 | |

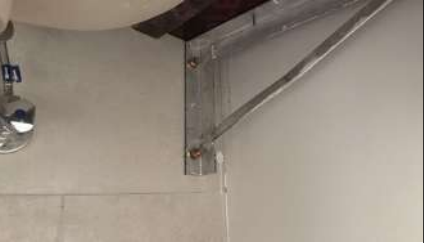
| Sl. No | Location | Category | Defect | Status | Level of Severity | Reference |
|---|---|---|---|---|---|---|
| 127 | First Floor Powder Room | Civil | Damaged paint on wall and paint paint overrun to wall tile noted on vanity cabinet | Open | 2 | |

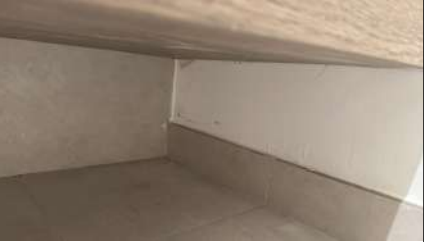
| Sl. No | Location | Category | Defect | Status | Level of Severity | Reference |
|---|---|---|---|---|---|---|
| 128 | First Floor Powder Room | Civil | Stains on wall noted below the vanity cabinet | Open | 2 | |

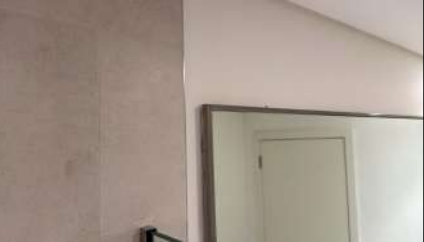
| Sl. No | Location | Category | Defect | Status | Level of Severity | Reference |
|---|---|---|---|---|---|---|
| 129 | First Floor Powder Room | Civil | Damaged plastering observed on wall around the vanity mirror | Open | 2 | |

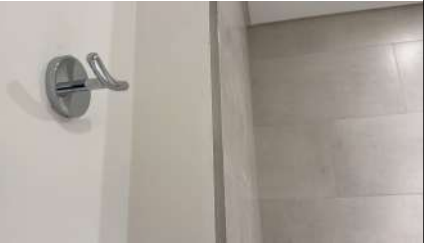
| Sl. No | Location | Category | Defect | Status | Level of Severity | Reference |
|---|---|---|---|---|---|---|
| 130 | First Floor Powder Room | Civil | Chipped wall termination | Open | 2 | |

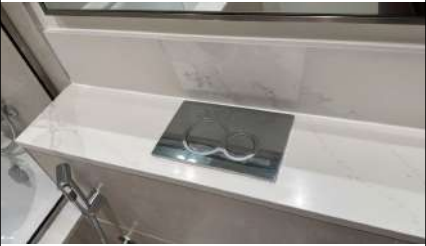
| Sl. No | Location | Category | Defect | Status | Level of Severity | Reference |
|---|---|---|---|---|---|---|
| 131 | First Floor Powder Room | Plumbing | Loose installation of commode flush tap | Open | 2 | |

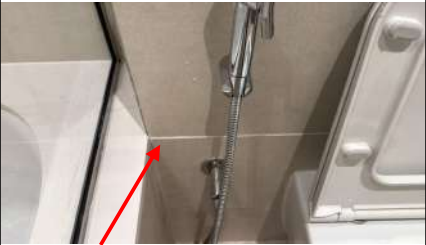
| Sl. No | Location | Category | Defect | Status | Level of Severity | Reference |
|---|---|---|---|---|---|---|
| 132 | First Floor Powder Room | Civil | Stepping spotted on wall tile | Open | 2 | |

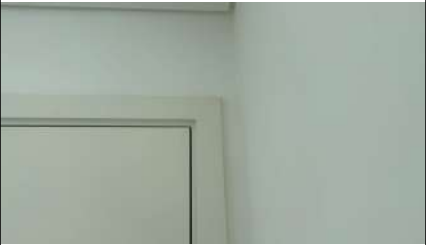
| Sl. No | Location | Category | Defect | Status | Level of Severity | Reference |
|---|---|---|---|---|---|---|
| 133 | First Floor Bedroom 1 | Civil | Crack noted around the architrave | Open | 2 | |

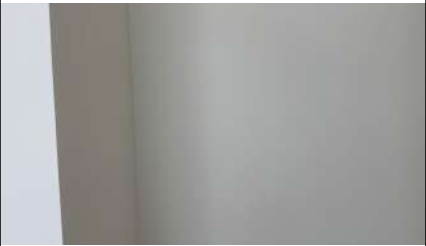
| Sl. No | Location | Category | Defect | Status | Level of Severity | Reference |
|---|---|---|---|---|---|---|
| 134 | First Floor Bedroom 1 | Civil | Scratch or stains on wall surface | Open | 2 | |

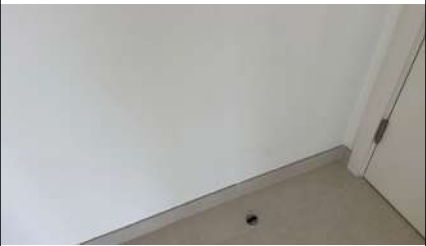
| Sl. No | Location | Category | Defect | Status | Level of Severity | Reference |
|---|---|---|---|---|---|---|
| 135 | First Floor Bedroom 1 | Civil | Paint variation noticed on wall surface | Open | 2 | |

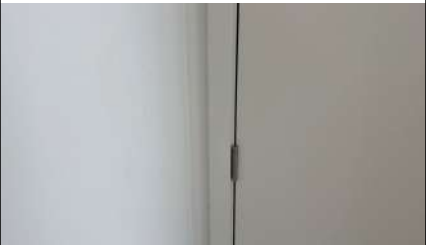
| Sl. No | Location | Category | Defect | Status | Level of Severity | Reference |
|---|---|---|---|---|---|---|
| 136 | First Floor Bedroom 1 | Civil | Paint variation noticed on wall surface and poor finishing noted around the architrave | Open | 2 | |

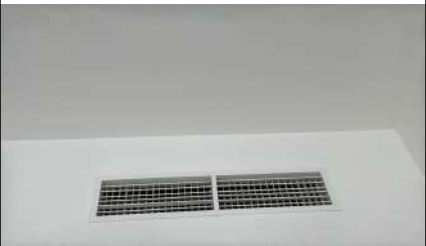
| Sl. No | Location | Category | Defect | Status | Level of Severity | Reference |
|---|---|---|---|---|---|---|
| 137 | First Floor Bedroom 1 | Civil | Hairline crack observed on wall surface | Open | 2 | |

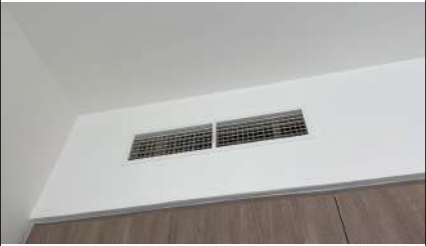
| Sl. No | Location | Category | Defect | Status | Level of Severity | Reference |
|---|---|---|---|---|---|---|
| 138 | First Floor Bedroom 1 | Mechanical | Dust build-up on AC unit | Open | 2 | |

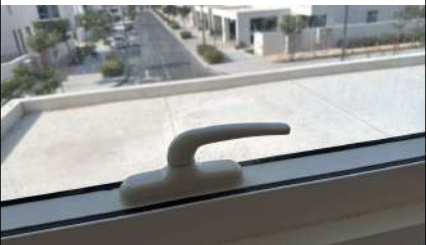
| Sl. No | Location | Category | Defect | Status | Level of Severity | Reference |
|---|---|---|---|---|---|---|
| 139 | First Floor Bedroom 1 | Civil | Minor paint coating damage on window handle | Open | 2 | |

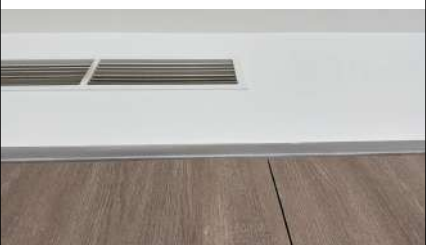
| Sl. No | Location | Category | Defect | Status | Level of Severity | Reference |
|---|---|---|---|---|---|---|
| 140 | First Floor Bedroom 1 | Civil | Chipped wall edge noted above the wardrobe | Open | 2 | |

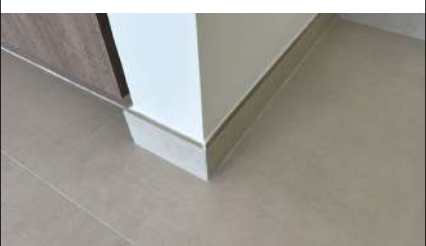
| Sl. No | Location | Category | Defect | Status | Level of Severity | Reference |
|---|---|---|---|---|---|---|
| 141 | First Floor Bedroom 1 | Civil | Chipped skirting tile corner | Open | 2 | |

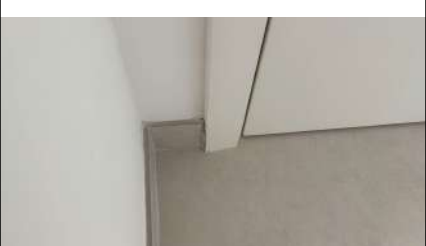
| Sl. No | Location | Category | Defect | Status | Level of Severity | Reference |
|---|---|---|---|---|---|---|
| 142 | First Floor Bedroom 2 | Civil | Improper grout application observed on skirting tile to architrave | Open | 2 | |

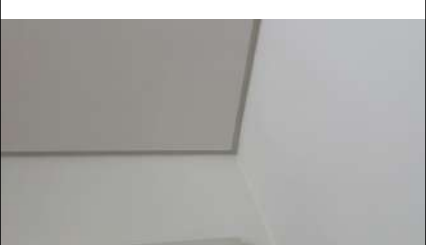
| Sl. No | Location | Category | Defect | Status | Level of Severity | Reference |
|---|---|---|---|---|---|---|
| 143 | First Floor Bedroom 2 | Civil | Crack observed on gypsum ceiling termination to wall | Open | 2 | |

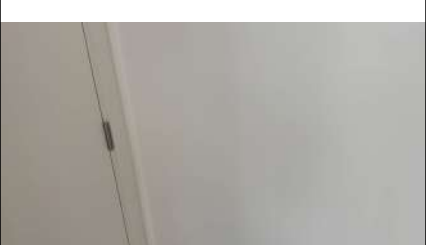
| Sl. No | Location | Category | Defect | Status | Level of Severity | Reference |
|---|---|---|---|---|---|---|
| 144 | First Floor Bedroom 2 | Civil | Scratch mark on wall surface | Open | 2 | |

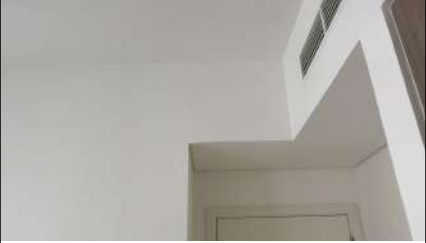
| Sl. No | Location | Category | Defect | Status | Level of Severity | Reference |
|---|---|---|---|---|---|---|
| 145 | First Floor Bedroom 2 | Civil | Undulation spotted on wall, possibly due to poor plastering finish | Open | 2 | |

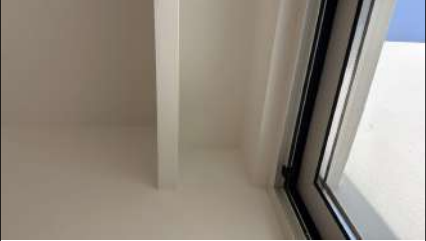
| Sl. No | Location | Category | Defect | Status | Level of Severity | Reference |
|---|---|---|---|---|---|---|
| 146 | First Floor Bedroom 2 | Civil | Paint variation noted on ceiling | Open | 2 | |

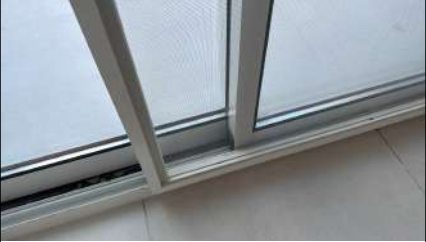
| Sl. No | Location | Category | Defect | Status | Level of Severity | Reference |
|---|---|---|---|---|---|---|
| 147 | First Floor Bedroom 2 | Civil | Damaged fly net | Open | 2 | |

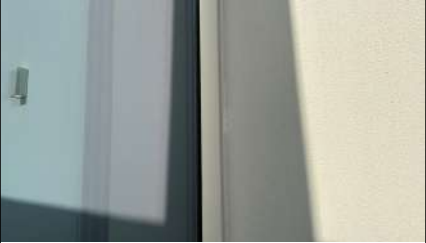
| Sl. No | Location | Category | Defect | Status | Level of Severity | Reference |
|---|---|---|---|---|---|---|
| 148 | First Floor Bedroom 2 (Balcony) | Civil | Paint variation noted on wall surface | Open | 2 | |

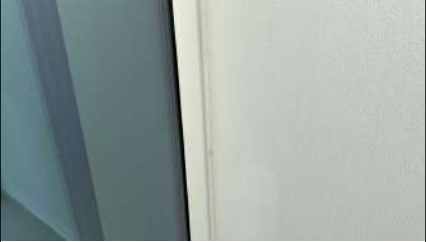
| Sl. No | Location | Category | Defect | Status | Level of Severity | Reference |
|---|---|---|---|---|---|---|
| 149 | First Floor Bedroom 2 (Balcony) | Civil | Paint variation and Improper paint application on wall termination | Open | 2 | |

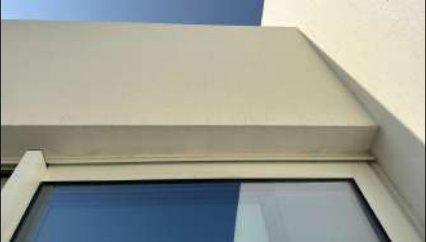
| Sl. No | Location | Category | Defect | Status | Level of Severity | Reference |
|---|---|---|---|---|---|---|
| 150 | First Floor Bedroom 2 (Balcony) | Civil | Paint variation noted on wall surface above sliding frame | Open | 2 | |

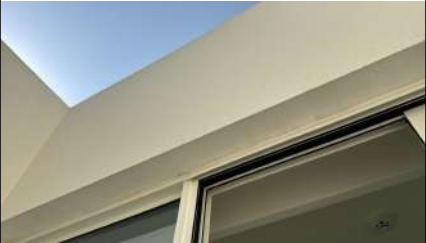
| Sl. No | Location | Category | Defect | Status | Level of Severity | Reference |
|---|---|---|---|---|---|---|
| 151 | First Floor Bedroom 2 (Balcony) | Civil | Paint variation noted on wall surface above sliding frame | Open | 2 | |

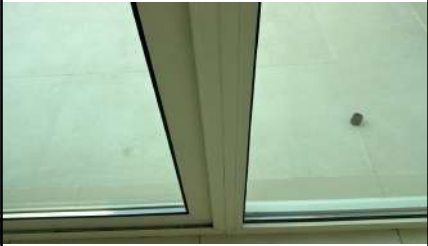
| Sl. No | Location | Category | Defect | Status | Level of Severity | Reference |
|---|---|---|---|---|---|---|
| 152 | First Floor Bedroom 2 (Balcony) | Civil | Improper sealing noted on sliding frame | Open | 2 | |

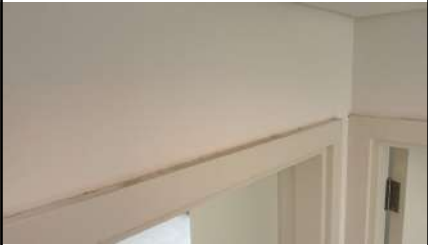
| Sl. No | Location | Category | Defect | Status | Level of Severity | Reference |
|---|---|---|---|---|---|---|
| 153 | First Floor Bedroom 2 | Civil | Poor sealant application noted around the architrave | Open | 2 | |

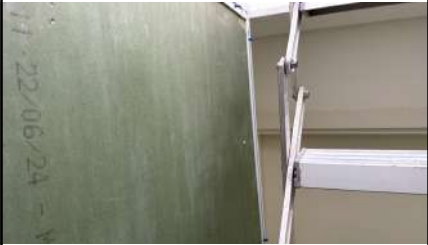
| Sl. No | Location | Category | Defect | Status | Level of Severity | Reference |
|---|---|---|---|---|---|---|
| 154 | Roof | Civil | Chipped gypsum roof hatch | Open | 2 | |

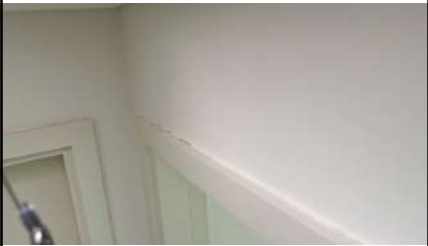
| Sl. No | Location | Category | Defect | Status | Level of Severity | Reference |
|---|---|---|---|---|---|---|
| 155 | First Floor Bedroom 1 | Civil | Poor sealant application noted around the architrave | Open | 2 | |

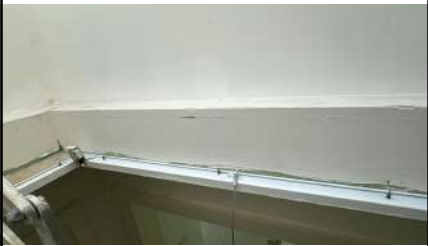
| Sl. No | Location | Category | Defect | Status | Level of Severity | Reference |
|---|---|---|---|---|---|---|
| 156 | Roof | Civil | Crack and improper paint application on roof hatch | Open | 2 | |

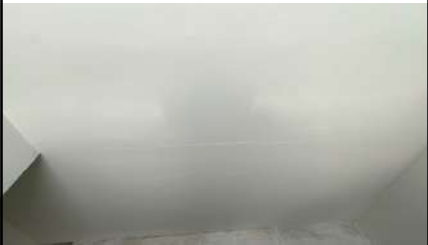
| Sl. No | Location | Category | Defect | Status | Level of Severity | Reference |
|---|---|---|---|---|---|---|
| 157 | Roof | Civil | Crack noticed on roof hatch | Open | 2 | |

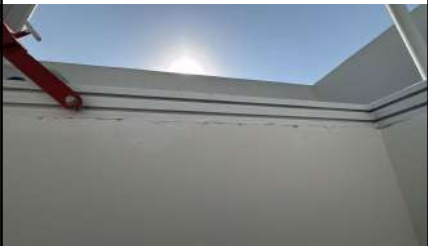
| Sl. No | Location | Category | Defect | Status | Level of Severity | Reference |
|---|---|---|---|---|---|---|
| 158 | Roof | Civil | Crack and improper finishing on roof hatch | Open | 2 | |

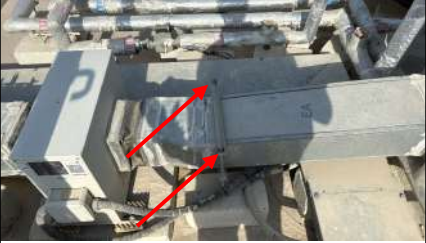
| Sl. No | Location | Category | Defect | Status | Level of Severity | Reference |
|---|---|---|---|---|---|---|
| 159 | Roof | Mechanical | Rusted screws noted | Open | 2 | |

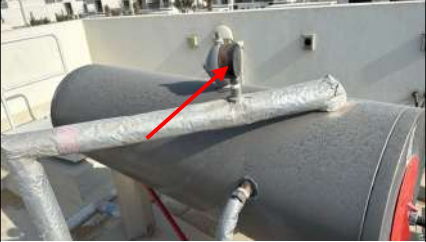
| Sl. No | Location | Category | Defect | Status | Level of Severity | Reference |
|---|---|---|---|---|---|---|
| 161 | Roof | Mechanical | Rust formation spotted on solar panel gauge | Open | 4 | |

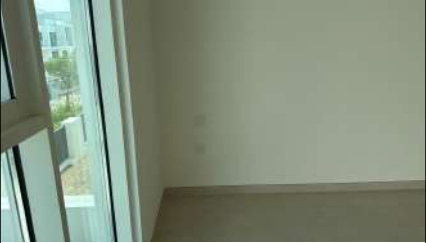
| Sl. No | Location | Category | Defect | Status | Level of Severity | Reference |
|---|---|---|---|---|---|---|
| 162 | First Floor Master Bedroom | Electrical | Misaligned switch board installation | Open | 2 | |

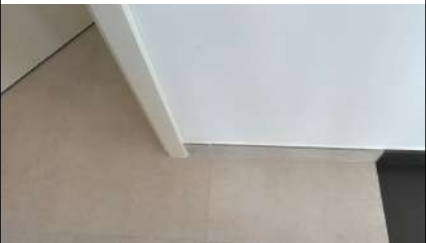
| Sl. No | Location | Category | Defect | Status | Level of Severity | Reference |
|---|---|---|---|---|---|---|
| 163 | Staircase | Civil | Misaligned skirting tile installation | Open | 2 | |

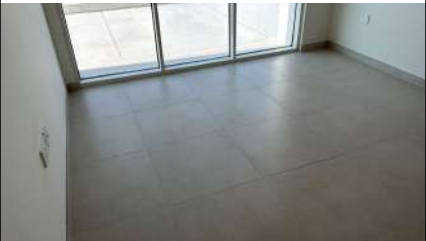
| Sl. No | Location | Category | Defect | Status | Level of Severity | Reference |
|---|---|---|---|---|---|---|
| 164 | First Floor Bedroom 1 | Civil | Stepping noted on almost all floor tile | Open | 2 | |

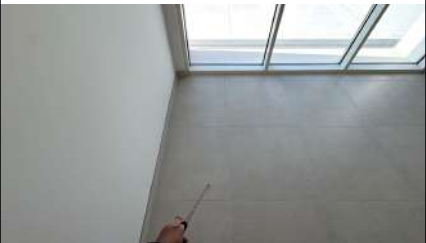
| Sl. No | Location | Category | Defect | Status | Level of Severity | Reference |
|---|---|---|---|---|---|---|
| 165 | First Floor Bedroom 1 | Civil | Hollow sound detected on floor tile | Open | 2 | |

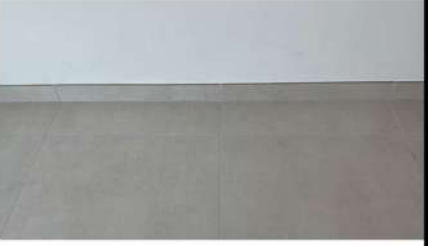
| Sl. No | Location | Category | Defect | Status | Level of Severity | Reference |
|---|---|---|---|---|---|---|
| 166 | First Floor Bedroom 1 | Civil | Chipped floor tile | Open | 2 | |

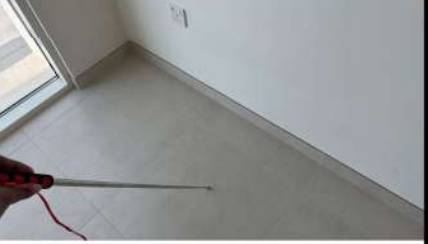
| Sl. No | Location | Category | Defect | Status | Level of Severity | Reference |
|---|---|---|---|---|---|---|
| 167 | First Floor Bedroom 1 | Civil | Hollow sound detected on floor tile | Open | 2 | |

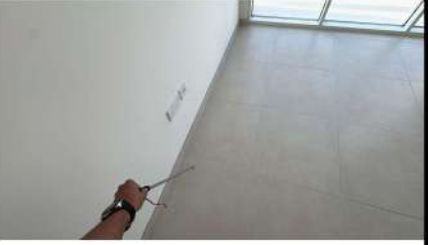
| Sl. No | Location | Category | Defect | Status | Level of Severity | Reference |
|---|---|---|---|---|---|---|
| 168 | First Floor Bedroom 1 | Civil | Hollow sound detected on floor tile | Open | 2 | |

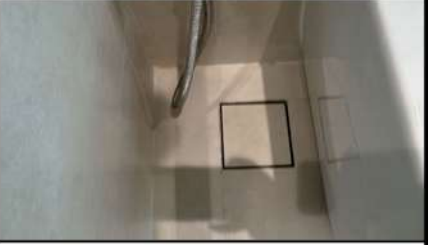
| Sl. No | Location | Category | Defect | Status | Level of Severity | Reference |
|---|---|---|---|---|---|---|
| 169 | First Floor Powder Room | Civil | Chipped floor tile around the floor drain | Open | 2 | |

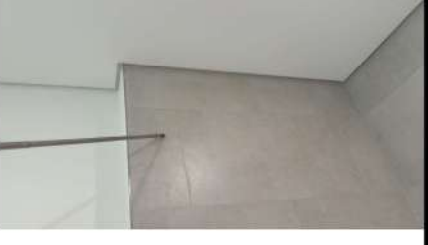
| Sl. No | Location | Category | Defect | Status | Level of Severity | Reference |
|---|---|---|---|---|---|---|
| 170 | First Floor Powder Room | Civil | hollow sound detected on wall tile | Open | 2 | |

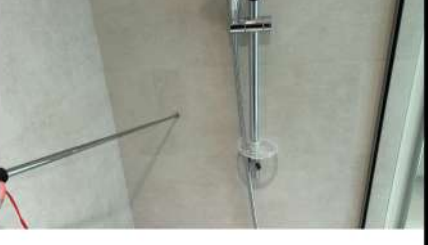
| Sl. No | Location | Category | Defect | Status | Level of Severity | Reference |
|---|---|---|---|---|---|---|
| 171 | First Floor Powder Room | Civil | hollow sound detected on wall tile | Open | 2 | |

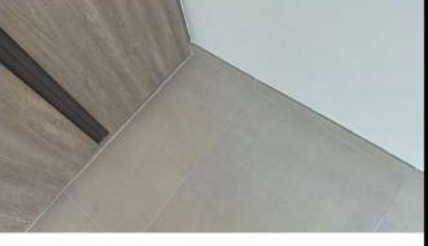
| Sl. No | Location | Category | Defect | Status | Level of Severity | Reference |
|---|---|---|---|---|---|---|
| 172 | First Floor Bedroom 2 | Civil | Insufficient epoxy application noted on floor tile | Open | 2 | |

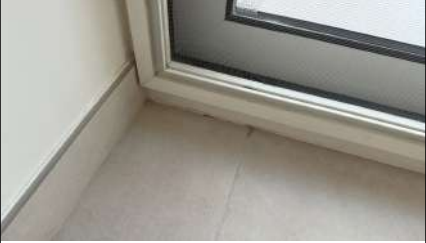
| Sl. No | Location | Category | Defect | Status | Level of Severity | Reference |
|---|---|---|---|---|---|---|
| 173 | First Floor Bedroom 2 | Civil | Chipped floor tile and inmproper sealing noted on floor tile to sliding frame | Open | 2 | |

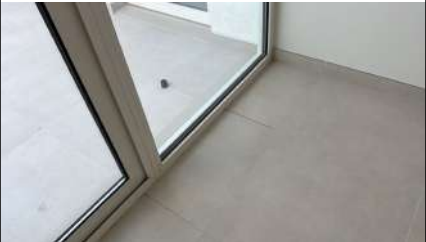
| Sl. No | Location | Category | Defect | Status | Level of Severity | Reference |
|---|---|---|---|---|---|---|
| 174 | First Floor Bedroom 2 | Civil | Stepping noted on floor tile | Open | 2 | |

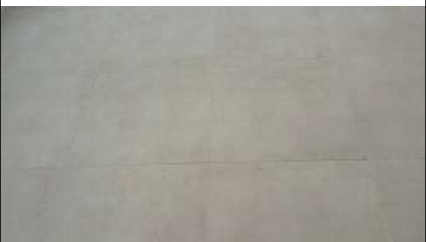
| Sl. No | Location | Category | Defect | Status | Level of Severity | Reference |
|---|---|---|---|---|---|---|
| 175 | First Floor Bedroom 2 | Civil | Chipped floor tile | Open | 2 | |

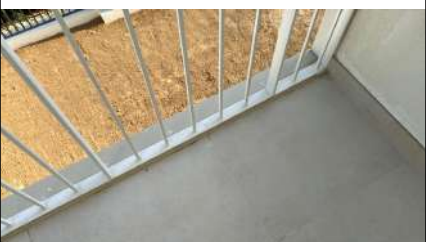
| Sl. No | Location | Category | Defect | Status | Level of Severity | Reference |
|---|---|---|---|---|---|---|
| 176 | First Floor Bedroom 2 (Balcony) | Civil | Damaged floor tile | Open | 2 | |

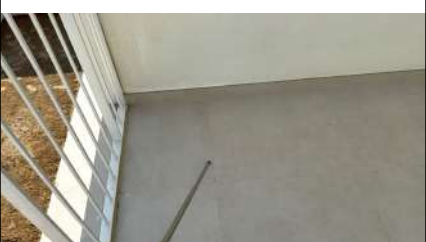
| Sl. No | Location | Category | Defect | Status | Level of Severity | Reference |
|---|---|---|---|---|---|---|
| 177 | First Floor Bedroom 2 (Balcony) | Civil | Stepping noted on floor tile | Open | 2 | |

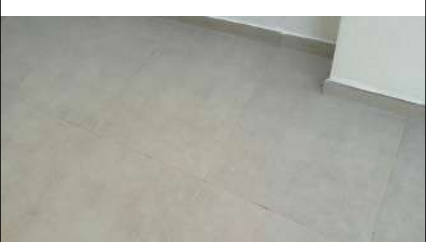
| Sl. No | Location | Category | Defect | Status | Level of Severity | Reference |
|---|---|---|---|---|---|---|
| 178 | First Floor Bedroom 2 | Civil | Insufficient epoxy application noted on floor tile | Open | 2 | |

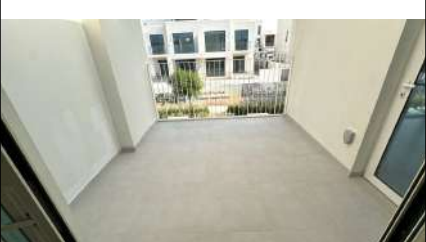
| Sl. No | Location | Category | Defect | Status | Level of Severity | Reference |
|---|---|---|---|---|---|---|
| 179 | First Floor Bedroom 2 (Balcony) | Civil | Hollow sound detected on all floor tiles | Open | 2 | |

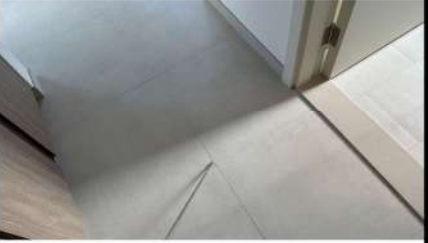
| Sl. No | Location | Category | Defect | Status | Level of Severity | Reference |
|---|---|---|---|---|---|---|
| 180 | First Floor Bedroom 2 | Civil | Stepping noted on floor tile | Open | 2 | |

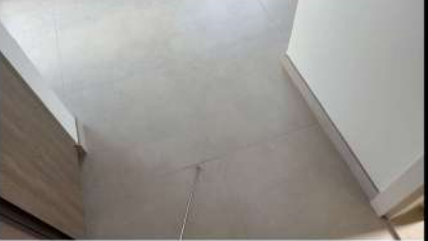
| Sl. No | Location | Category | Defect | Status | Level of Severity | Reference |
|---|---|---|---|---|---|---|
| 181 | First Floor Bedroom 2 | Civil | Stepping noted on floor tile | Open | 2 | |

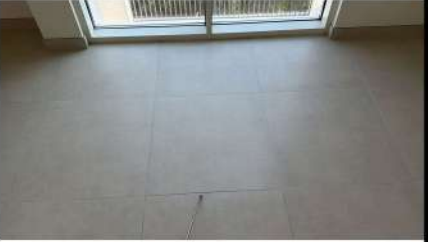
| Sl. No | Location | Category | Defect | Status | Level of Severity | Reference |
|---|---|---|---|---|---|---|
| 182 | First Floor Bedroom 2 | Civil | Stepping noted on floor tile | Open | 2 | |

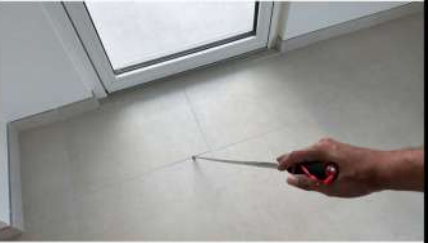
| Sl. No | Location | Category | Defect | Status | Level of Severity | Reference |
|---|---|---|---|---|---|---|
| 183 | First Floor Bedroom 2 | Civil | Stepping noted on floor tile | Open | 2 | |

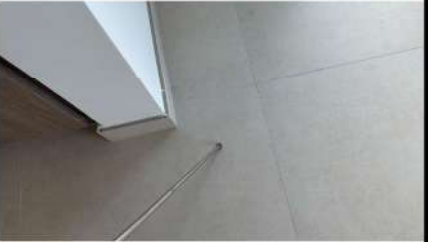
| Sl. No | Location | Category | Defect | Status | Level of Severity | Reference |
|---|---|---|---|---|---|---|
| 184 | First Floor Bedroom 2 | Civil | Chipped floor tile | Open | 2 | |

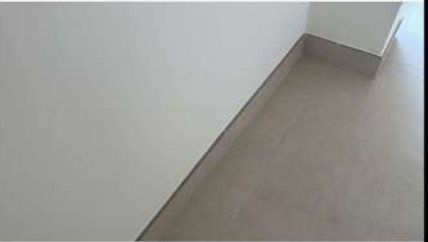
| Sl. No | Location | Category | Defect | Status | Level of Severity | Reference |
|---|---|---|---|---|---|---|
| 185 | First Floor Bedroom 2 | Civil | Rust formation noticed on skirting tile steel frame | Open | 2 | |

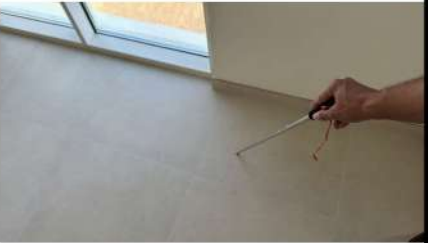
| Sl. No | Location | Category | Defect | Status | Level of Severity | Reference |
|---|---|---|---|---|---|---|
| 186 | First Floor Bedroom 2 | Civil | Hollow sound detected on floor tile | Open | 2 | |

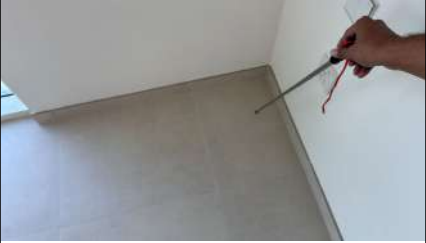
| Sl. No | Location | Category | Defect | Status | Level of Severity | Reference |
|---|---|---|---|---|---|---|
| 187 | First Floor Master Bedroom | Civil | Hollow sound detected on floor tile | Open | 2 | |

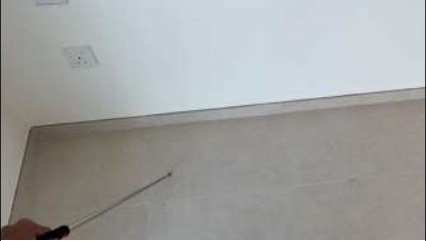
| Sl. No | Location | Category | Defect | Status | Level of Severity | Reference |
|---|---|---|---|---|---|---|
| 188 | First Floor Master Bedroom | Civil | Hollow sound detected on floor tile | Open | 2 | |

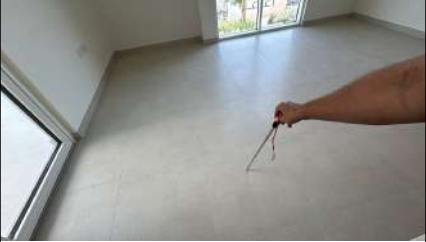
| Sl. No | Location | Category | Defect | Status | Level of Severity | Reference |
|---|---|---|---|---|---|---|
| 189 | First Floor Master Bedroom | Civil | Hollow sound detected on floor tile | Open | 2 | |

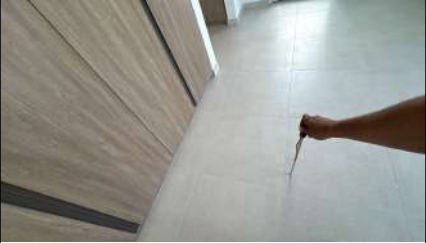
| Sl. No | Location | Category | Defect | Status | Level of Severity | Reference |
|---|---|---|---|---|---|---|
| 190 | First Floor Master Bedroom | Civil | Hollow sound detected on floor tile | Open | 2 | |

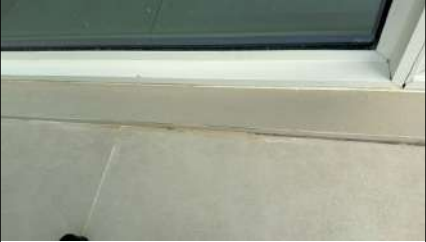
| Sl. No | Location | Category | Defect | Status | Level of Severity | Reference |
|---|---|---|---|---|---|---|
| 191 | First Floor Master Bedroom (Balcony) | Civil | Improper sealing noted on floor tile to skirting tile | Open | 2 | |

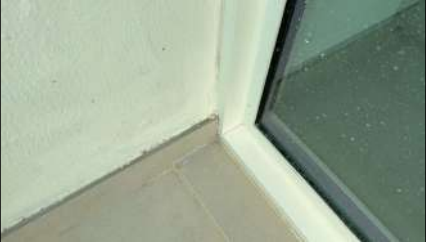
| Sl. No | Location | Category | Defect | Status | Level of Severity | Reference |
|---|---|---|---|---|---|---|
| 192 | First Floor Master Bedroom (Balcony) | Civil | Paint variation noted on wall surface | Open | 2 | |

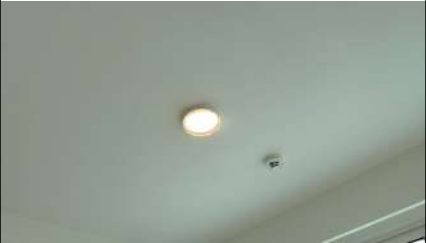
| Sl. No | Location | Category | Defect | Status | Level of Severity | Reference |
|---|---|---|---|---|---|---|
| 193 | First Floor Bedroom 2 | Electrical | Remove all the plaster application noted on ceiling light | Open | 2 | |

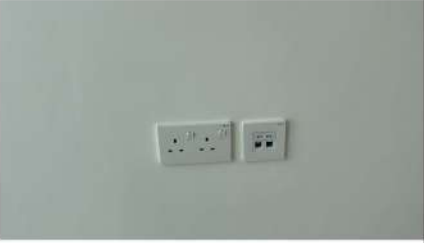
| Sl. No | Location | Category | Defect | Status | Level of Severity | Reference |
|---|---|---|---|---|---|---|
| 194 | First Floor Bedroom 2 | Electrical | Misaligned installation of switch board | Open | 2 | |

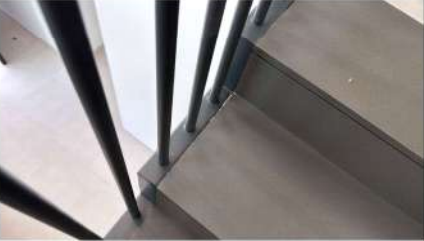
| Sl. No | Location | Category | Defect | Status | Level of Severity | Reference |
|---|---|---|---|---|---|---|
| 195 | Staircase | Civil | Improper grouting noted on floor tile to handrail frame | Open | 2 | |

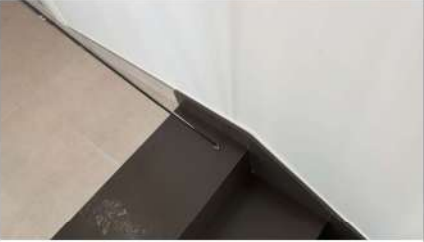
| Sl. No | Location | Category | Defect | Status | Level of Severity | Reference |
|---|---|---|---|---|---|---|
| 196 | Staircase | Civil | Hollow sound detected on staircase tread | Open | 2 | |

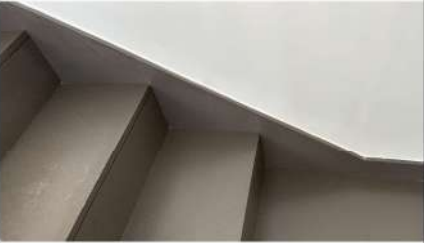
| Sl. No | Location | Category | Defect | Status | Level of Severity | Reference |
|---|---|---|---|---|---|---|
| 197 | Staircase | Civil | Improper grout application observed on staircase skirting tile | Open | 2 | |

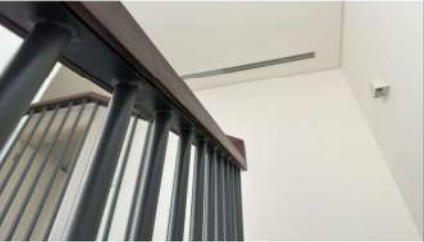
| Sl. No | Location | Category | Defect | Status | Level of Severity | Reference |
|---|---|---|---|---|---|---|
| 198 | Staircase | Civil | Visible gap noted on staircase handrail to wooden frame, check throughout the area | Open | 2 | |

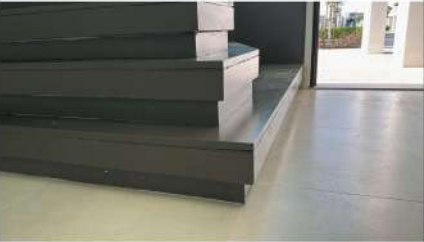
| Sl. No | Location | Category | Defect | Status | Level of Severity | Reference |
|---|---|---|---|---|---|---|
| 199 | Staircase | Civil | Improper sealing noted on staircase rise joints | Open | 2 | |

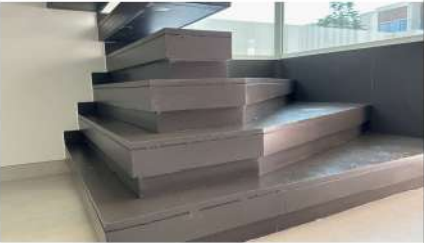
| Sl. No | Location | Category | Defect | Status | Level of Severity | Reference |
|---|---|---|---|---|---|---|
| 200 | Staircase | Civil | Improper sealing noted on staircase rise joints | Open | 2 | |

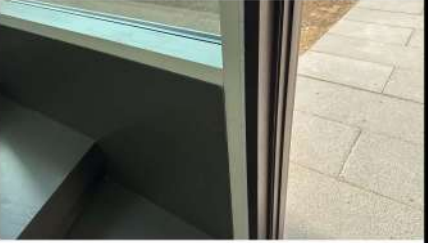
| Sl. No | Location | Category | Defect | Status | Level of Severity | Reference |
|---|---|---|---|---|---|---|
| 201 | Staircase | Civil | Misaligned wall tile installation | Open | 2 | |

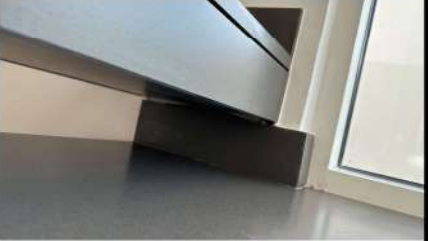
| Sl. No | Location | Category | Defect | Status | Level of Severity | Reference |
|---|---|---|---|---|---|---|
| 202 | Staircase | Civil | Improper grouting found below the staircase | Open | 2 | |

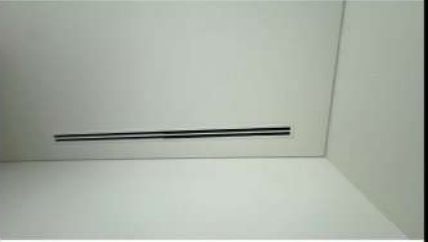
| Sl. No | Location | Category | Defect | Status | Level of Severity | Reference |
|---|---|---|---|---|---|---|
| 203 | Staircase | Mechanical | Stains were found on ceiling AC grill panel | Open | 2 | |

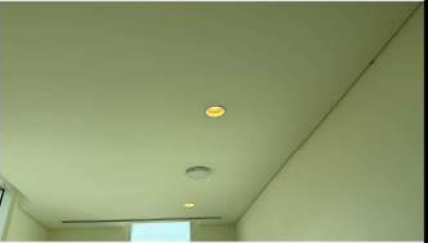
| Sl. No | Location | Category | Defect | Status | Level of Severity | Reference |
|---|---|---|---|---|---|---|
| 204 | Staircase | Electrical | Visible gaps were noted around the ceiling spotlights | Open | 2 | |

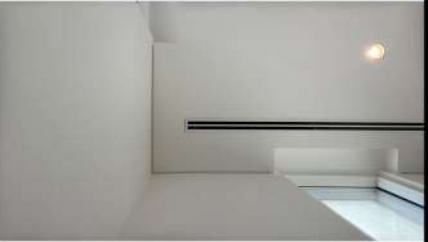
| Sl. No | Location | Category | Defect | Status | Level of Severity | Reference |
|---|---|---|---|---|---|---|
| 205 | Staircase | Mechanical | Gaps were found around the ceiling AC grill panel | Open | 2 | |

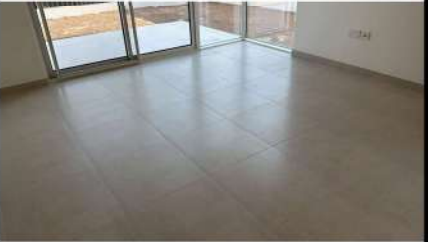
| Sl. No | Location | Category | Defect | Status | Level of Severity | Reference |
|---|---|---|---|---|---|---|
| 206 | Ground floor living area | Civil | Stepping noted on almost all floor tile | Open | 2 | |

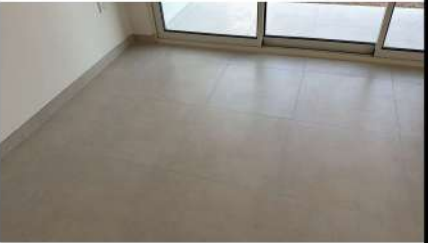
| Sl. No | Location | Category | Defect | Status | Level of Severity | Reference |
|---|---|---|---|---|---|---|
| 207 | Guest room | Civil | Stepping noted on almost all floor tile | Open | 2 | |

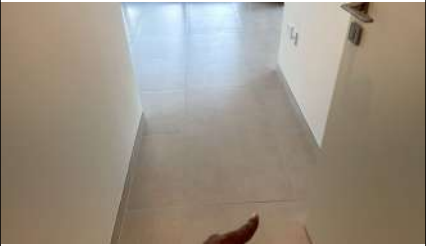
| Sl. No | Location | Category | Defect | Status | Level of Severity | Reference |
|---|---|---|---|---|---|---|
| 208 | Guest room | Civil | Stepping noted on floor tile | Open | 2 | |

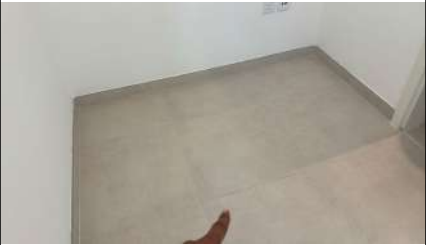
| Sl. No | Location | Category | Defect | Status | Level of Severity | Reference |
|---|---|---|---|---|---|---|
| 209 | Guest room | Civil | Stepping noted on floor tile | Open | 2 | |

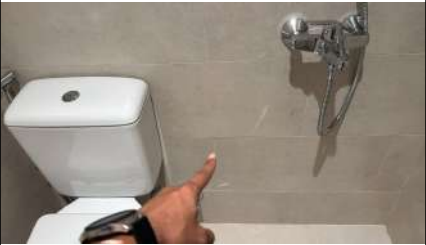
| Sl. No | Location | Category | Defect | Status | Level of Severity | Reference |
|---|---|---|---|---|---|---|
| 210 | Maid Room (Bathroom) | Civil | Stepping noted on wall tile | Open | 2 | |

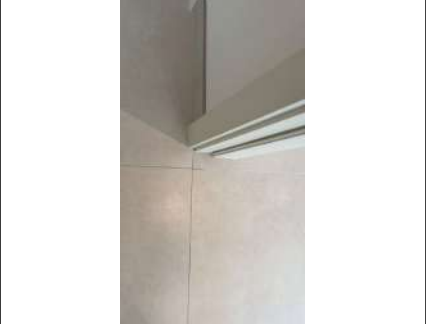
| Sl. No | Location | Category | Defect | Status | Level of Severity | Reference |
|---|---|---|---|---|---|---|
| 211 | Maid Room | Civil | Chipped floor tile | Open | 2 | |

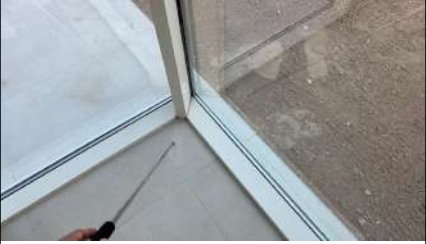
| Sl. No | Location | Category | Defect | Status | Level of Severity | Reference |
|---|---|---|---|---|---|---|
| 212 | Ground floor living area | Civil | Hollow sound detected on floor tile | Open | 2 | |

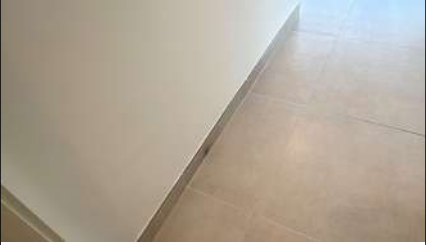
| Sl. No | Location | Category | Defect | Status | Level of Severity | Reference |
|---|---|---|---|---|---|---|
| 213 | Guest room | Civil | Stains were found on skirting tile | Open | 2 | |

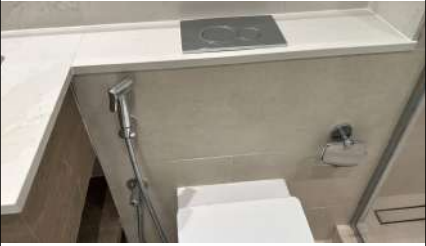
| Sl. No | Location | Category | Defect | Status | Level of Severity | Reference |
|---|---|---|---|---|---|---|
| 214 | Ground floor powder room | Civil | Stepping noted on wall tile | Open | 2 | |

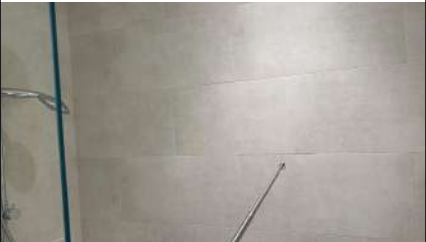
| Sl. No | Location | Category | Defect | Status | Level of Severity | Reference |
|---|---|---|---|---|---|---|
| 215 | Ground floor powder room | Civil | Stepping noted on wall tile | Open | 2 | |

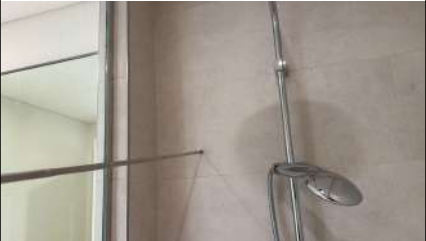
| Sl. No | Location | Category | Defect | Status | Level of Severity | Reference |
|---|---|---|---|---|---|---|
| 216 | Ground floor powder room | Civil | Hollow sound detected on wall tile | Open | 2 | |
