## Prelude Subsea System Dashboard

Current as at: 05/07/2020

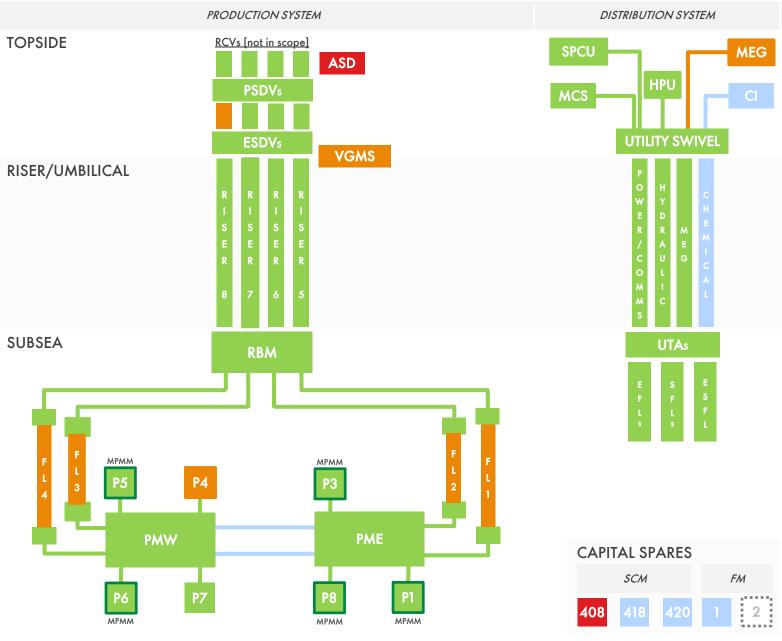
COMMENTARY		IDENTIFIED
	<ul> <li>PHPU LP5 Regulator function deteriorating WO 61840503</li> <li>P1 and P7 MEG supply leaks topside WO 61877511, 61885121</li> <li>P5 MEG Flow Meter failed. Repair scheduled Aug 2021. WO 61773697.</li> </ul>	May 2021 June 2021 Mar 2021
	<ul> <li>P5 MEG MOV weeping due to valve body corrosion. WO 61806433.</li> </ul>	Mar 2021
	<ul> <li>VGMS nil readings. Troubleshooting ongoing.</li> </ul>	June 2021
	<ul> <li>Riser 8 polymer coupon access fitting damaged since installation.</li> <li>NCR raised. Planned for replacement during turnaround.</li> </ul>	Dec 2018
	<ul> <li>VGMS GRVs to be removed to allow monitoring of riser annulus.</li> <li>Planned for Q4 2021. WO 60899023-6.</li> </ul>	Jul 2019
	<ul> <li>Flowline spans exceeding allowable lengths at buckle trigger locations. Engineering for remediation underway targeting 2022 execution. WO 61850106-14</li> </ul>	Sep 2019

<ul> <li>P4 LVDT error. Sensor fault. Well flowing with mitigations. FM c/o in Q3 2021.</li> </ul>	Jan 2021

- FM 1 (formerly fitted to P6) with new MPMM choke. Repair completed December 2020. Staged at DOSB.
- FM 2 fabrication complete. In transit to DOSB. Ready for install Q3 2021.
   ISM completed on 2 SCMs in May 2021. SCM 408 internal fault under investigation with TFMC
