# PRUSA PRINTER PARTS MANUFACTURING PROCESS OPTIMISATION AND DEVIATION CONTROL REPORT BASED ON KIC ANALYSIS

Name and Student ID: Zhifeng Song

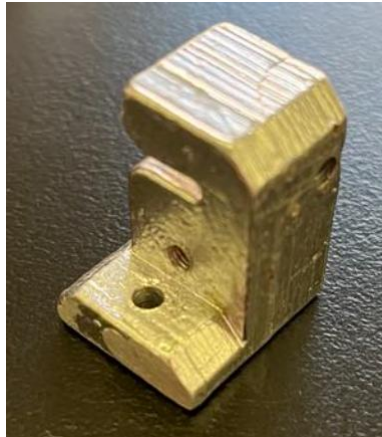
*Actual parts drawing 1*

Castings Y-axis tensioner In this inspection, multiple critical dimensions were found to be out of tolerance, primarily concentrated in deviations in the position of the tensioning hole and bolt hole, as well as excessive belt clearance thickness. The deviations primarily stem from unreasonable cooling path design, mould positioning deviations, and unstable clamping.

1. Improve the stability of the mould temperature control system, ensure uniform cooling, and reduce expansion and contraction deviations.
2. Add positioning points to enhance the clamping force of the mould and prevent misalignment.
3. Regularly perform positioning inspection and adjustment of moulds to improve dimensional consistency.

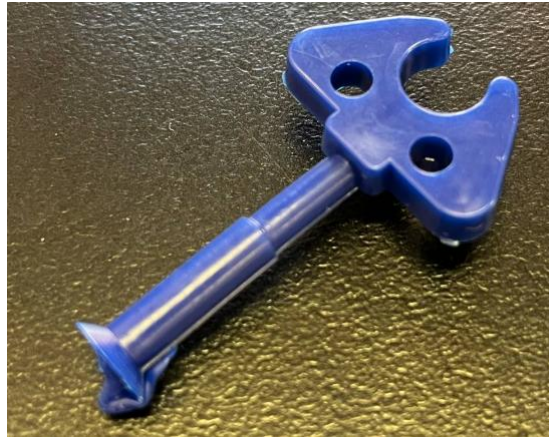
*Actual parts drawing 1*

The Y-axis guide rod clamping block was inspected for 5 critical dimensions, all of which failed to meet specifications. The bolt hole spacing deviation is -0.29 mm, and the rod hole diameter deviation is -0.29 mm, both exceeding the tolerance range, primarily due to uneven mould shrinkage and cooling; the bolt hole diameter deviation is -0.09 mm, indicating insufficient machining accuracy; the rod gap deviation is +0.50 mm, caused by mould deformation. It is recommended to improve the mould structure and optimise the cooling path to enhance dimensional consistency.
