42-47RE

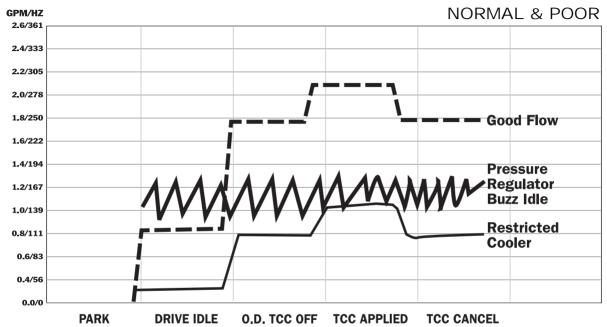
Condition: Repeated planetary failure, TCC lining failure.

Notes: Flow is less due to 5/16" vs. 3/8" cooler line on 42RE and 47RE units. Good cooler flow circuits have sharp increase/decrease of lockup control. Updated valves allow fluid in park to charge converter.

Correction: Replace cooler lines and/or radiator. Converter failure plugs lines and then overheats planets.
