4T60-E

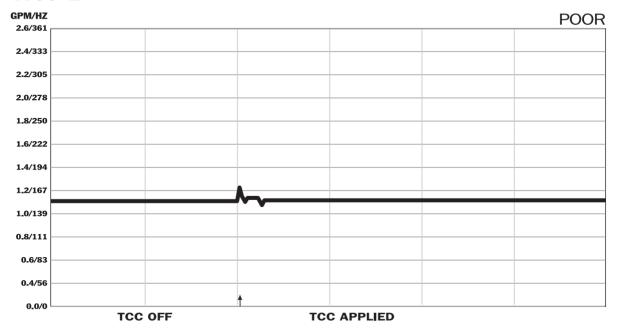
Condition: Poor or no TCC apply, work bore at TCC apply valve.
