4R70W ('95-HIGH MILEAGE)

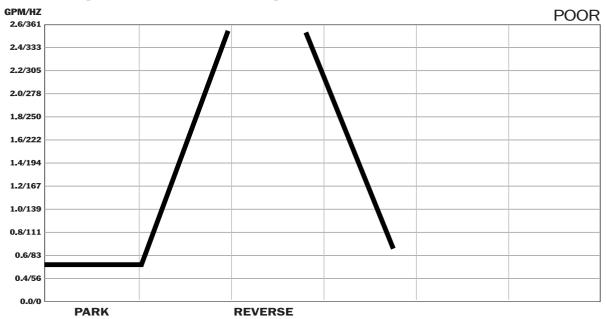
Condition: Aerated fluid (pump grabbing air), poor suction porting, gaskets, etc.

Notes: Initial start, then reverse engagement. Can occur at end of 1-2 shift.

Correction: New pump, Sonnax Bypass Clutch Control Sleeve & Plunger Valve **76948-04K**, pressure regulator valve and converter regulator valve.
