4R44E/5R55E ('99)

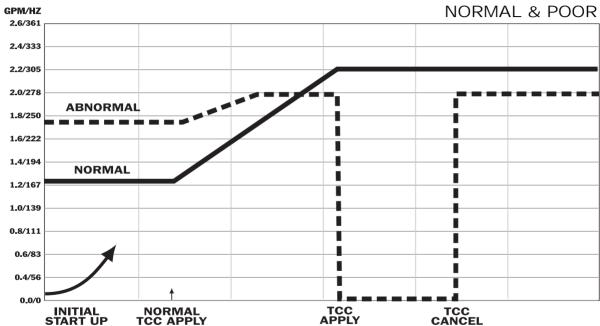
Condition: Dotted line is with TCC control valve installed backward.

Notes: Normal TCC apply and flow rate sensitive to pump rpm – set 728 code.
