Checking valve bodies with a homemade hydraulic test stand

By Rick Hoffman

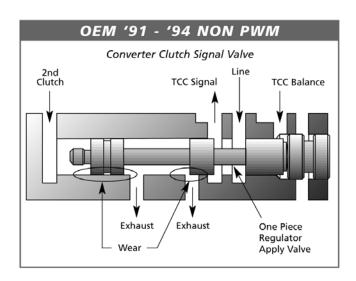
In AXODE, AODE, AX4N, and CD4E units, converter shudder and reduced cooler flow can be traced to worn bypass/TCC control valve lineups. This can be easily checked for wear by isolating and checking for leakage. Shown is a bypass clutch control sleeve and plunger valve being tested for leakage. This bore is showing a 1.5 Hz leak. I replaced the sleeve and plunger assembly and rechecked the leakage. This unit came in with overheated planets.

TCC Bypass valve testing in AXODE Valve body

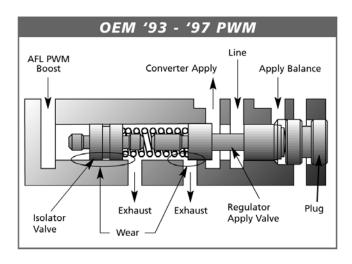
An example is the 4T60-E TCC apply valve. Leakage at the largest spool will cause a no lockup condition, even if the scanner says TCC enable yes, but the valve is not stroked. Leakage at the other lands can cause no lockup when hot, DTC 740, torque converter shudder and burn-up of lockup plate. After repairing this complaint, a modified / closed solenoid can be installed. Pressure is applied to the TCC signal passage and you can watch the valve stroke.

TCC Apply Valve in Ford 4T60-E
