PART NUMBERS 77942-01K, -02K

Torque Converter Clutch Solenoid Snout

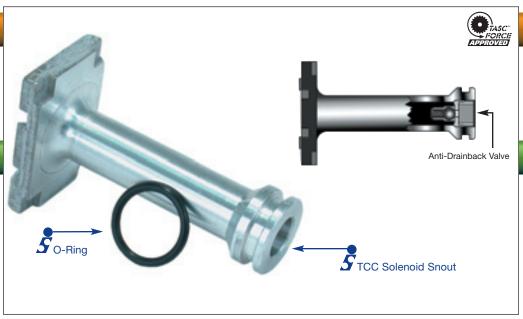
The OEM plastic solenoid snout cracks where it contacts the plunger valve, causing oil leaks, while the PWM TCC signal drainback valve becomes loose or melts and blocks the converter apply valve.

Converter clutch apply problems

• Overheated converter • Loss of lube

Replace the broken solenoid snout with an aluminum snout either with or without a built-in anti-drainback valve.
