**PART NUMBER 34880-01**

## Output Speed Sensor (Reluctor) Ring

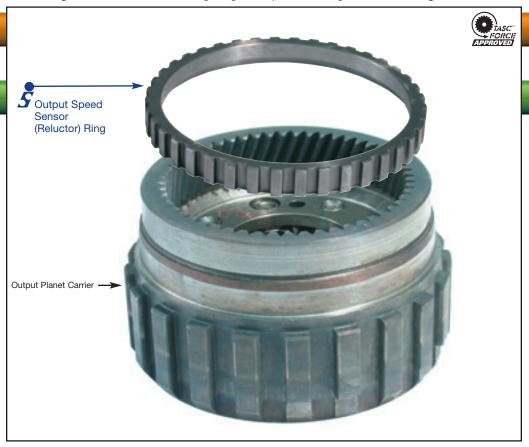
1 Speed Sensor (Reluctor) Ring

## Lost or erratic output sensor signal

Cracked or broken reluctor ring teeth.

Replace the damaged OEM ring without having to replace the complete output carrier assembly.
