Good Vibrations, 4T60-E Differential Problems By Gary Carne

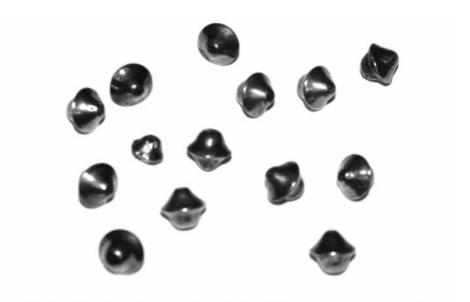
STOP!! This is where you MUST verify that you do not have any contamination, specifically in the lube tube itself. If the transmission is a GM SRTA Service Replacement Transmission Assembly, contamination IN THE LUBE TUBE may well be the "vibratory media" that is used in the cleaning process at the GM SRTA plants. That lube tube may actually be plugged with these media particles, which are small enough to slide inside the tube. If you don't completely disassemble the accumulator cover assembly, including the connecting hose and clamps, you'll never be able to see all the small media pieces that have become lodged in the lube tube's bends and crimps. We have seen as many as 10 of these media pieces in these lube tubes.

LITTLE CULPRITS -- The vibratory media used in the GM SRTA cleaning process are smaller than a pea and even harder to find in crimps, bends and hoses. These little media can block lubrication and cause big problems.

You may think that a strong blast of air will remove any vibratory media that may be affecting the unit. You're wrong! Remember, air will go where oil will not. Units with this problem have "air tested" just fine. The only sure bet is to grab a few pipe cleaners and ream out the lube tube, paying particular attention to the bends and crimps where the media tends to collect. It is also recommended that ALL lube tubes have solvent or parts cleaner run through them to verify flow.
