## **4R100 Repeated Converter Failure**

By Bob Warnke

In this lesson we will hear of a 4R100 in a 2000, 7.3 diesel with repeated (four times) converter failures.

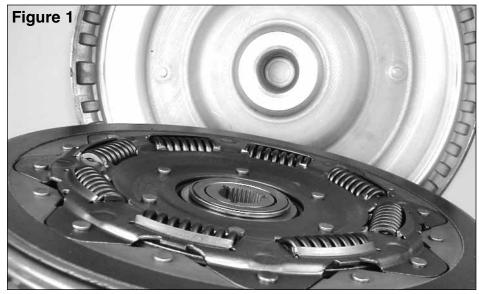
4R100 Multi-Plate Converter with Bearing Style Turbine Hub

In the 4R100 converter example, the piston travel is controlled by the exhaust of fluid past the turbine hub. If too close/restrictive, the release oil will slowly exhaust as the TCC piston forces the oil out (see Figure 1).
