PART NUMBERS 84754-36K, -37K, -38K, -39K

### **Shift Valves**

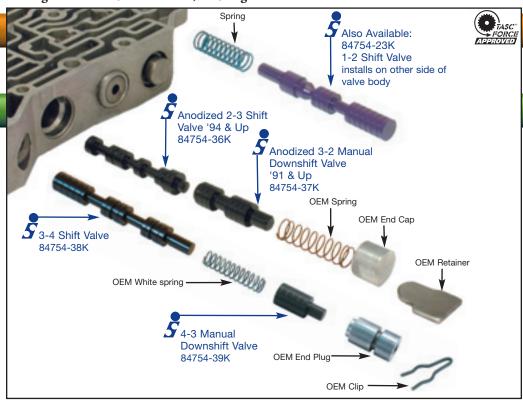
The non-anodized valves score and seize in the bore

### Erratic or temperature-sensitive shifts

• 2nd gear start • 2-3 shuttle shift, no 3rd gear • No 4th • Anodized valves unavailable

These valves are hard anodized with annular grooves which eliminate surface wear and reduce valve hang-up.
